Ville de Montréal

**TRUNK SEWER INSPECTION AND
CONDITION ASSESSMENT STUDY**

Project Bonaventure

DRAFT REPORT

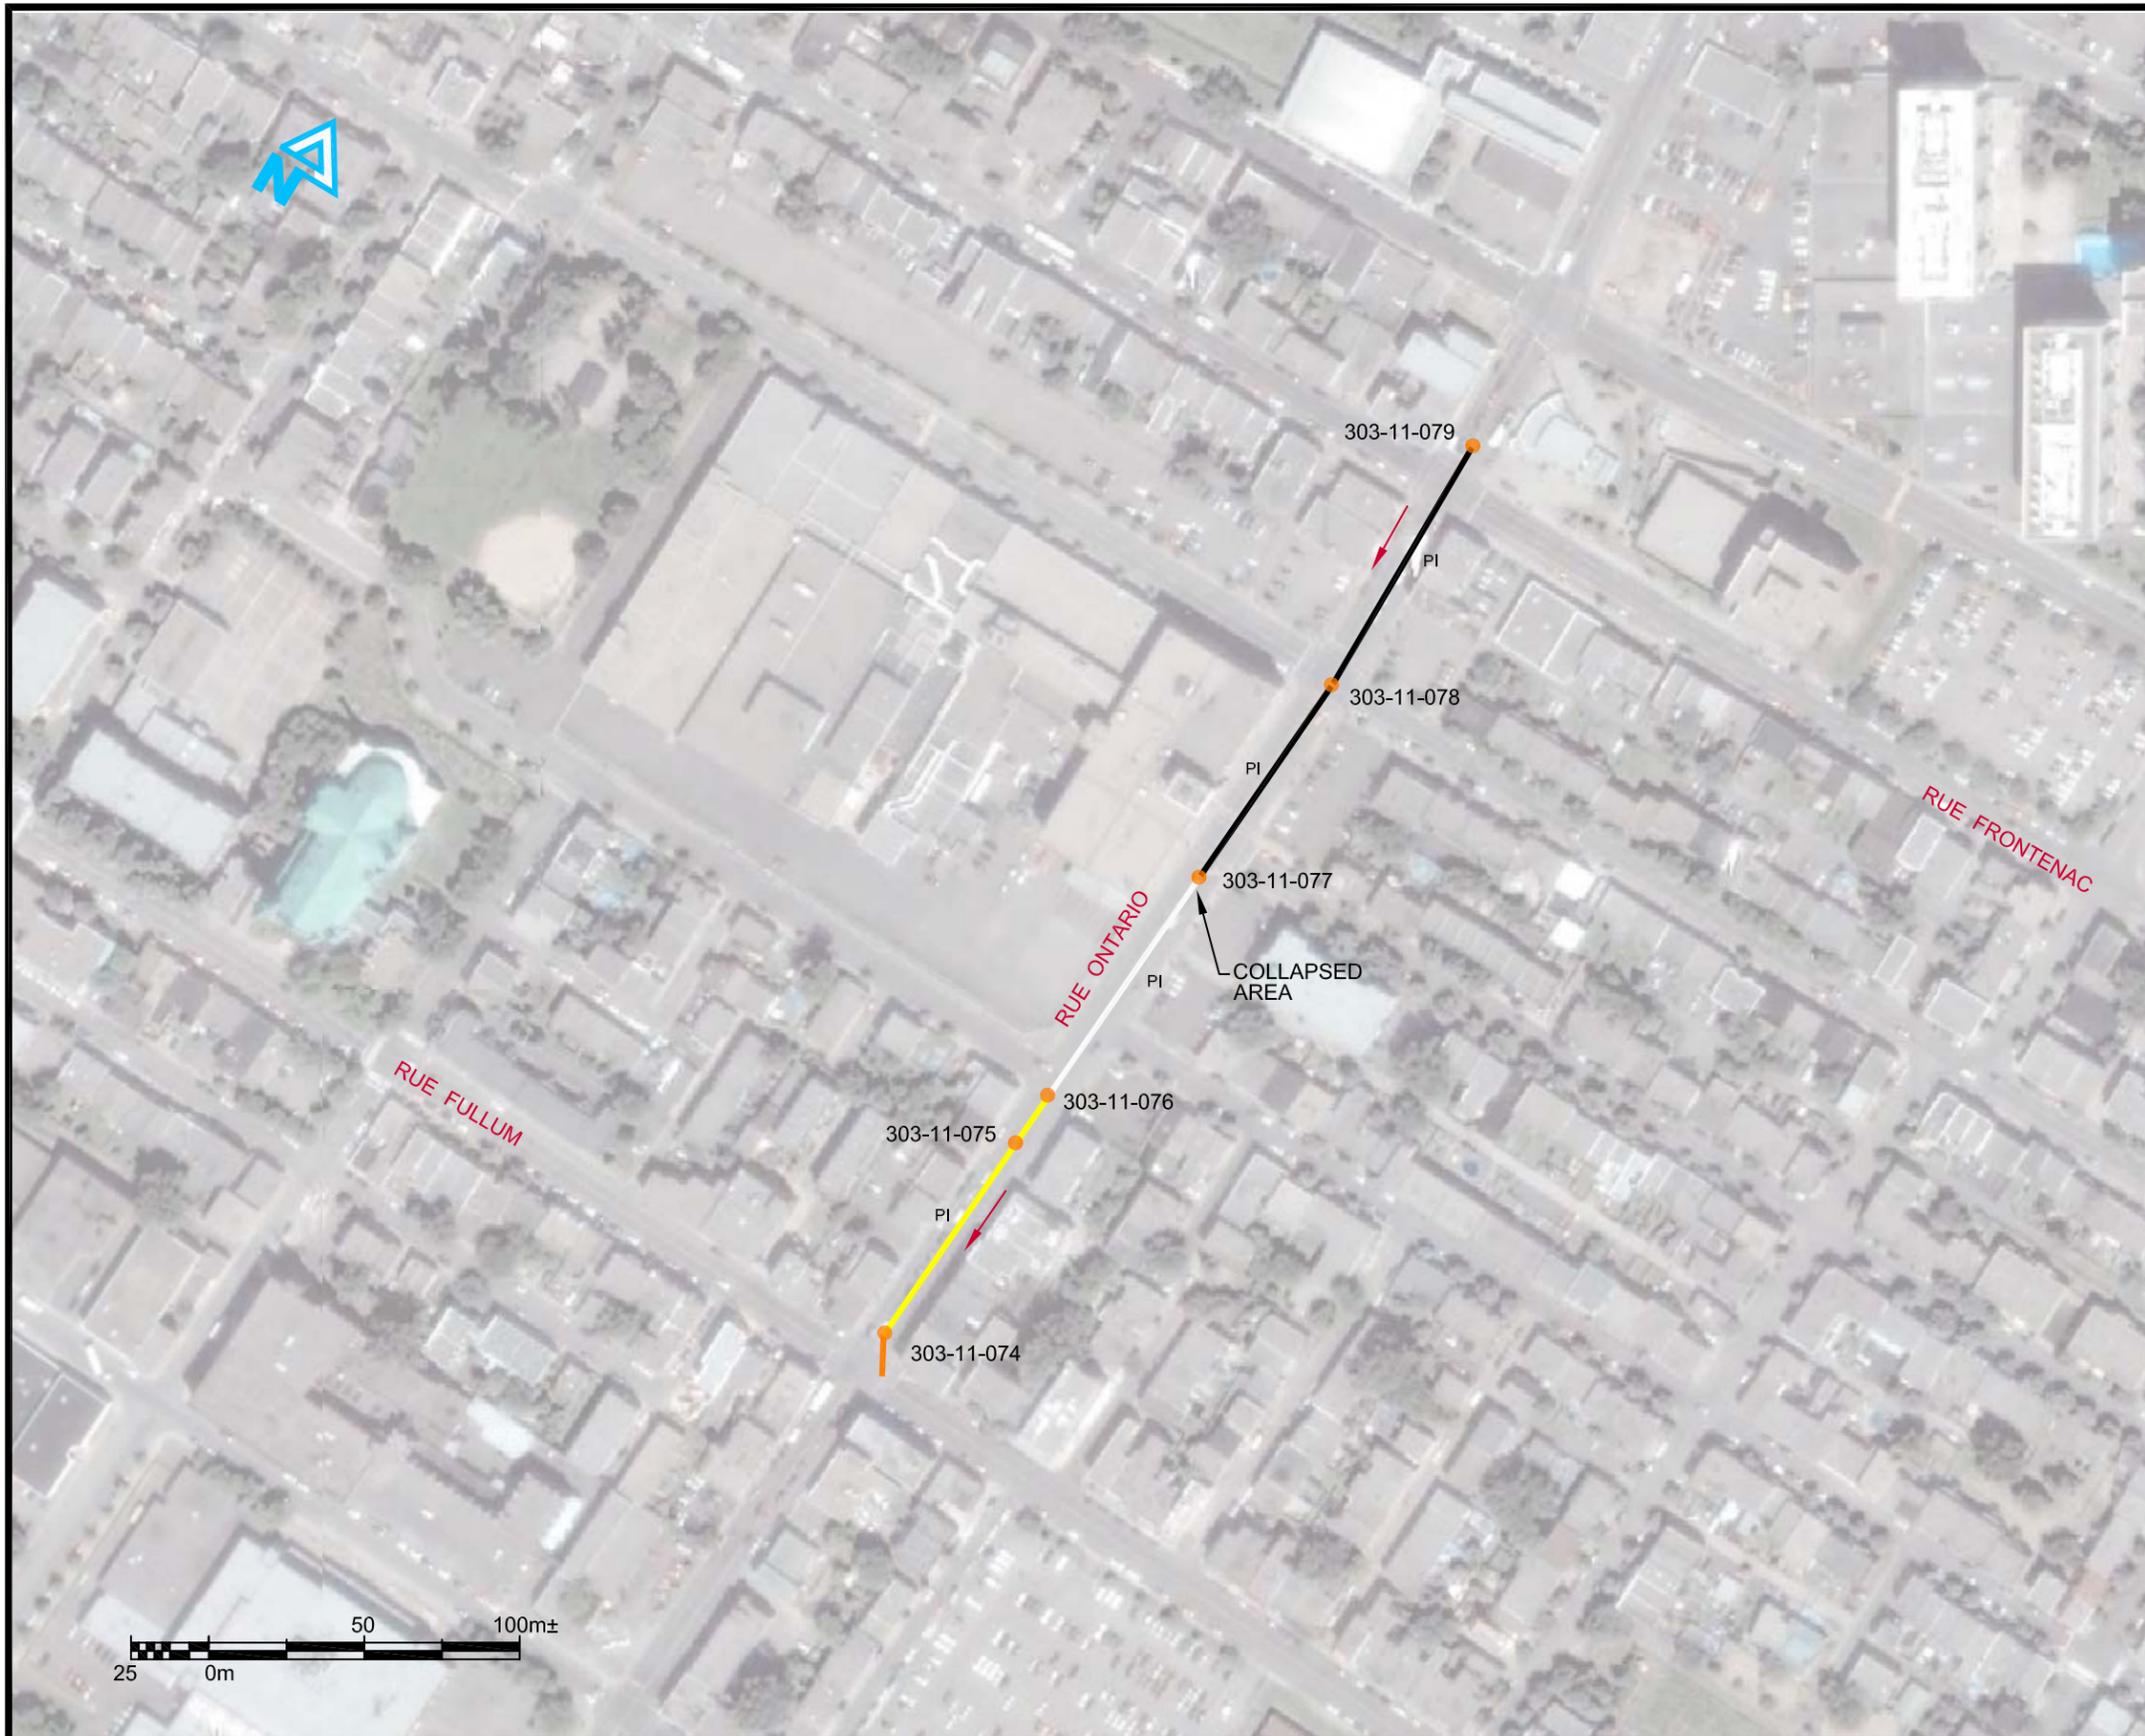
FIGURE 2-1

General: The sewer comprises a 900 x 600 mm egg shaped brick pipe throughout all sections. The sewer was found to be in Poor to Failed condition. Extensive areas of debris and brick rubble prevented complete inspection of some sections. Detailed inspection observations are provided in Table 2-1 and Figure 2-1. Moderate to severe structural damage was observed including mortar loss, fractures, holes, horizontal and vertical deformation and full collapse. Voids in the surrounding backfill were observed at the collapse area (see photograph 3-1 in Chapter 3). A utility pipe (watermain?) was observed across the sewer obvert which has caused significant damage to the brick fabric.

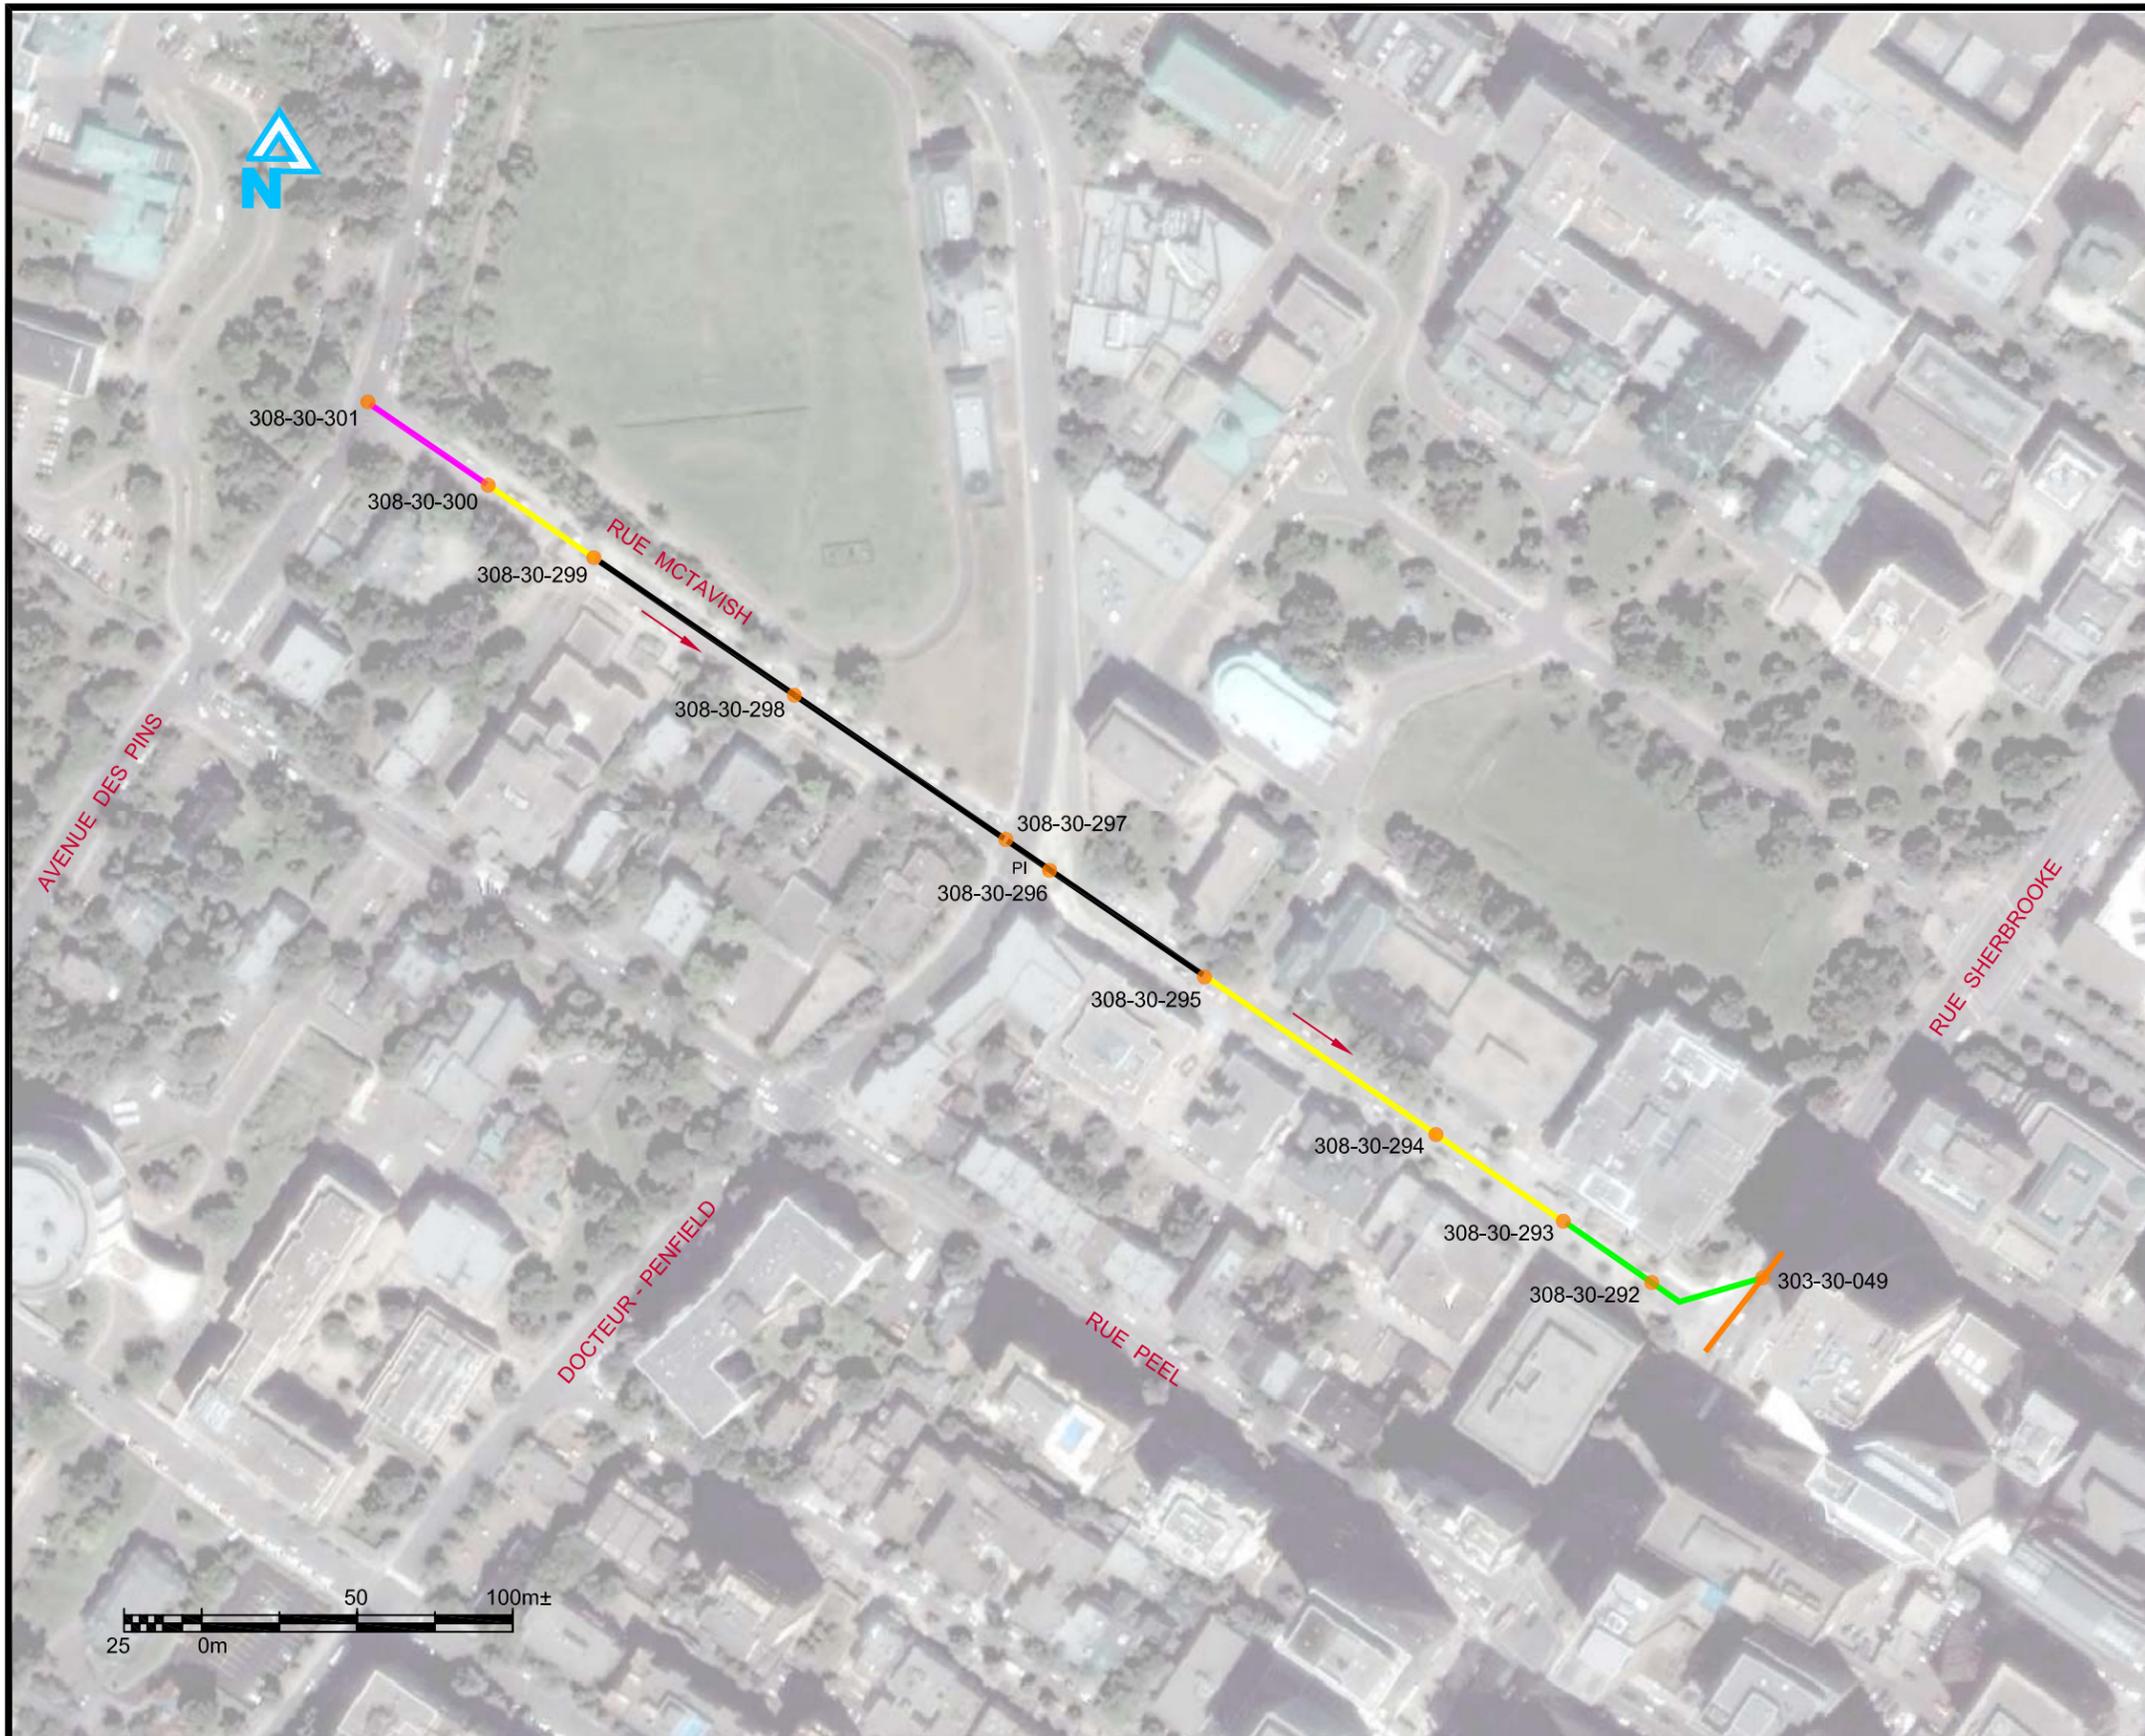
FIGURE 2-2

General: This sewer comprises three types; 900 x 600 mm egg shaped concrete pipe (2 sections), 900 x 600 mm egg shaped brick pipe (8 sections) and a single 750 mm circular concrete. Detailed inspection observations are provided in Table 2-2 and Figure 2-2. Moderate structural distress was observed. However significant infiltration, including running and gushing infiltration, was observed (see photographs in Chapter 3). Pipe size and material changed in two sections (to 600 mm concrete pipe). These may correspond to previous sewer repairs.

Service: Very fast flow with very clear sewage. Moderate to heavy running and gushing infiltration throughout the upper sewer sections. Infiltrating water is under obvious pressure and in some cases can be seen issuing vertically up through the sewer invert. Mortar has been washed out in some areas with resulting shifted and displaced bricks. Pockets of sediment and rubble were observed in downstream sections. Otherwise sections are clean and well scoured. Water level is relatively constant at about 5% of full pipe. Water levels increase to 50% in the downstream reach in part due to observed sediment and rubble deposits.

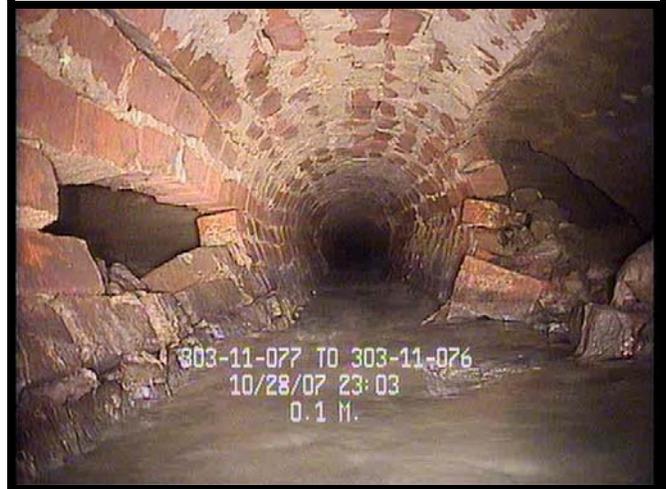
Collapsed sewer with voids at both springlines (Ontario St., MH 303-11-077 to MH 303-11-076)

It is recommended that the highest priority be given to reconstructing or rehabilitating these sections that have failed. Prior to repair, the City should be prepared for the possible sudden failure of the road surfaces at one or more of these sections.

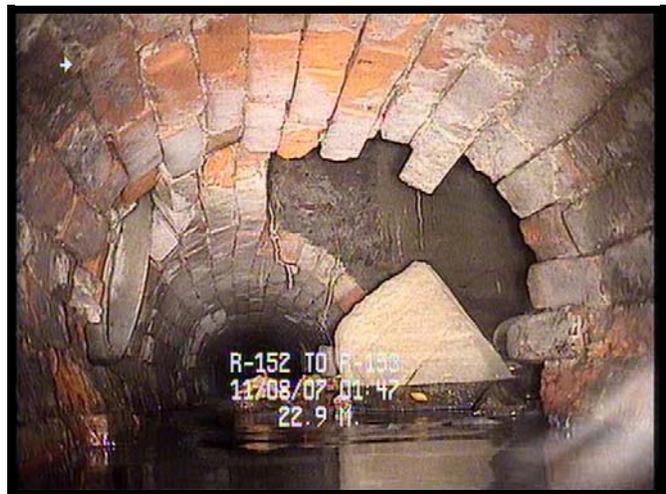
Photograph 3-2

Collapsed sewer with void (St. Paul, MH R-152 to R-153)

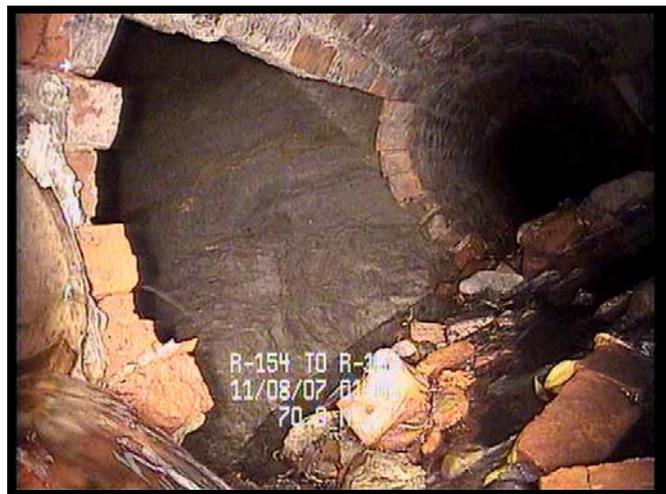
Photograph 3-3

Numerous sections were found to be in Bad condition due to heavy silt and rubble accumulations. The depth and extent of the observed debris seriously impacts hydraulic performance (see Photographs 3-3 and 3-6). Due to the depth of sediment, many of these sections could not be fully inspected with CCTV equipment. As a result additional defects, in the form of moderate to serious structural defects, could exist, undetected, in some of these sections. Typically a comprehensive cleaning program would be indicated. However, given the risk of worsening existing damage in these sewers, routine cleaning with high pressure

Collapsed sewer with void (St. Paul, MH R-154 to R-153)

Therefore it is recommended that a selective cleaning program be implemented. Individual sections should be selected for careful cleaning and monitoring. Continuous CCTV inspection, for example, would be needed as the cleaning progresses to ensure no additional structural damage is caused. Alternatively, given the widespread structural damage observed in the Project Bonaventure area, consideration could be given to simply including these sewers in the previously recommended rehabilitation program. Reconstructing some sections may in fact be less costly than cleaning and/or rehabilitation. It should be kept in mind that likely many of these sections will reveal significant structural distress once cleaned.

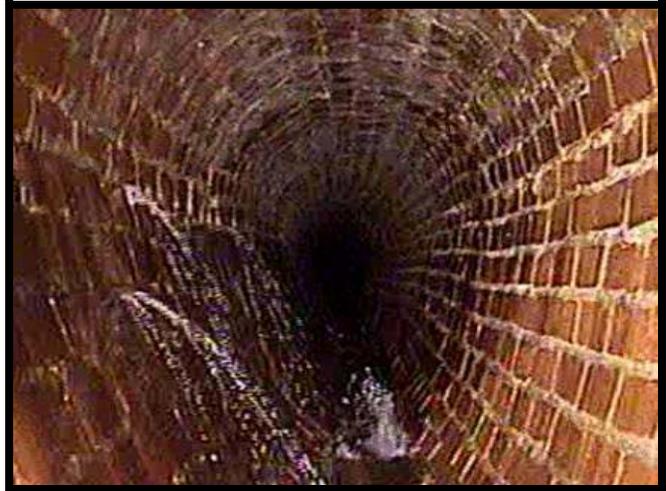
Photograph 3-4

The rate of infiltration and apparent groundwater pressure along the McTavish sewer is remarkable. The pressure of the infiltrating water causes gushing water in the invert to divert flow in the sewer. Water can be seen coming up through the invert in Photograph 3-4. Mortar has been washed out of some joints with resulting displaced bricks. Extensive cracks and fractures are frequent. The incoming water is clear. The sewage itself is unusually clear. It is understood that the City's water supply reservoir is located adjacent to the sewer.

Running and gushing infiltration

It is recommended that investigations be carried out at first opportunity to confirm the nature and source of the high groundwater pressures. It is further recommended that the sections of the McTavish sewer currently in Bad condition be rehabilitated or reconstructed in order to alleviate the infiltration issues. It should be confirmed that the groundwater pressures will not be transferred to other underground services once the sewer is repaired. Furthermore the potential for leakage from the reservoir should be assessed. It is noted that the heavy infiltration tends to occur along the east side of the sewer or in the sewer invert. Continuation of this infiltration could lead to significant bedding washout and eventual collapse of the sewer fabric. Sewer failure and road collapse in this area could have catastrophic consequences for the reservoir foundations and general slope stability along McTavish. The existence of voids around the sewer can not be ruled out and hence it is suggested that the recommended investigations be carried out at the first opportunity.

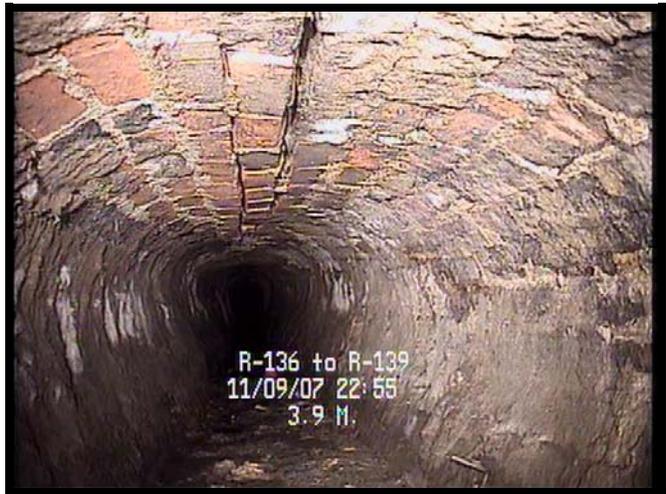
Photograph 3-5

Numerous sewer sections were rated in Bad condition due to extensive structural damage. These are listed in Table 3-1. Structural damage includes longitudinal fractures and deformation (5% to 10%, more in some cases, see Photograph 3-5), missing mortar, missing bricks, missing brick fabric and active infiltration. As with the previously noted Failed sections, these sewer sections remain standing due to the heavily consolidated soil envelopes. However, significant random

Fractures and Vertical deformation (> 10%)

It is recommended that a comprehensive rehabilitation program be developed and implemented for these sewers (as listed in Table 3-1). This program should consider the benefit of complete reconstruction versus rehabilitation, on a case by case basis. Where adjoining sewer sections are in Poor condition, these adjoining sewers should be included in the program. It is understood that significant road re-construction works are planned for Autoroute Bonaventure. Careful consideration should be given as to how the damaged sewers can be best addressed during this road reconstruction work. Assessment of drainage patterns and drainage needs should also be assessed. Opportunities to separate combined sewers, re-direct flow, or to construct new sewers, should be assessed in order to allow for abandonment of some of the badly damaged sections.

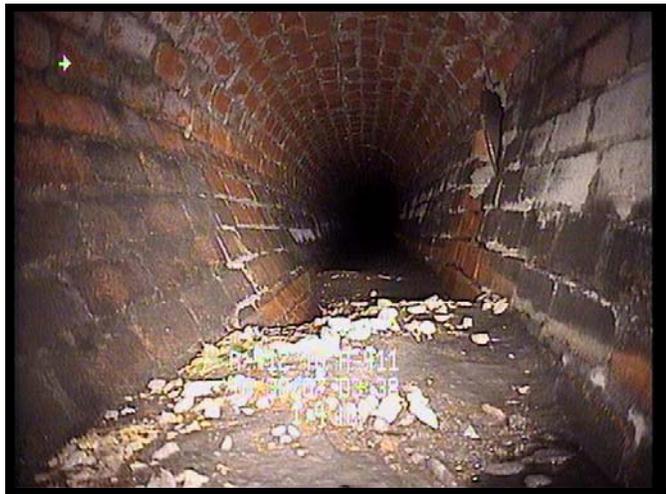
Photograph 3-6

Debris in sewer (> 25%)
