CONSULTATION • INVESTIGATION • DESIGN • CONSTRUCTION REVIEW

**EDIFICE** EXPERTS

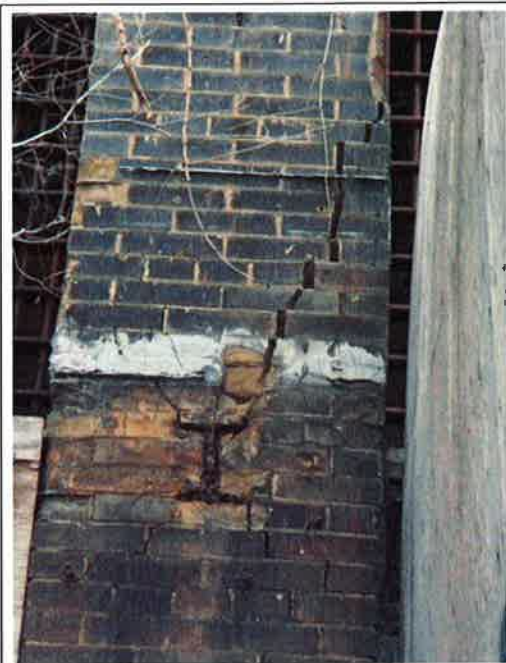
**Photograph No. 8:** Severe fracturing and displacement of the masonry column surrounding embedded steel beam (south façade) **(CRITICAL CONDITION)**

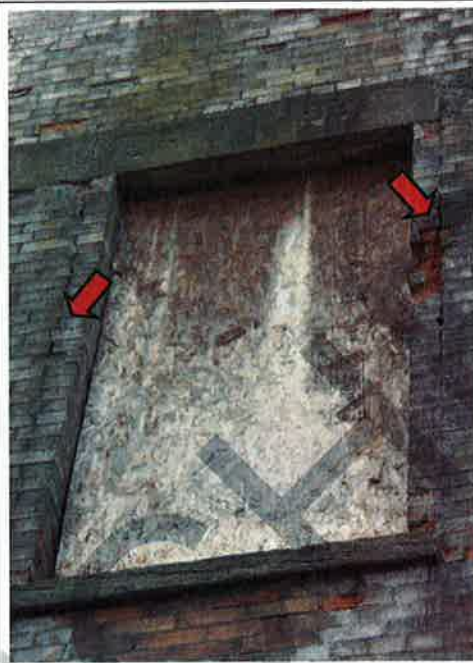
**Photograph No. 9:** Severe longitudinal cracking and spalling of the brick units (east façade) **(CRITICAL CONDITION)**

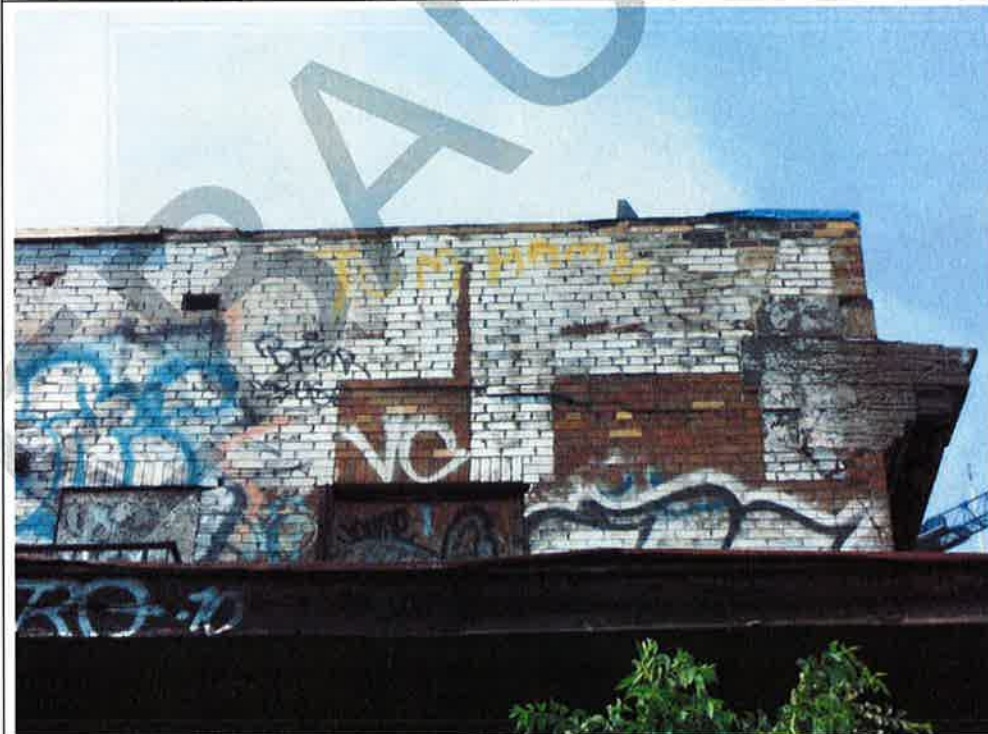
**Photograph No. 10:** Significant lateral displacement of the masonry elements at parapet level and displacement of the stone cornice (south façade) **(CRITICAL CONDITION)**

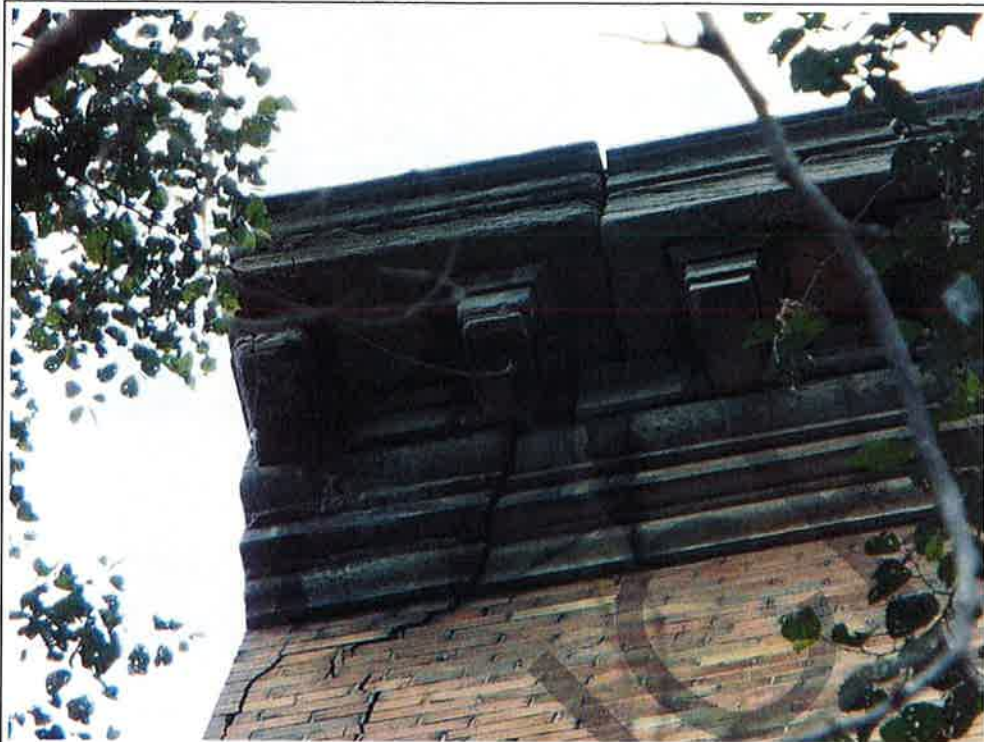
Photograph No. 11: Displacement and severe fracturing of the brick masonry, stone cornice and dentils (southeast corner) **(CRITICAL CONDITION)**

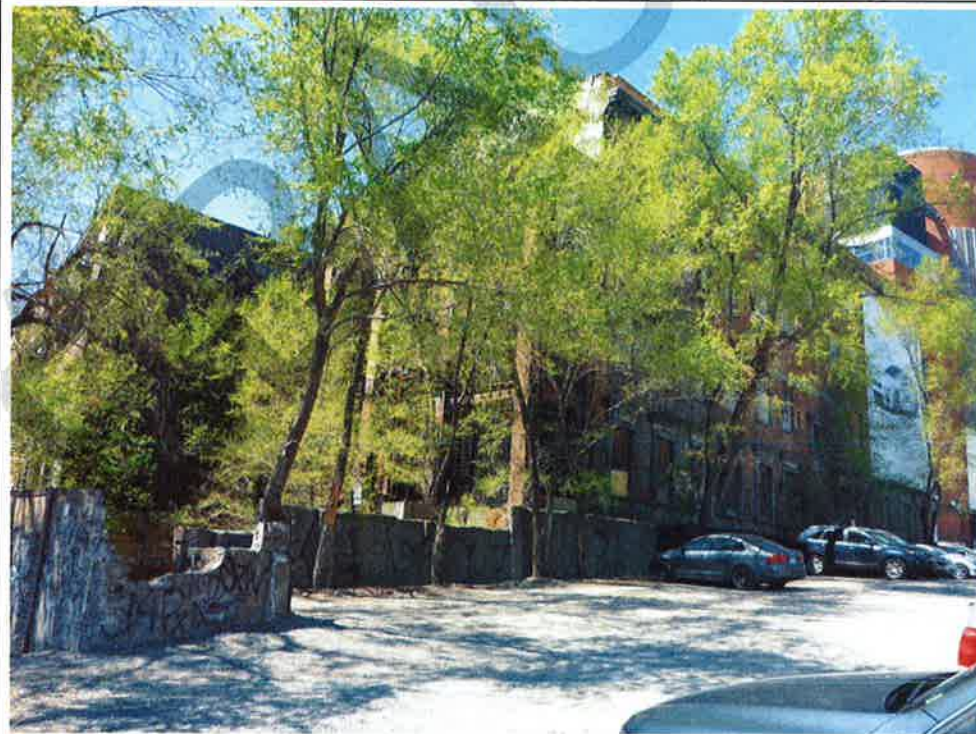
Photograph No. 12: Deteriorated concrete retaining wall along rear east façade

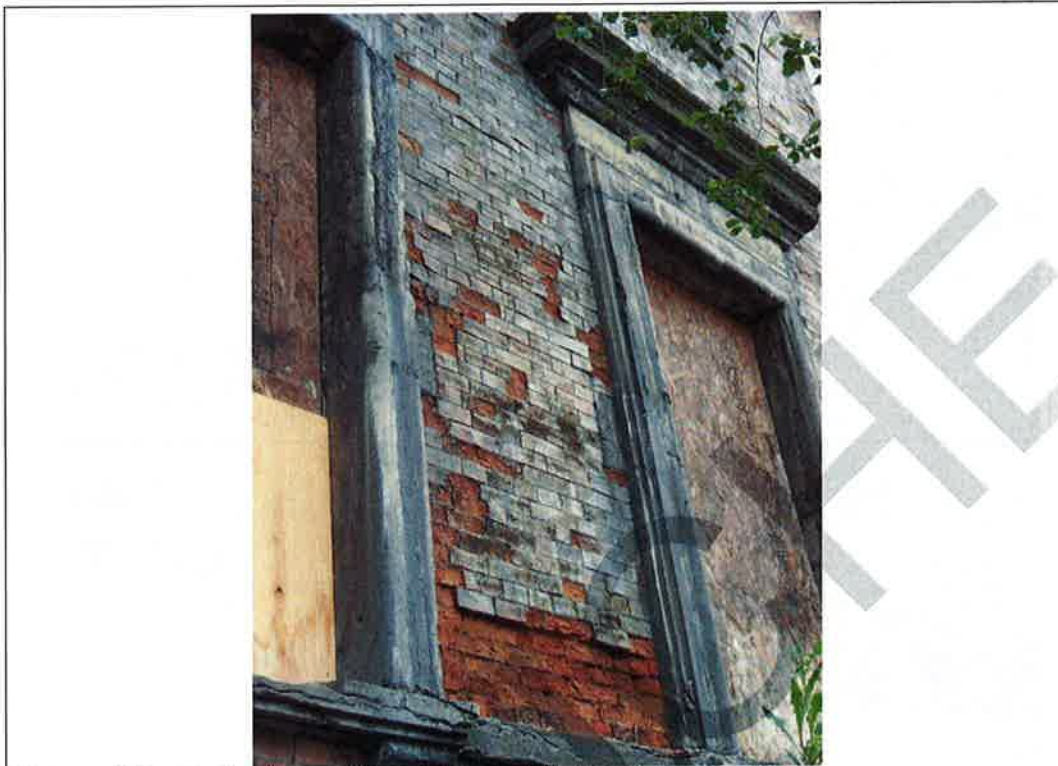
**Photograph No. 13:** Significant spalling and delaminated brick units (east façade)

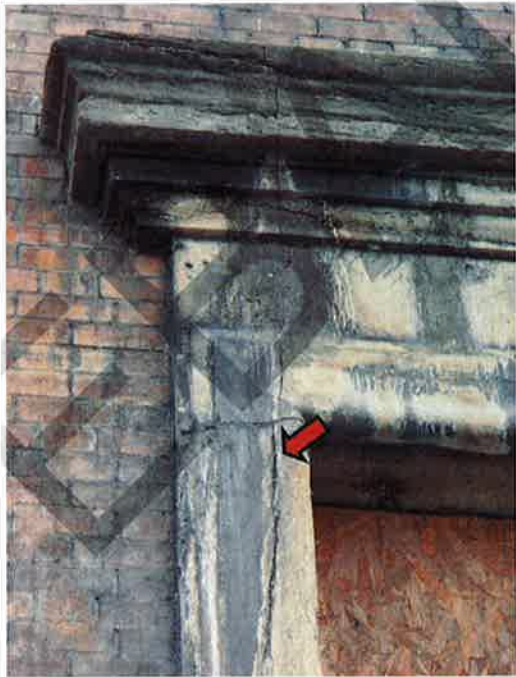
**Photograph No. 14:** Vertical crack in dripstone over window opening (east façade)

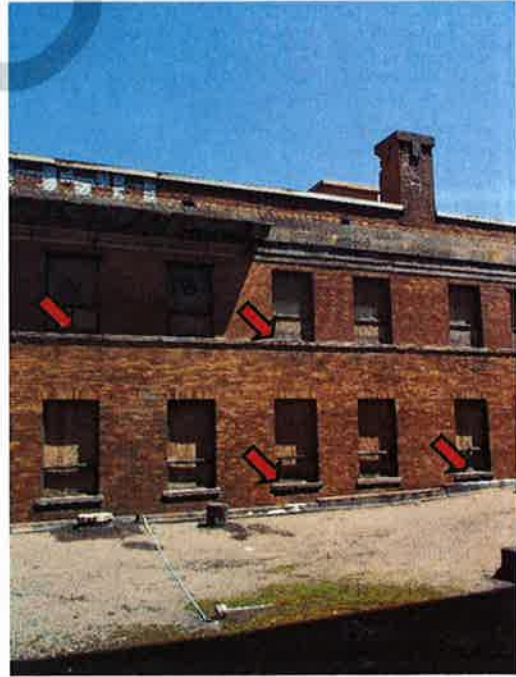
**Photograph No. 15:** Widespread erosion and spalling of stone window sills and string courses (west façade)

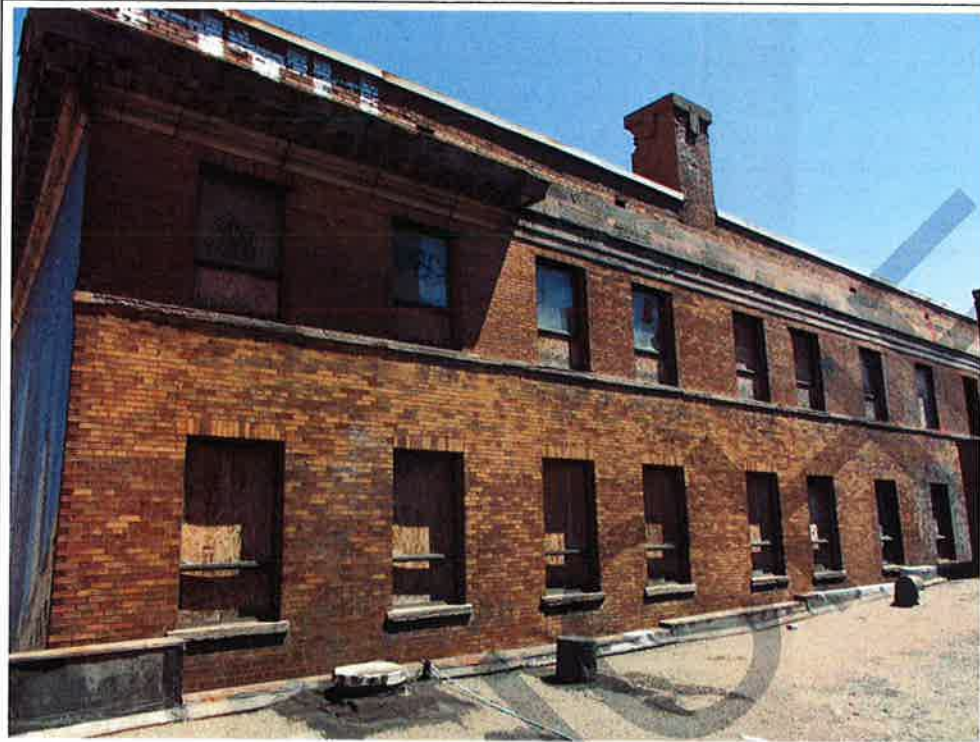
**Photograph No. 16:** Numerous missing window panes (west façade)

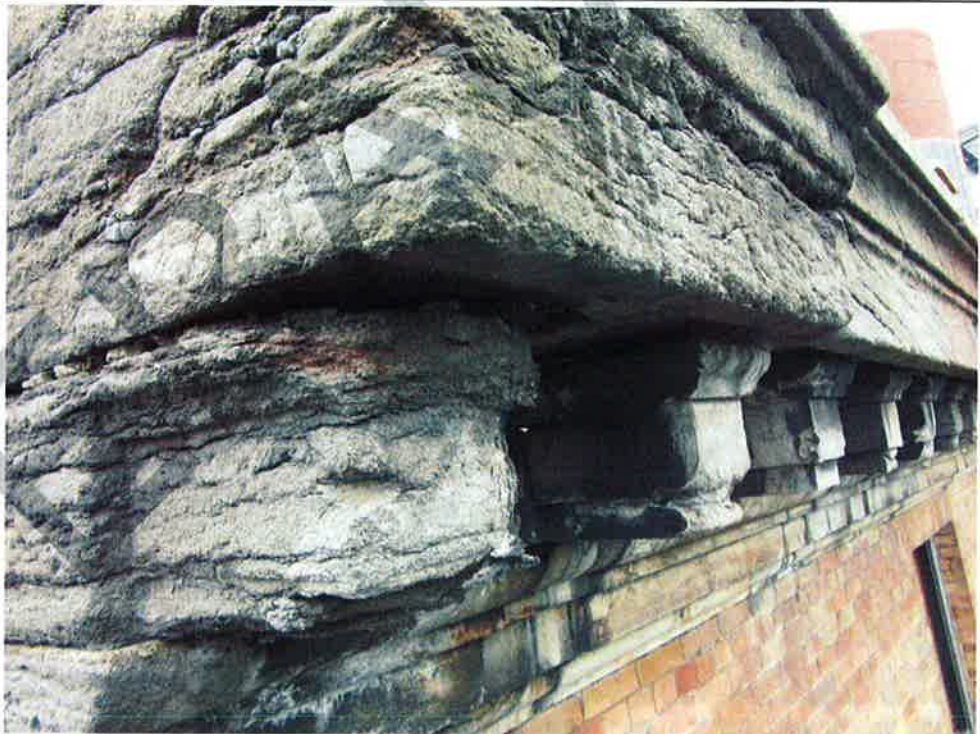
**Photograph No. 17:** Mortar erosion and significant flaking and erosion of ornamental stone dentil at cornice level (southeast corner)

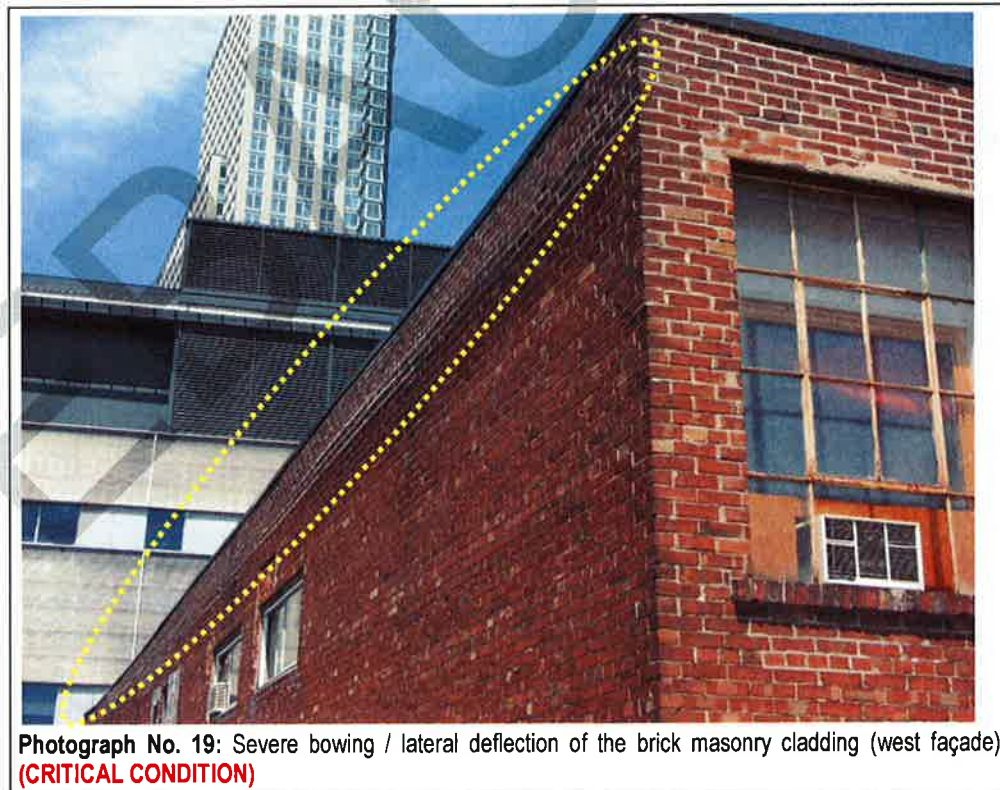
#### 4.1.2 Building 1180

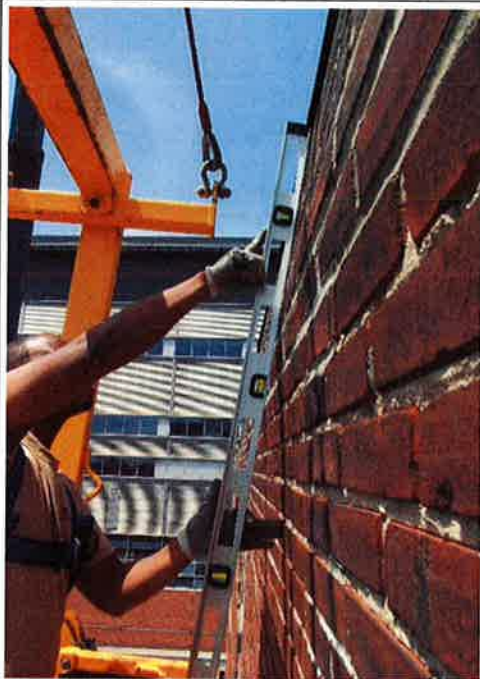
**Photograph No. 20:** Severe bowing/lateral deflection of the brick masonry cladding (west façade) **(CRITICAL CONDITION)**

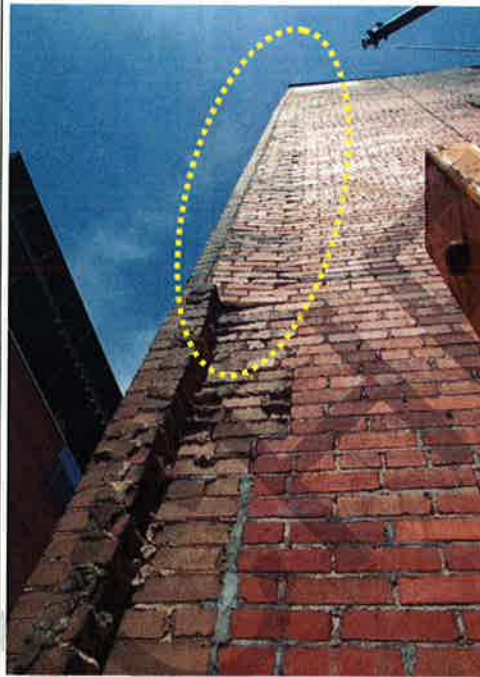
**Photograph No. 21:** Northern portion of the west façade was noted to be out of axis **(CRITICAL CONDITION)**

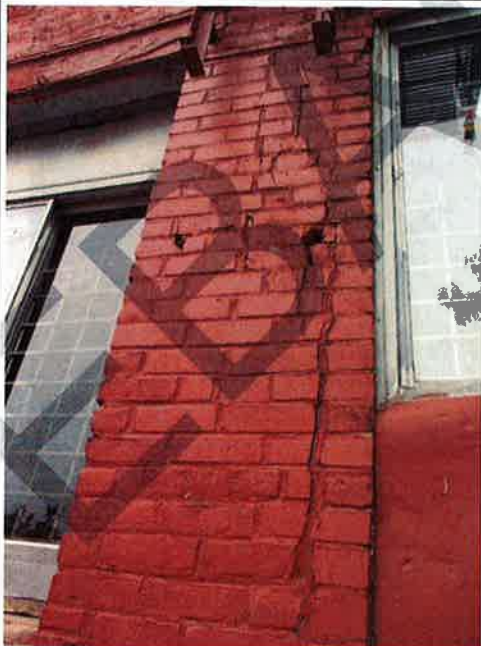
**Photograph No. 22:** Localized longitudinal cracking of masonry column cladding adjacent to window jambs (south façade) **(CRITICAL CONDITION)**

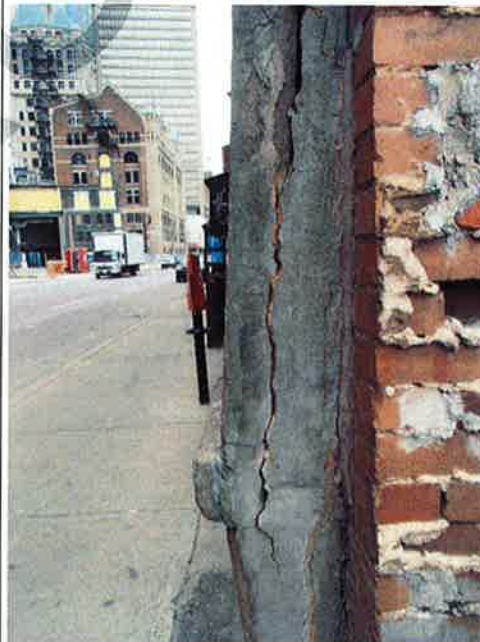
**Photograph No. 23:** Fracturing and lateral displacement of the stone cladding at the street level (north façade)

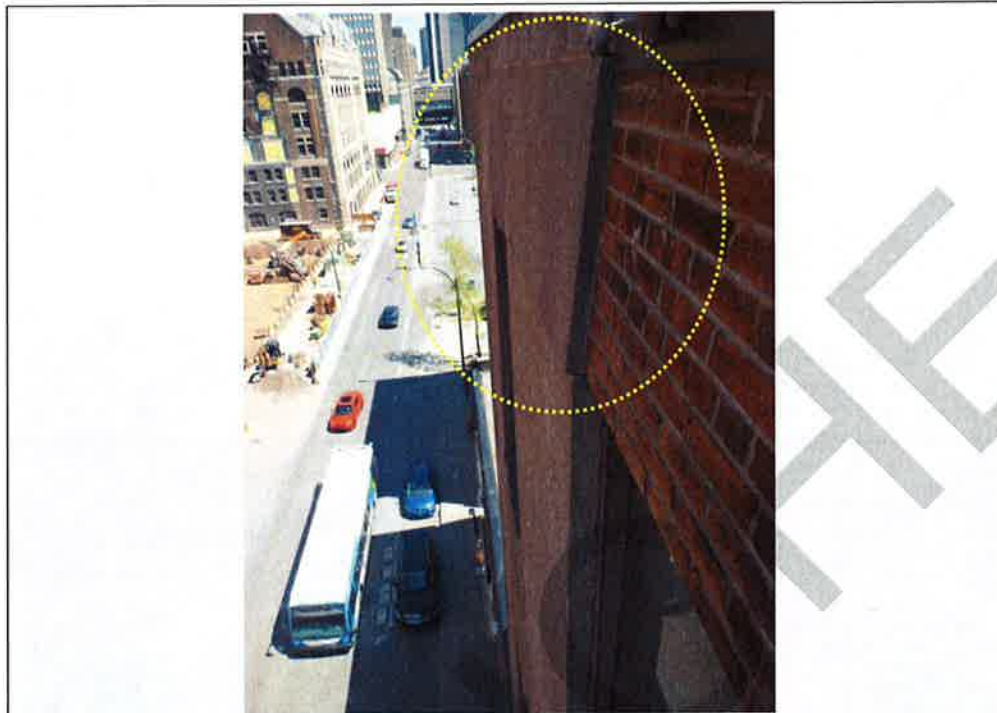
Photograph No. 24: Outward displacement of the stone cladding element at the parapet level (north façade) **(CRITICAL CONDITION)**

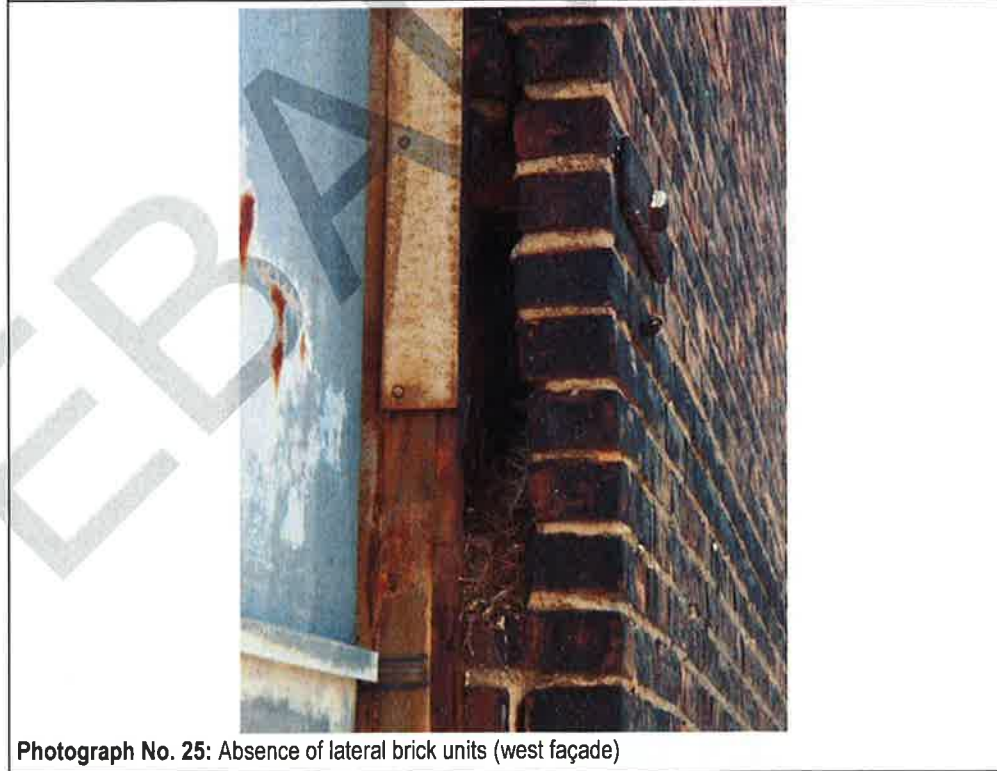
Photograph No. 25: Absence of lateral brick units (west façade)

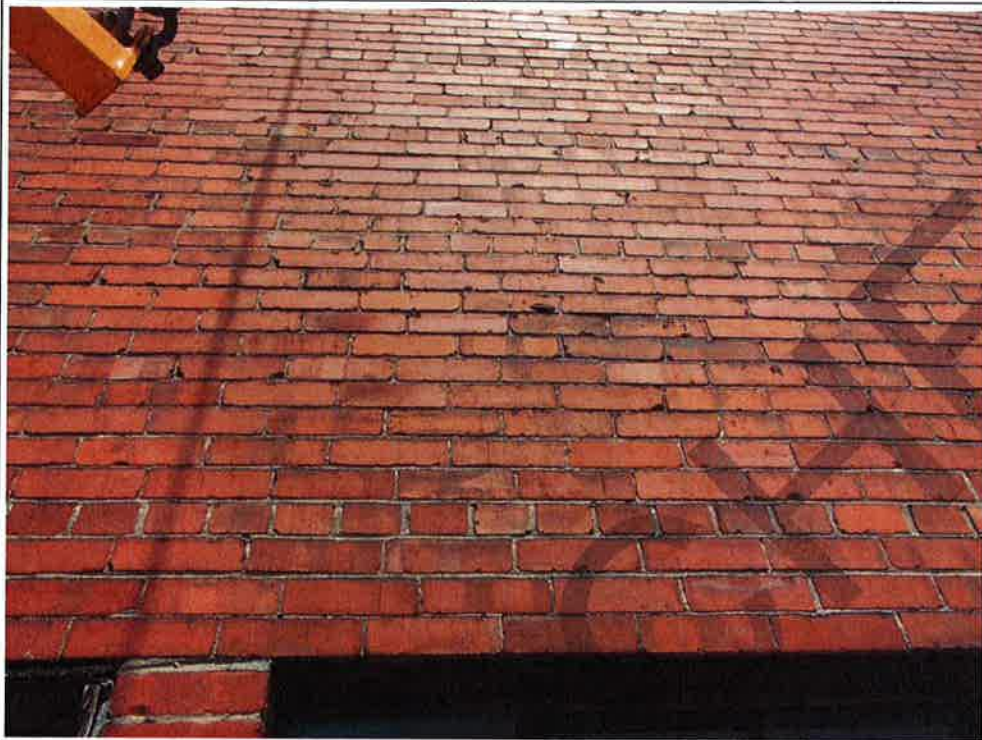
Photograph No. 26: Typical hairline cracking of the brick masonry units (west façade)

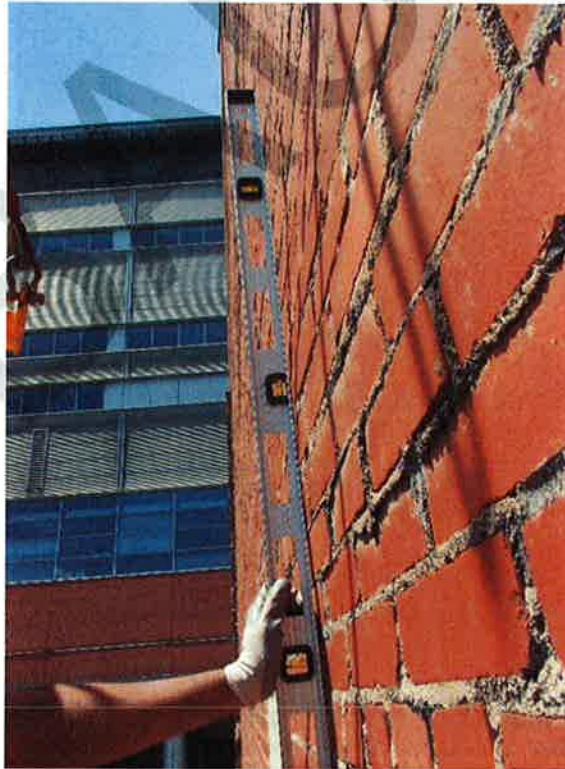
Photograph No. 27: Bowing/deflection of a portion of the brick masonry cladding (west façade)

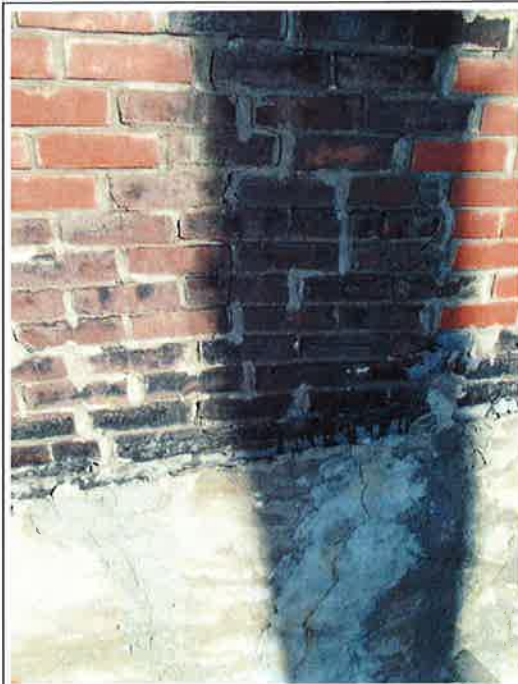
**Photograph No. 28:** Fissured mortar joints and cracked cementitious parging (south façade)

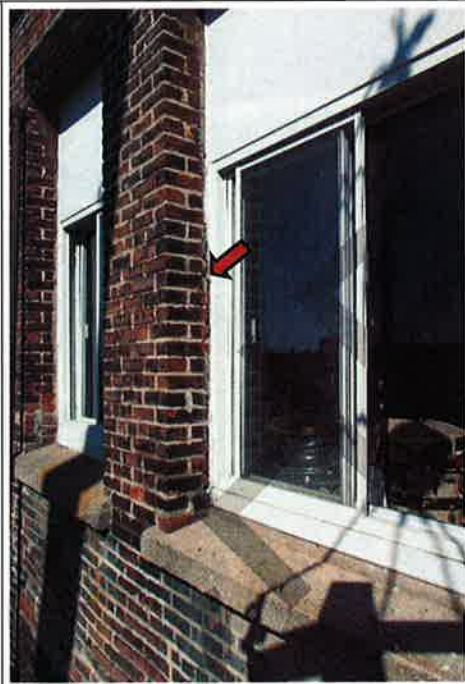
**Photograph No. 29:** Vertical crack along mortar filled joint at the masonry wall/window junction (south façade)

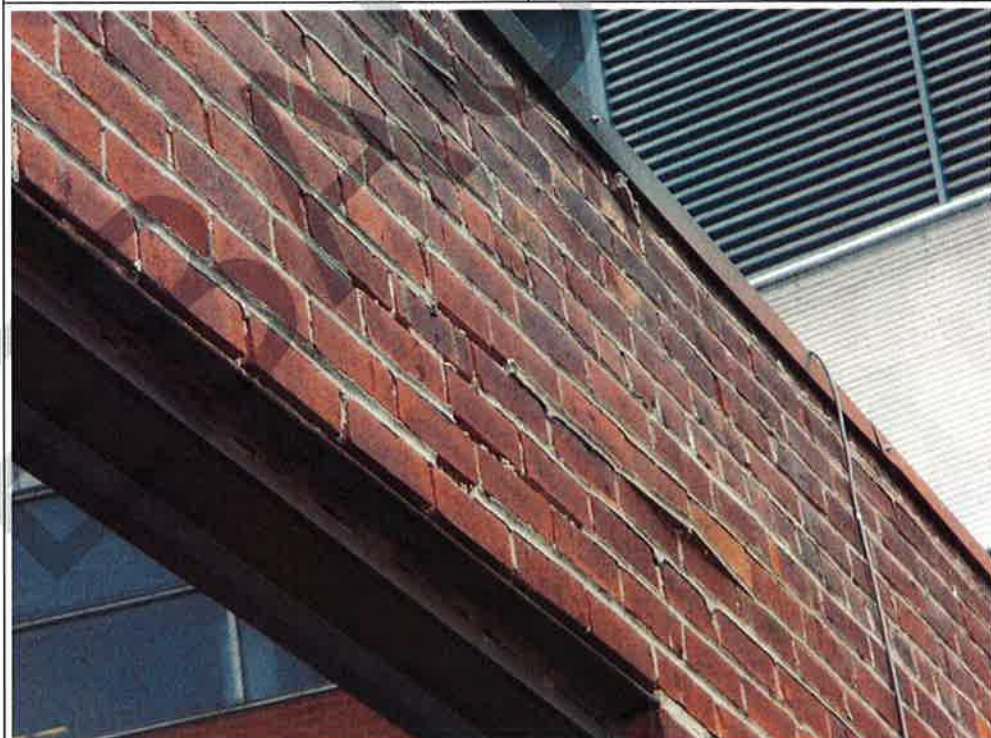
**Photograph No. 30:** Poorly bonded and spalled mortar joints (east façade – roof level)

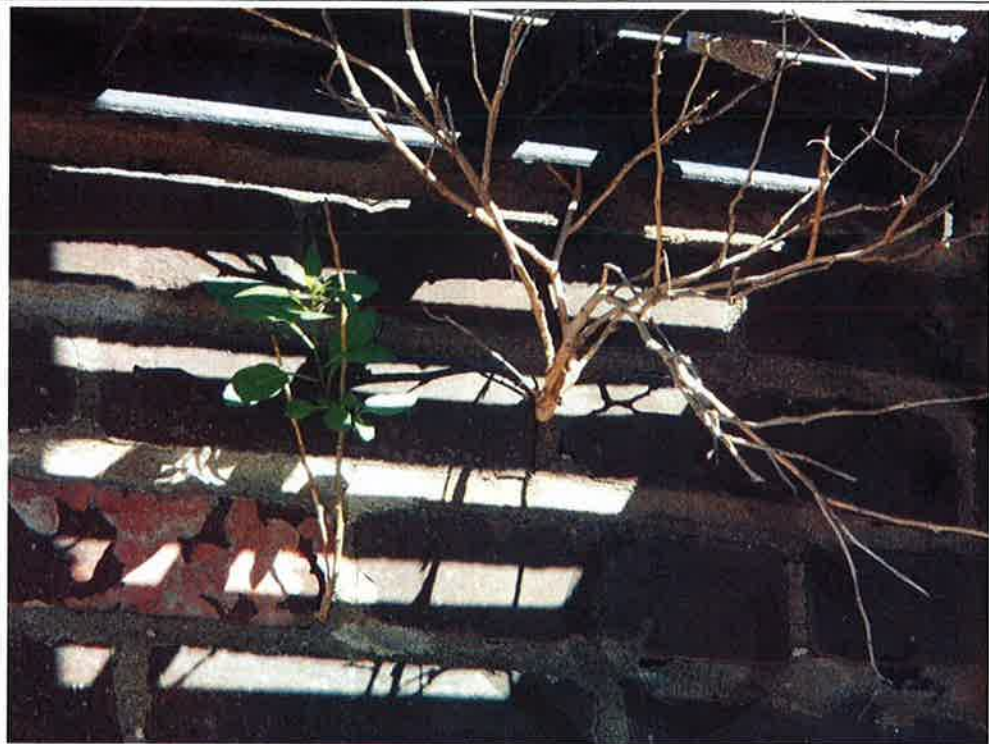
**Photograph No. 31:** Extreme vegetation growth between brick units (south façade)

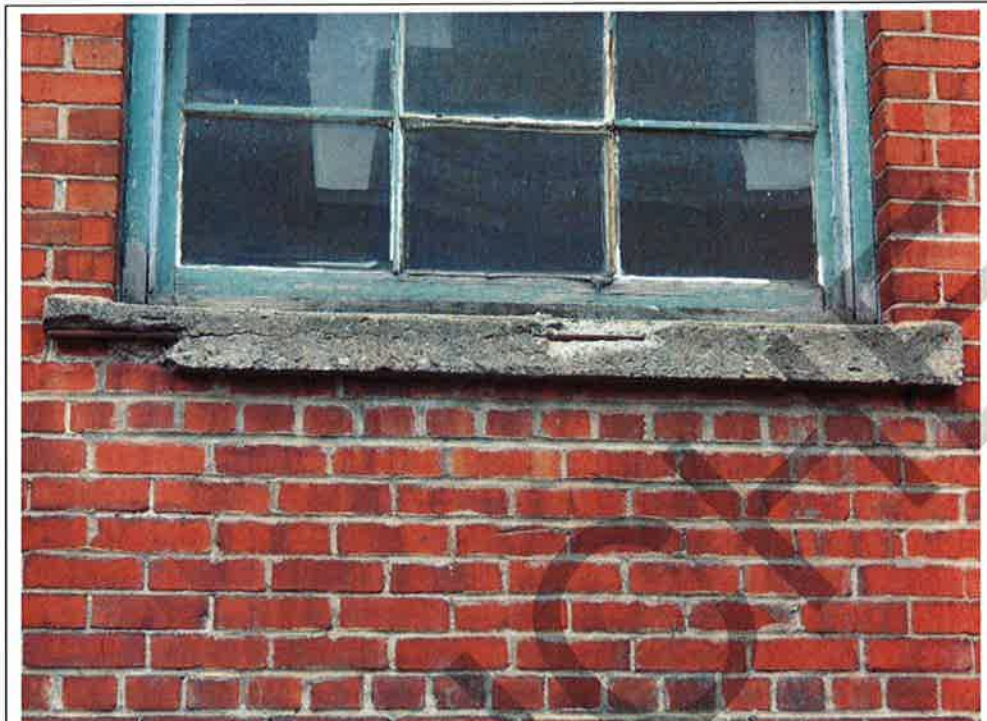
**Photograph No. 33:** Fractured concrete window sill with exposed and corroded steel reinforcement (east façade – roof level)

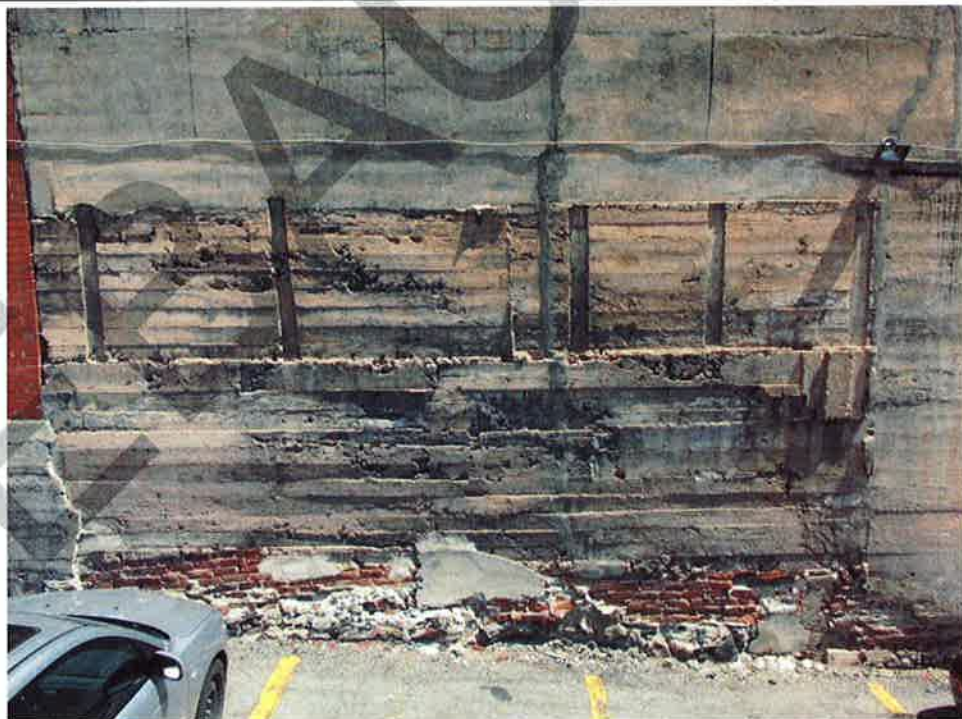
**Photograph No. 34:** Significant honeycombing and concrete delamination, and ongoing erosion of mortar, parging and brick (west façade)

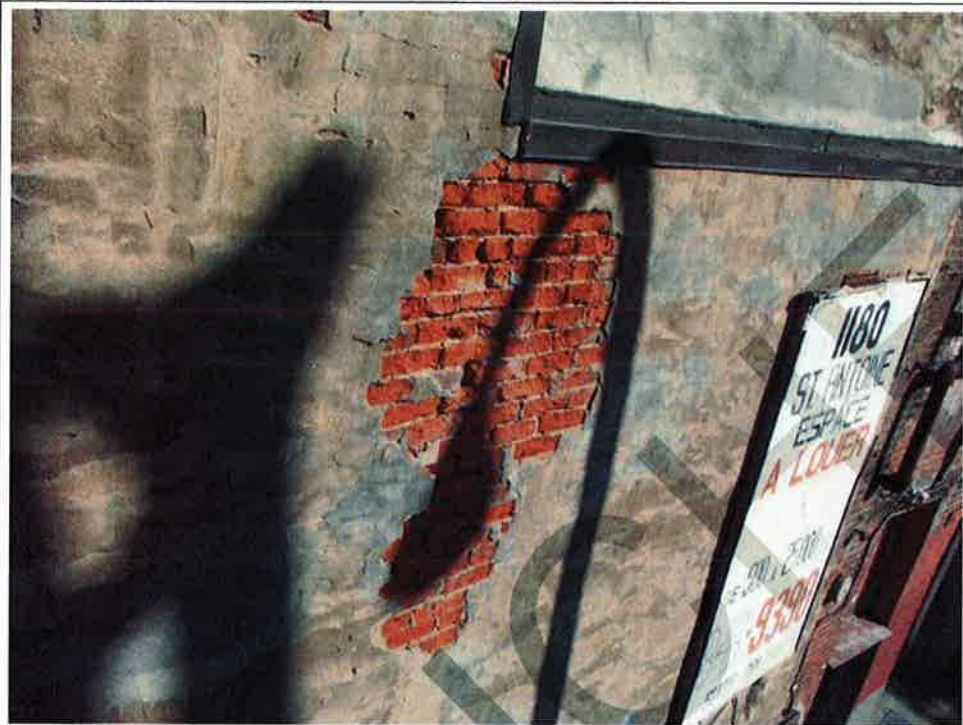
**Photograph No. 35:** Typical deteriorated and cracked cementitious parging, exposing spalled brick units (south façade)

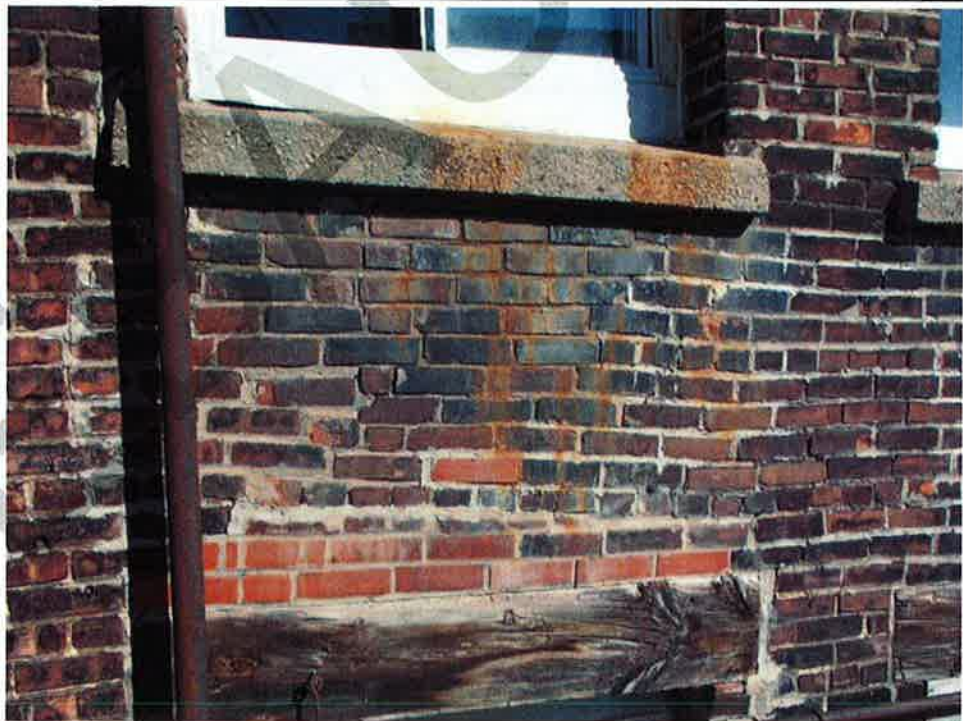
**Photograph No. 36:** Rust staining on and below concrete window sill. Note significant misalignment of window base and brick courses (south façade)

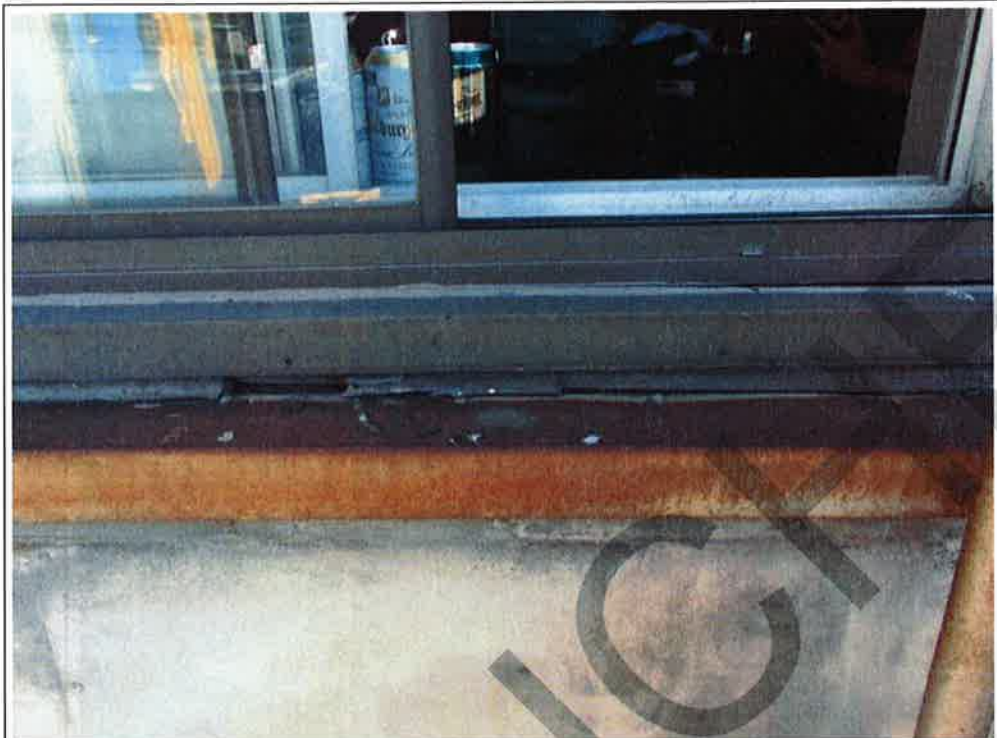
**Photograph No. 37:** Typical sign of heavily deteriorated or missing caulking of joints surrounding window frame (west façade)

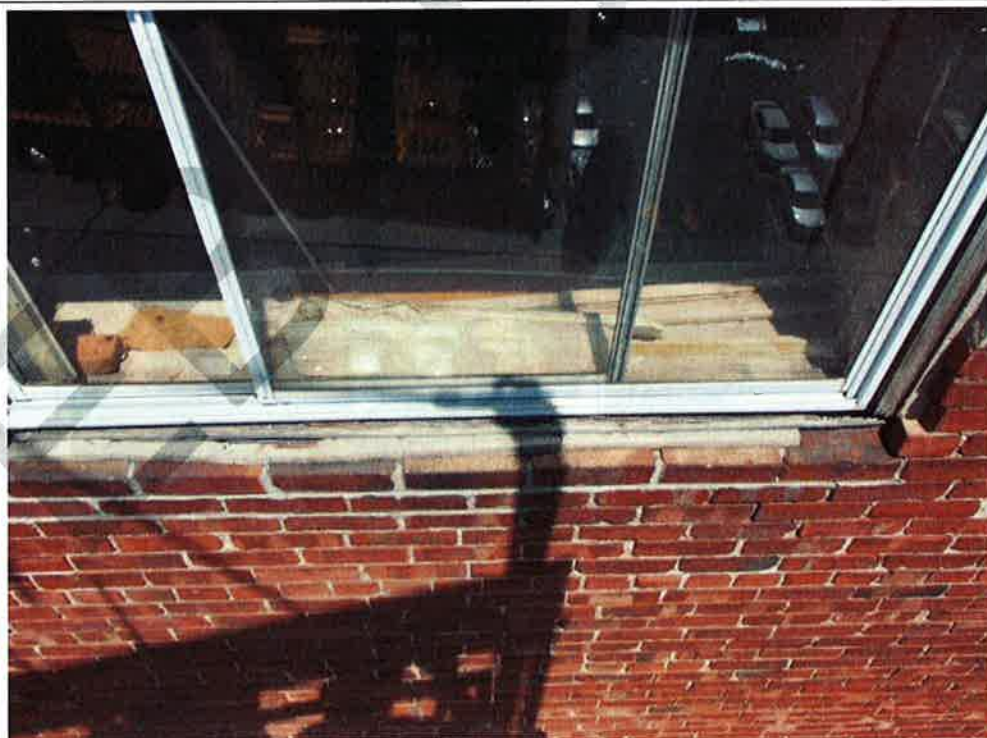
**Photograph No. 38:** Typical sign of missing window sill or metal flashing (west façade)

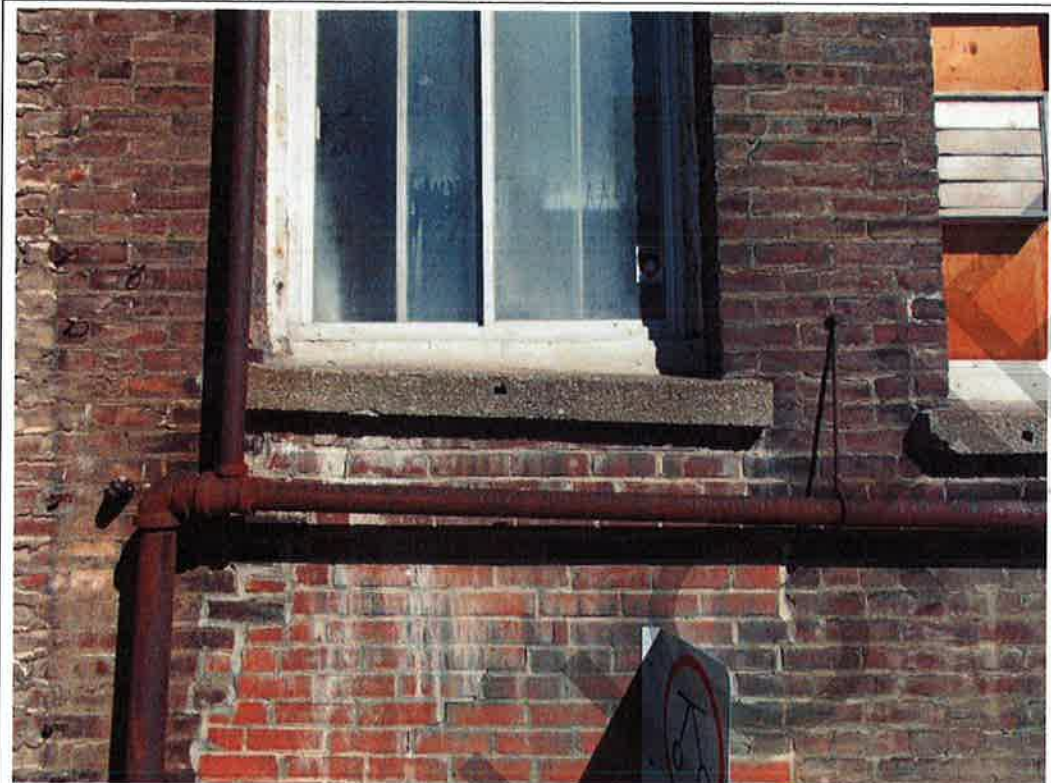
**Photograph No. 39:** Out of axis concrete window sill and localized step cracking of the mortar joints (south façade)

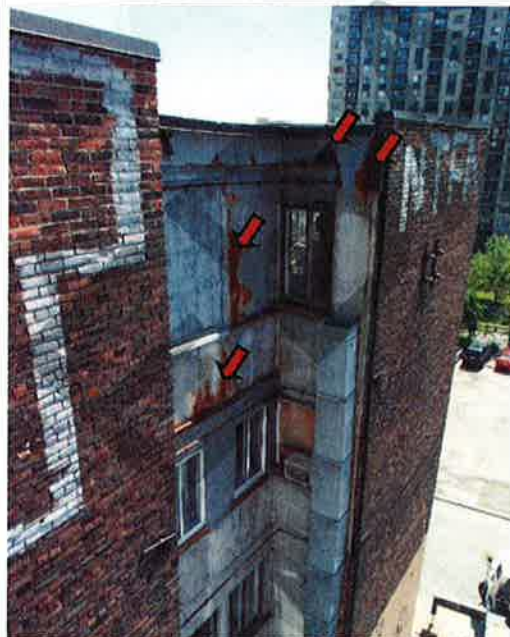
**Photograph No. 40:** Typical sign of heavily corroded, warped and poorly sealed metal sheet siding (west façade)

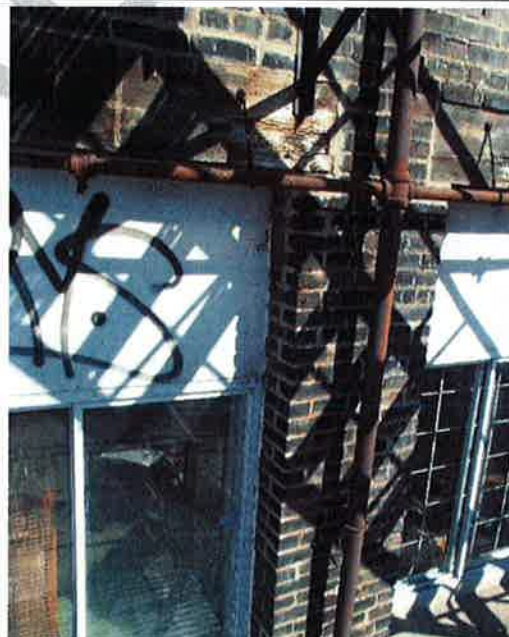
**Photograph No. 41:** Typical sign of external sprinkler network exhibiting widespread corrosion (south façade)

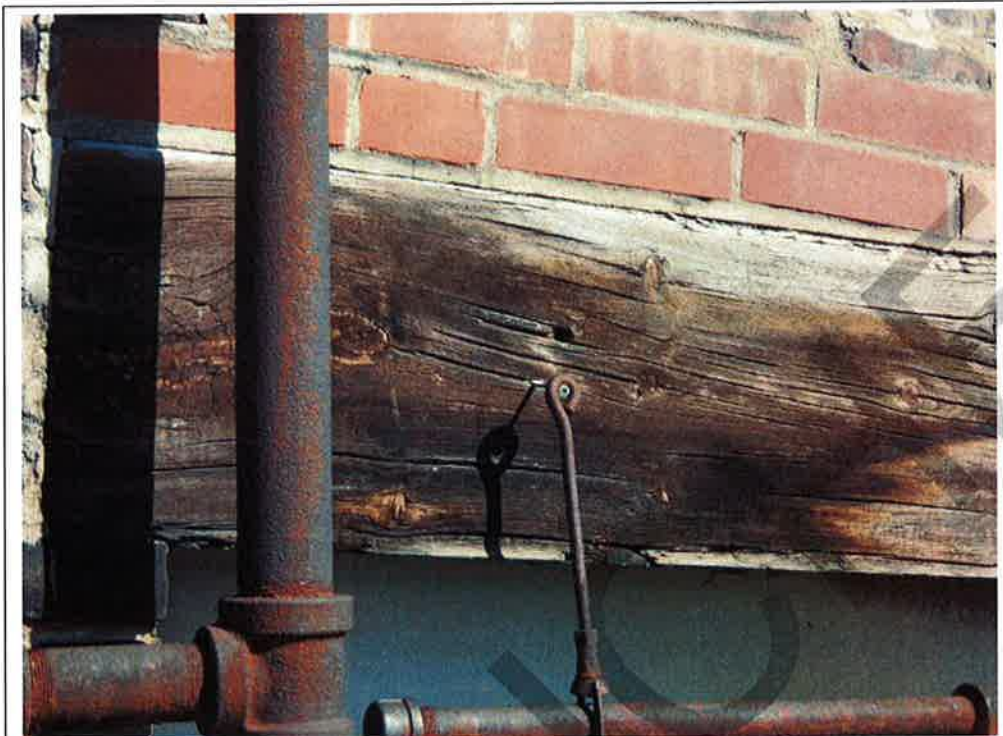
Photograph No. 42: Typical signs of inadequate anchoring of the sprinkler pipe (south façade)

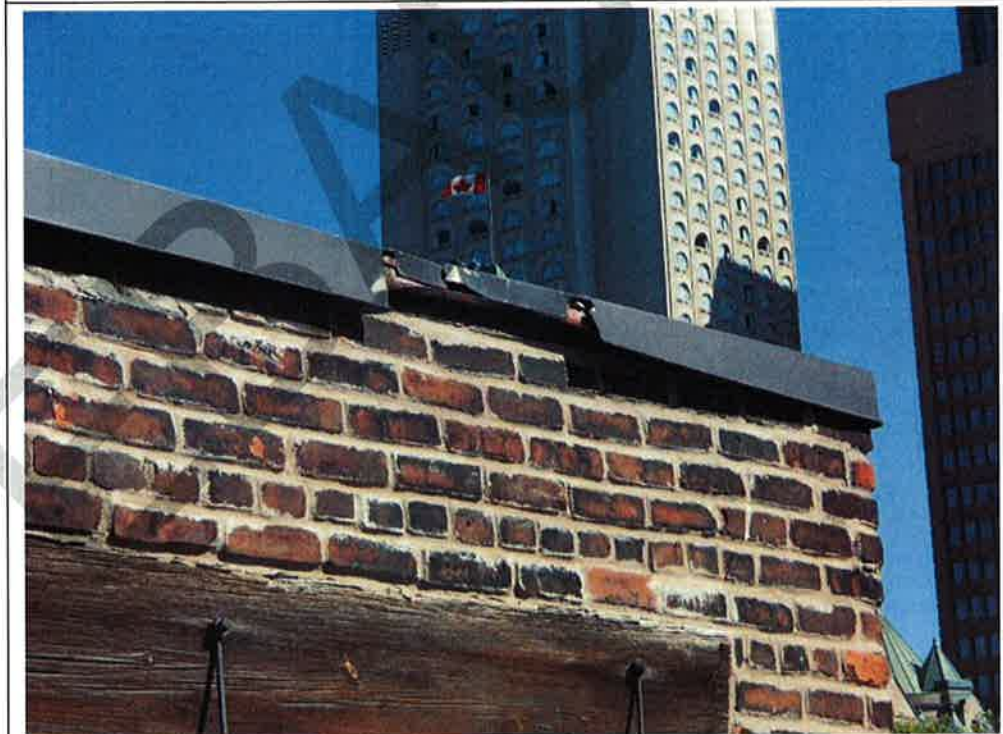
Photograph No. 43: Typical signs of localized damaged metal flashing (south façade)

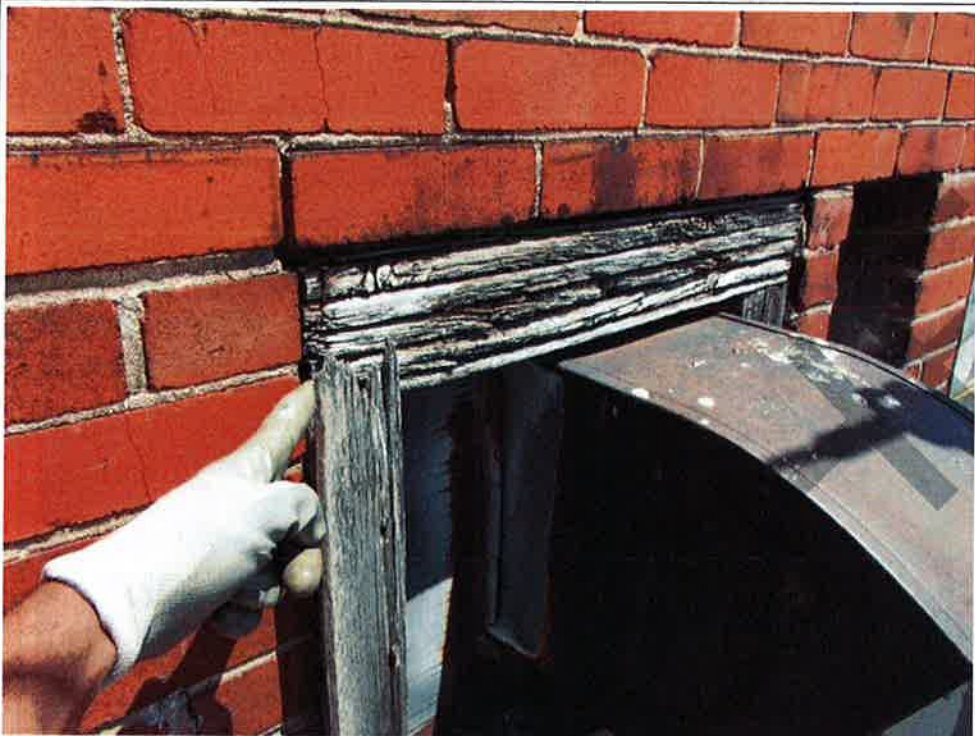
**Photograph No. 44:** Heavily deteriorated, rotted and splintered wood frame around exhaust duct (west façade)

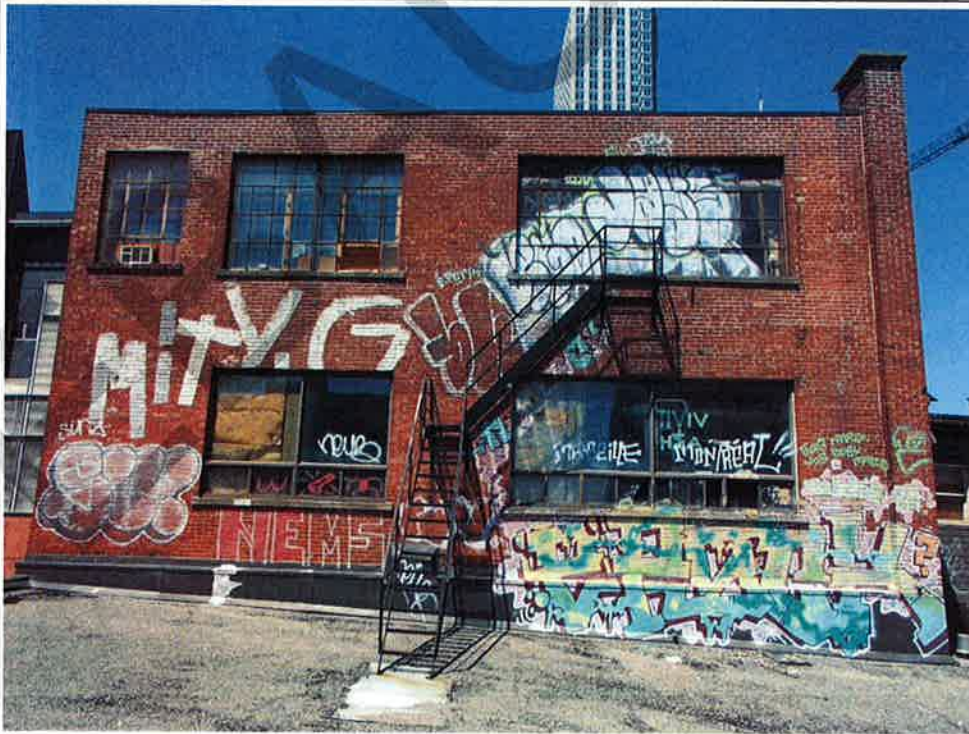
**Photograph No. 45:** Graffiti art on masonry facade (south façade – roof level)

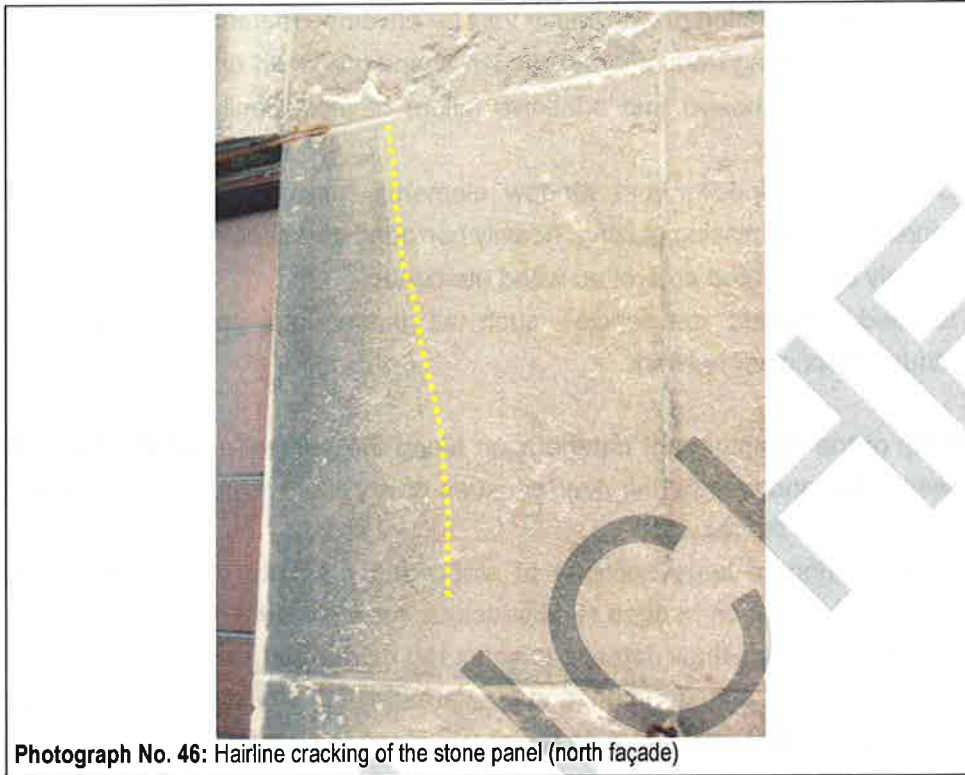
#### 4.2 Summary and Discussion of Results
