CONSULTATION • INVESTIGATION • DESIGN • CONSTRUCTION REVIEW

**EDIFICE** EXPERTS

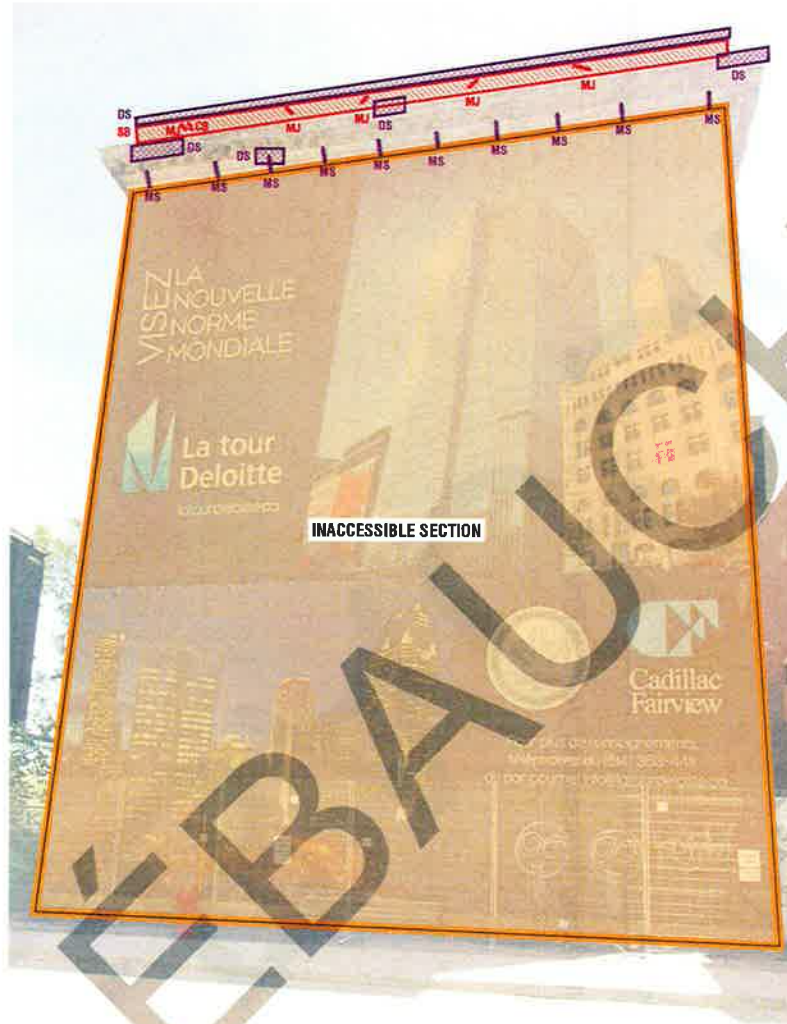
MUST MAINTAIN FENCING UNTIL FULL ASSESSMENT OF FACADES CAN BE CONDUCTED.

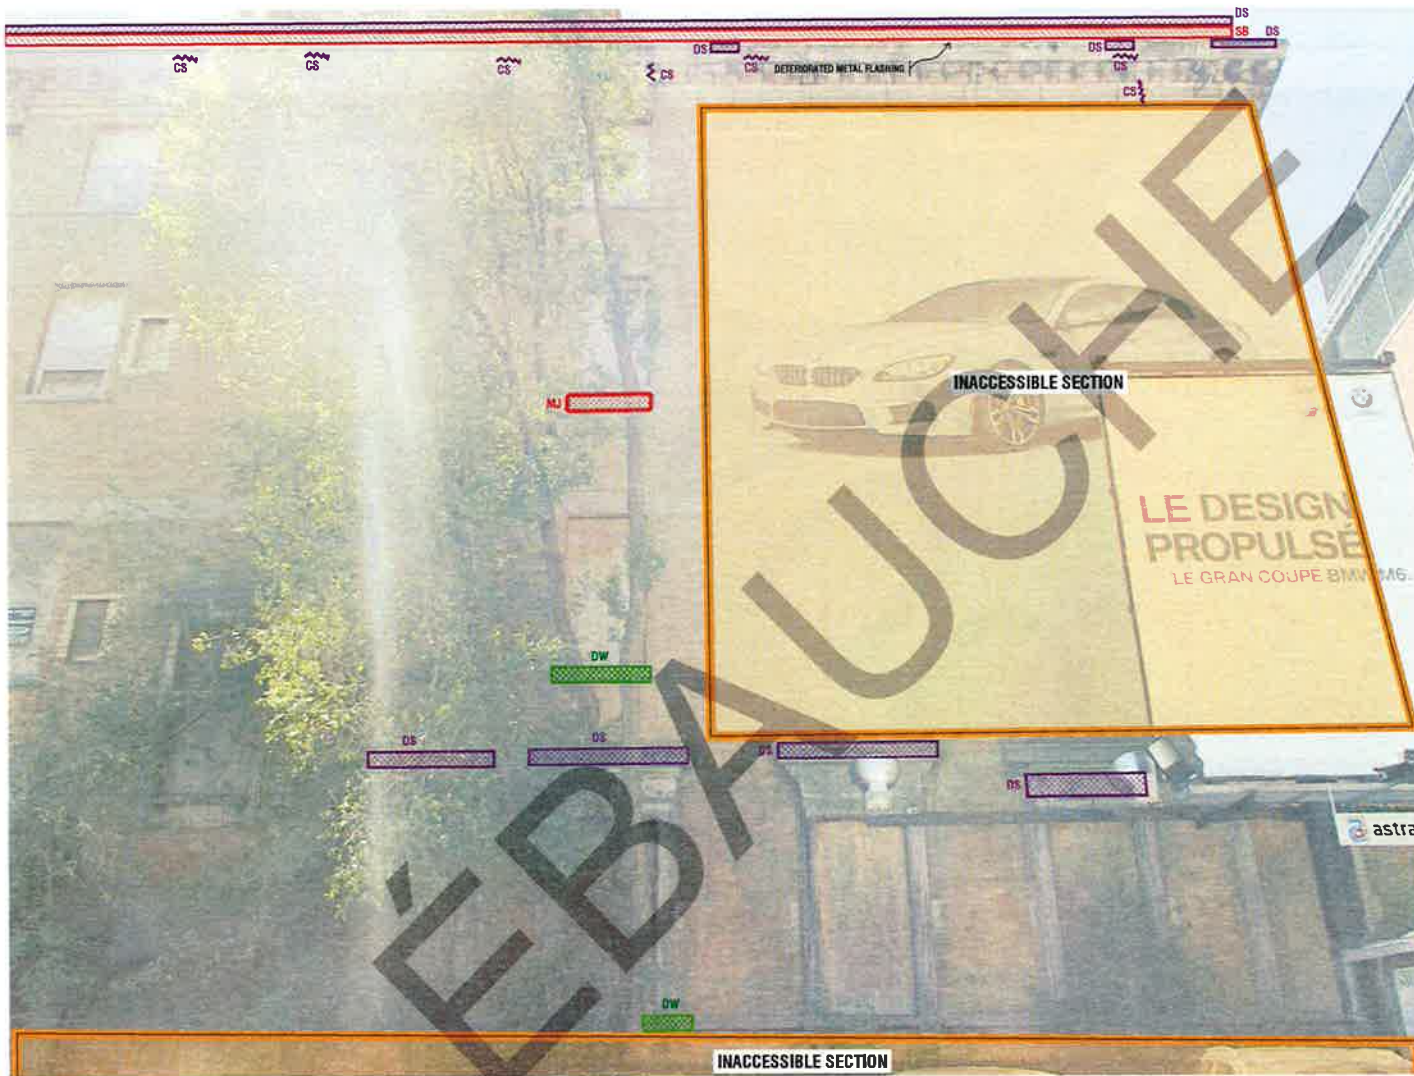
<b>MISCELLANEOUS</b>	<b>EF</b> [Symbol]	<b>TR</b> [Symbol]	<b>GS</b> [Symbol]	<b>GENERALIZED STAINING (POLLUTION AND / OR WATER RUN-OFF)</b>
[Symbol]	<b>WO</b> [Symbol]	<b>OR</b> [Symbol]	<b>RS</b> [Symbol]	<b>OTHER FAILURE / NOTIFICATION (SEE NOTE)</b>
[Symbol]	<b>PHOTOGRAPH</b>	<b>OR</b> [Symbol]	<b>RS</b> [Symbol]	<b>OTHER FAILURE / NOTIFICATION (SEE NOTE)</b>

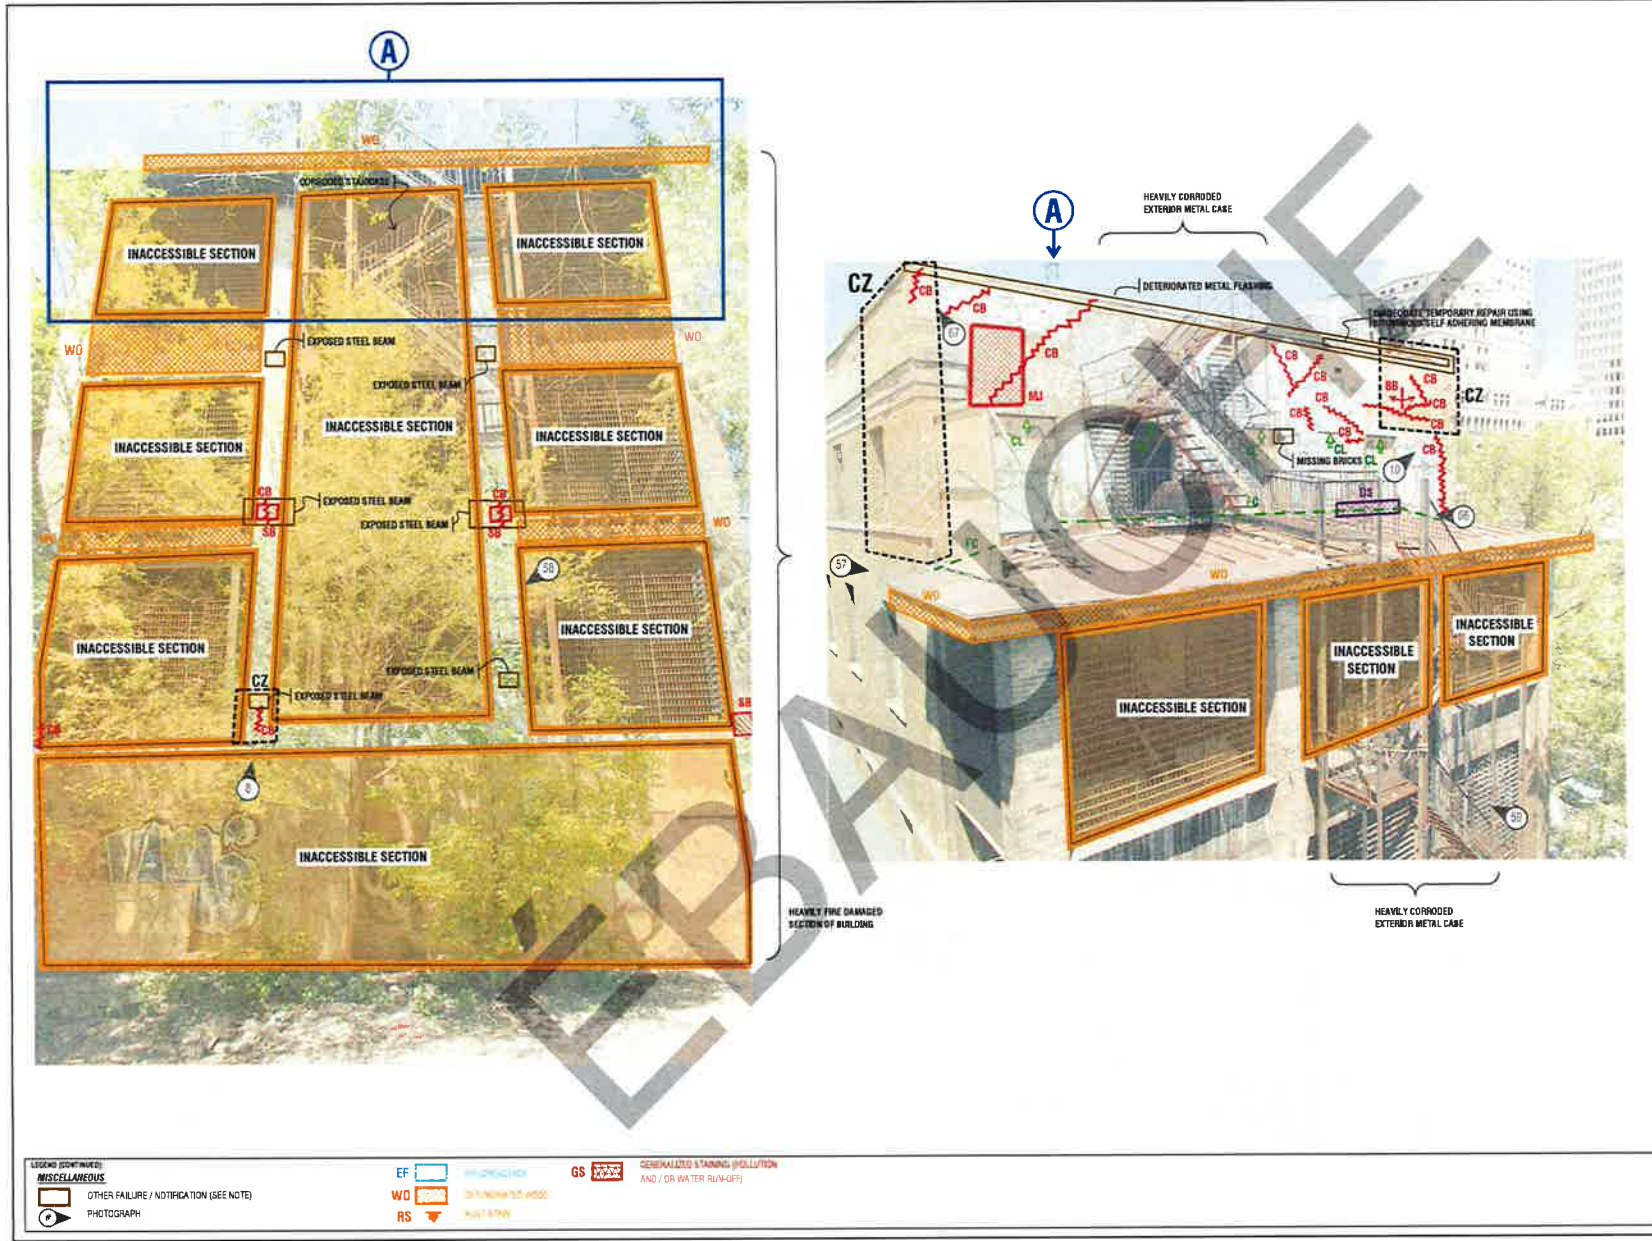
- LEGEND
- CZ** [Symbol] ADVANCED DETERIORATION / CRITICAL ZONE
  - BRICK**
  - SB** [Symbol] SPALLED BRICK
  - MJ** [Symbol] DETERIORATED OR CRACKED MORTAR JOINT

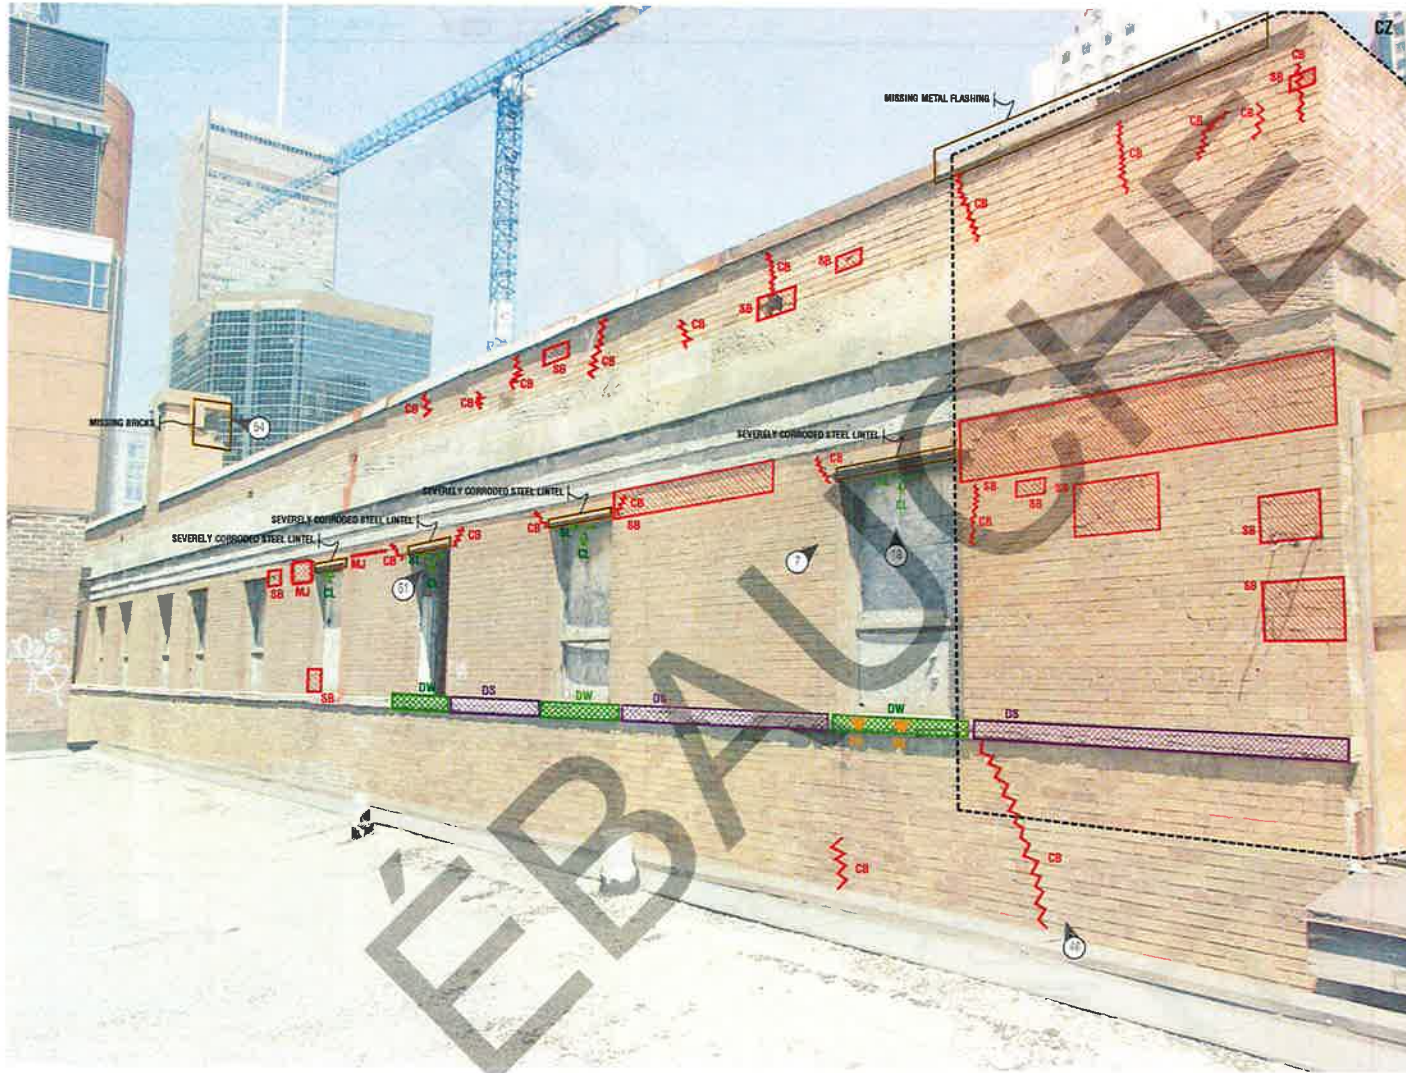
CLIENT:	CADILLAC FAIRVIEW	
PROJECT:	CONDITION ASSESSMENT OF THE BUILDING FACADES 1182 TO 1190 ST ANTOINE WEST MONTREAL (QUEBEC)	
TITLE:	1182 - SOUTH ELEVATION LOCATION OF DEFICIENCIES	
DATE:	JUNE 2013	PROJECT NO.: ED20102-A1
PREPARED BY:	J MASSOUD	FILE NO.: ED20102a1-dssn1
DRAWN BY:	J.MASSOUD	DRAWING NO.: <b>EE-04</b>
CHECKED BY:	D.J.ABRAHAM

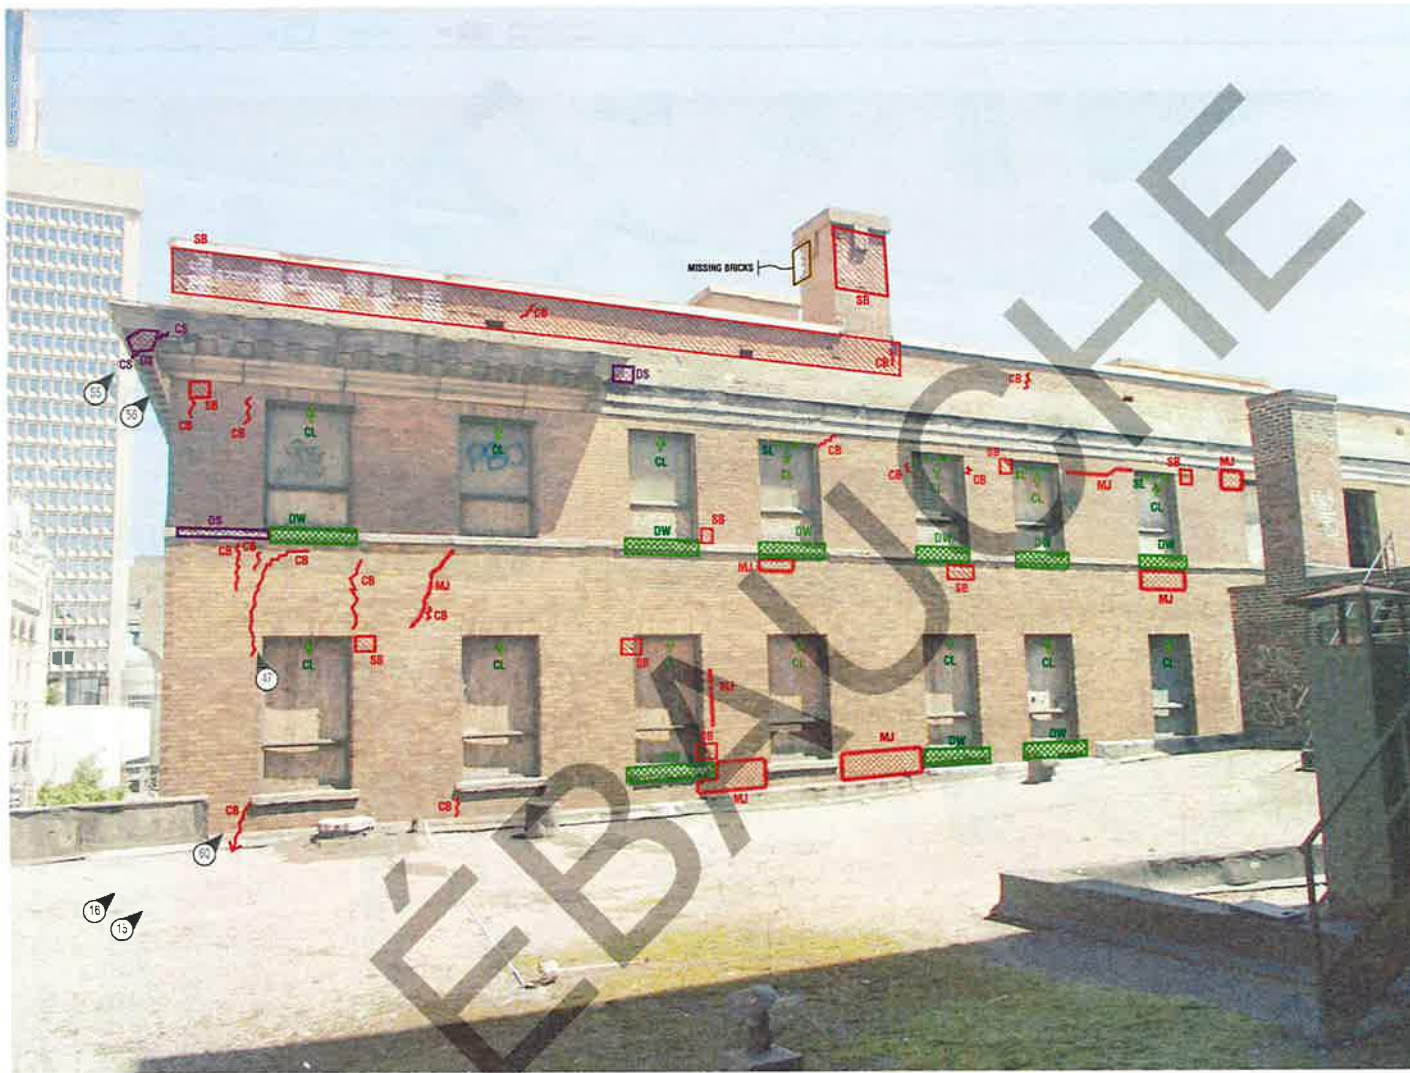
GENERALIZED STAINING (POLYMERIZATION AND / OR WATER RUN-OFF)

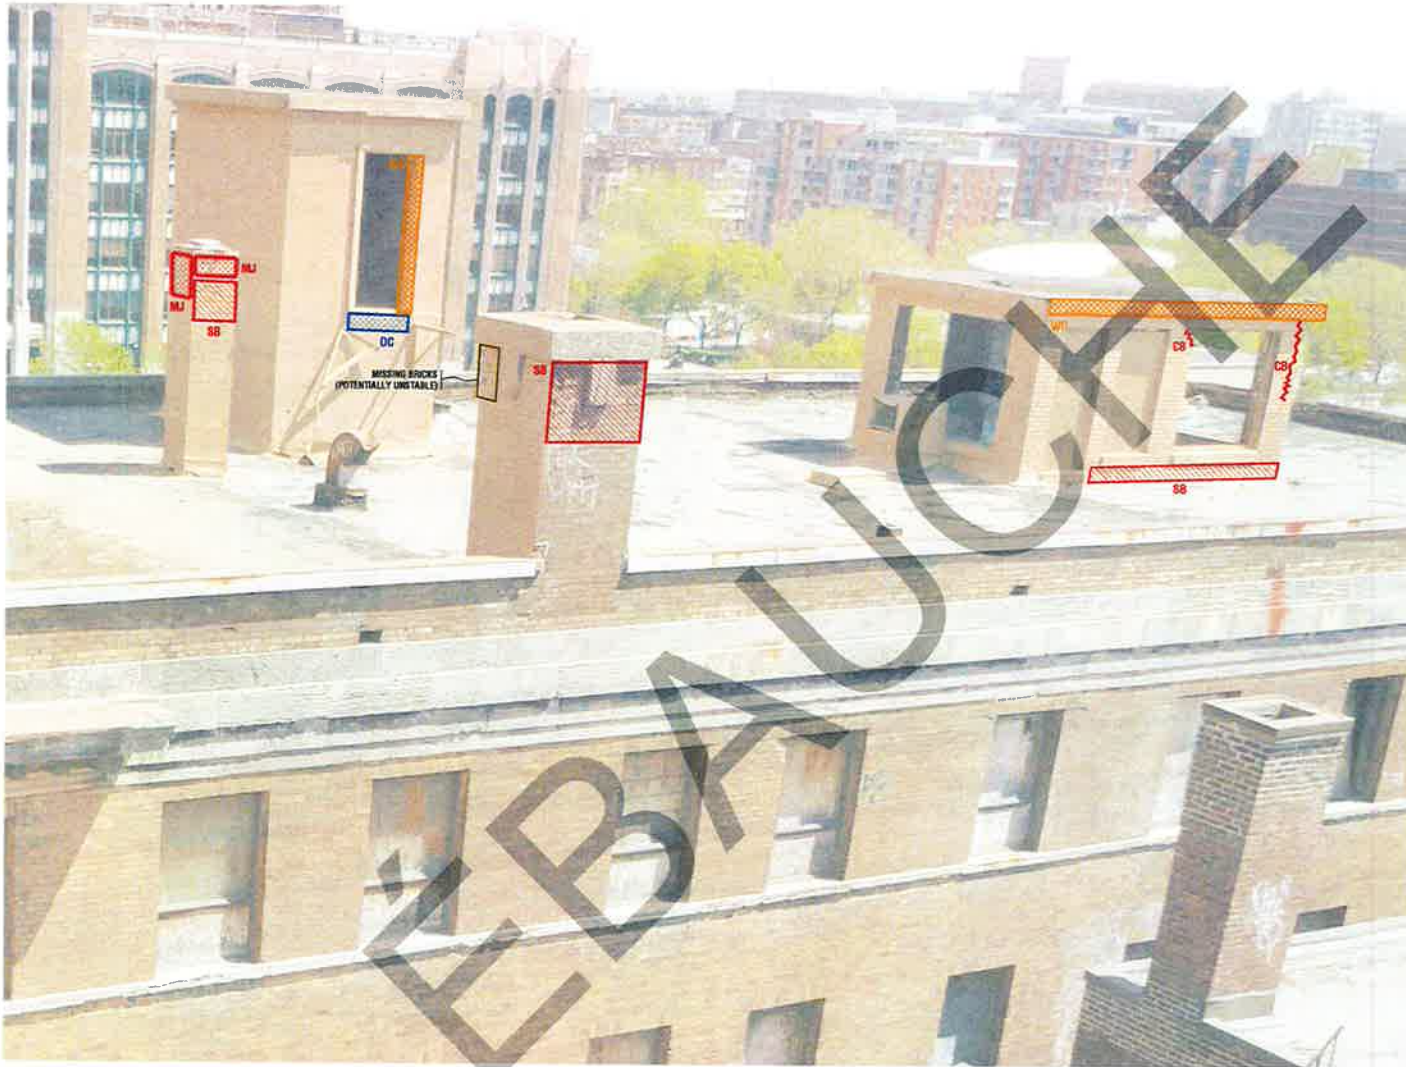
[Symbol] OTHER FAILURE / NOTIFICATION (SEE NOTE)  
 [Symbol] PHOTOGRAPH

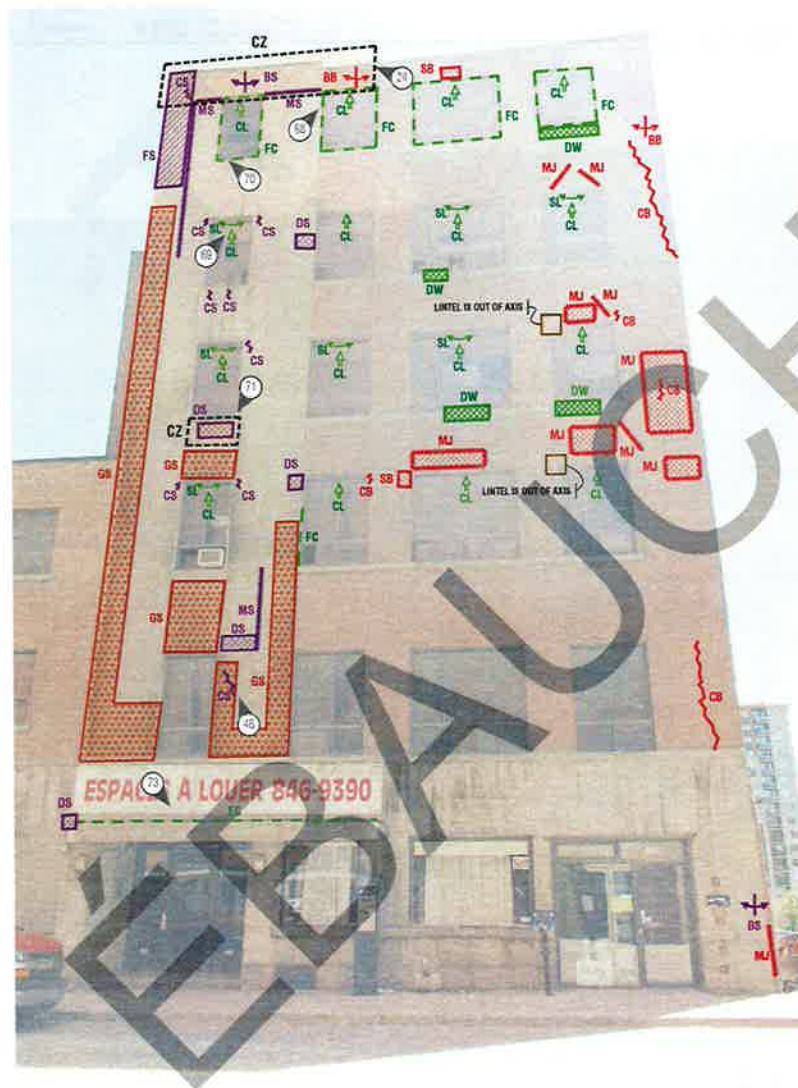
<b>MISCELLANEOUS</b>	<b>EF</b>	<b>SH</b>	<b>GS</b>
OTHER FAILURE / NOTIFICATION (SEE NOTE)	EIF	SH/SHOCKS	GENERALIZED STAINING, POLLUTION AND / OR WATER RUN-OFF
PHOTOGRAPH	<b>WO</b>	<b>WT</b>	
	<b>RS</b>	<b>WT</b>

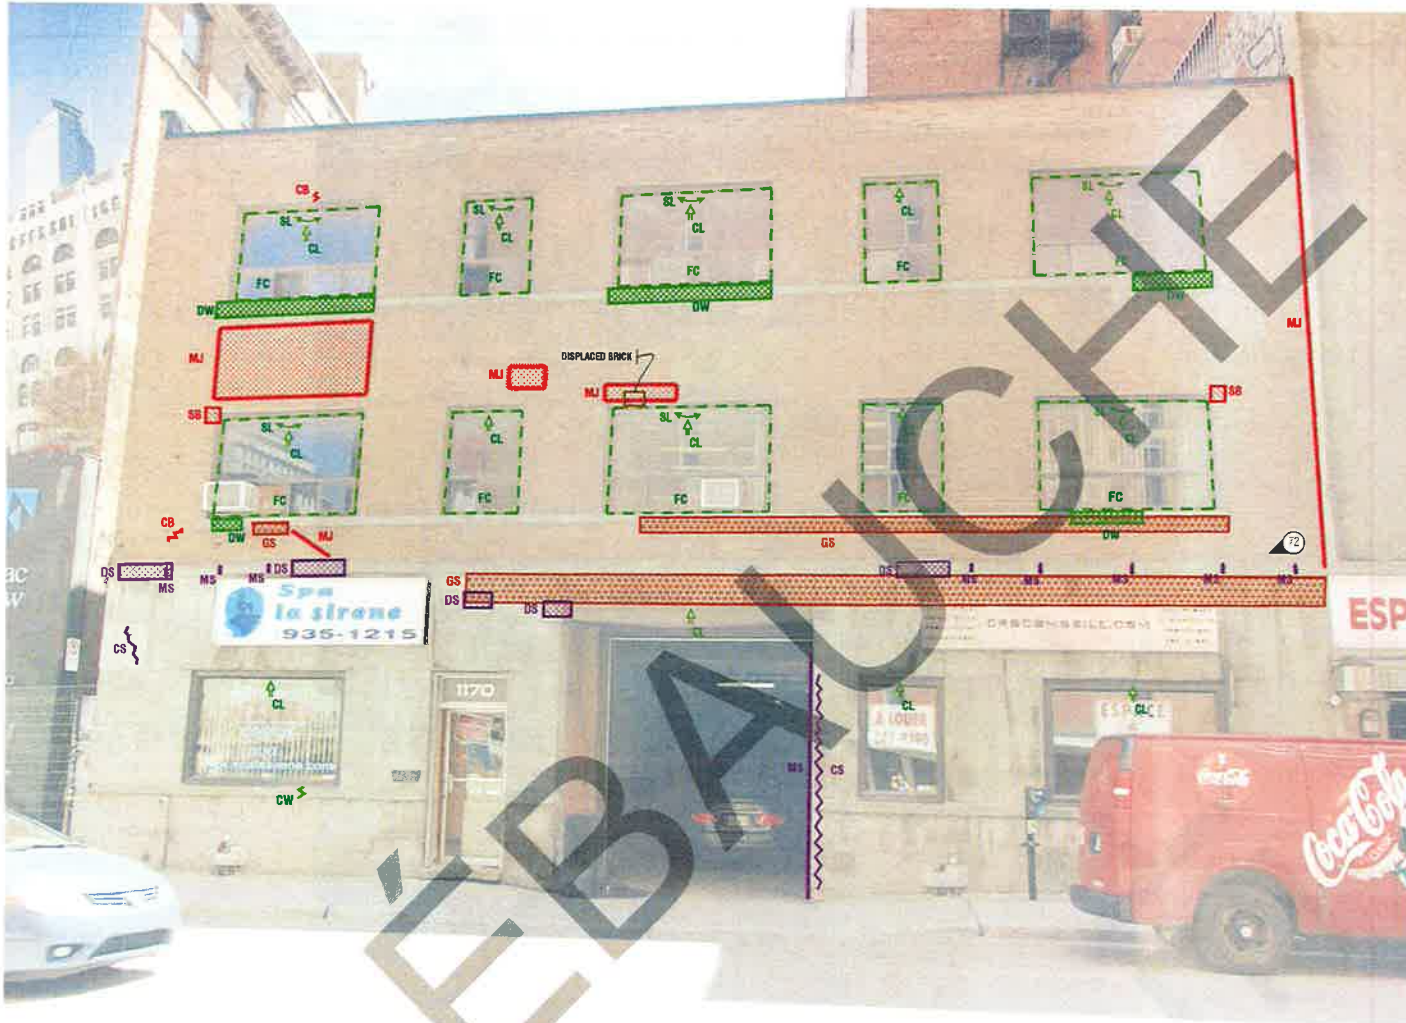
<b>MISCELLANEOUS</b>	<b>EF</b>	<b>EF</b>	<b>GS</b>	GENERALIZED STAINING, POLLUTION AND / OR WATER RUN-OFFS
OTHER FAILURE / NOTIFICATION (SEE NOTE)	REPAIRS/NOTICE	REPAIRS/NOTICE	REPAIRS/NOTICE	
PHOTOGRAPH	<b>WD</b>	<b>WD</b>	<b>RS</b>	DETERIORATION TO WOOD
	<b>RS</b>	<b>RS</b>		RUST STAIN

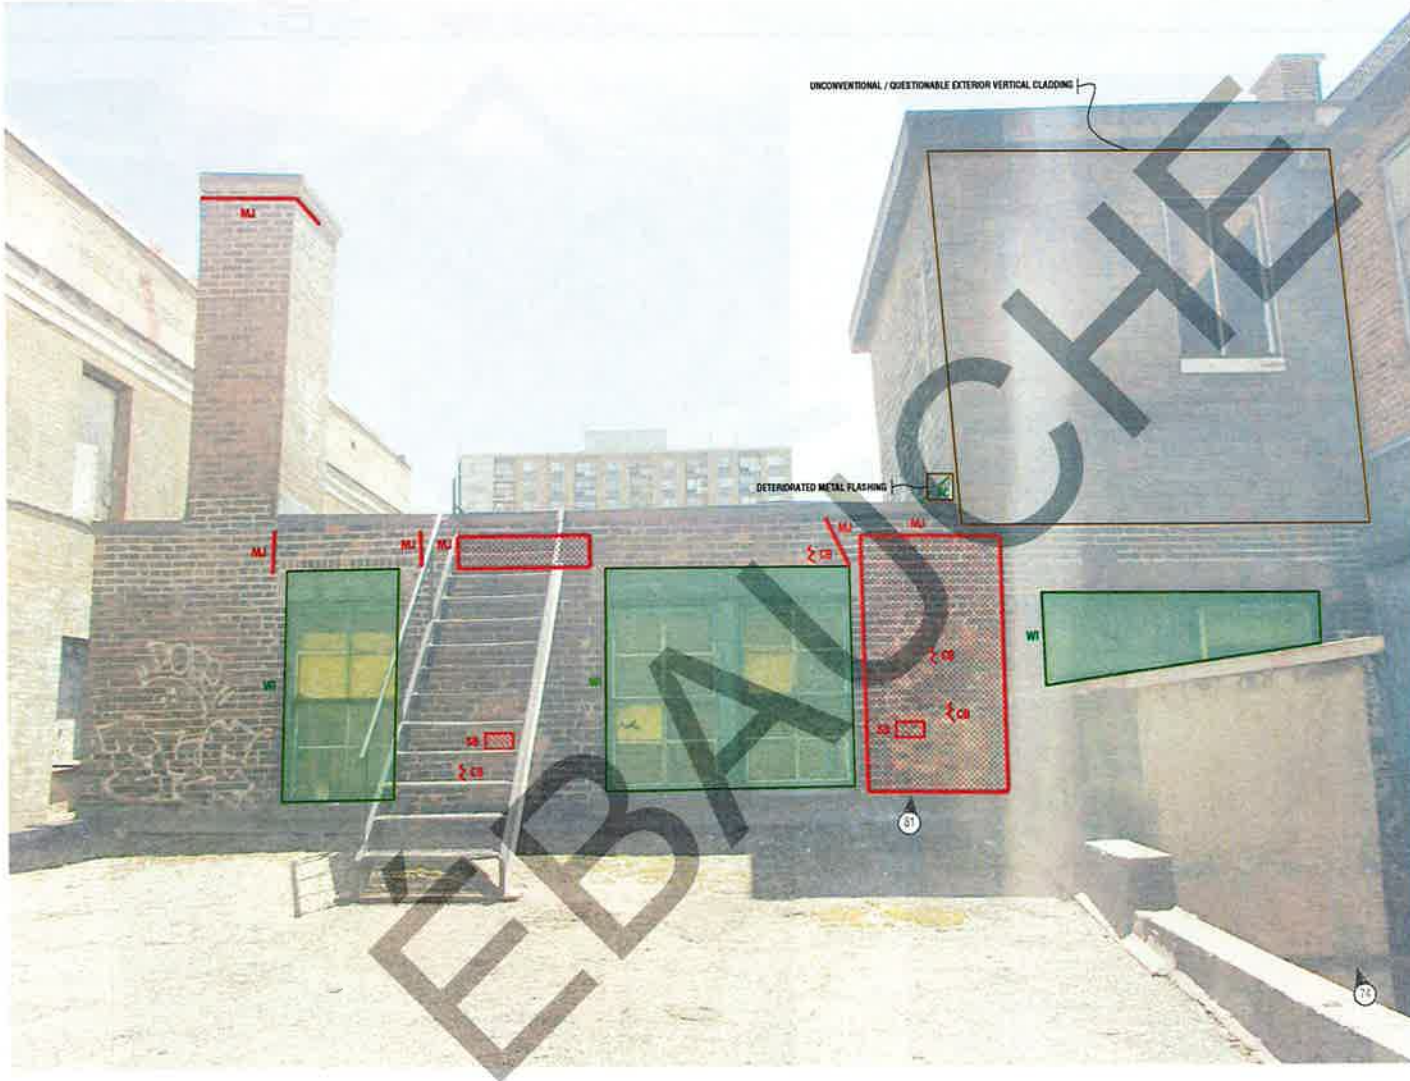
<b>MISCELLANEOUS</b>	<b>EF</b> [Blue dashed line]	<b>DEFICIENCIES</b>	<b>GS</b> [Red brick pattern]	<b>GENERALISED STAINING (POLLUTION AND / OR WATER RUN-OFF)</b>
<b>OTHER FAILURE / NOTIFICATION (SEE NOTE)</b>	<b>WO</b> [Red dashed line]	<b>WORKING ON SITE</b>		
<b>PHOTOGRAPH</b>	<b>RS</b> [Red arrow]	<b>NOT A TIME</b>

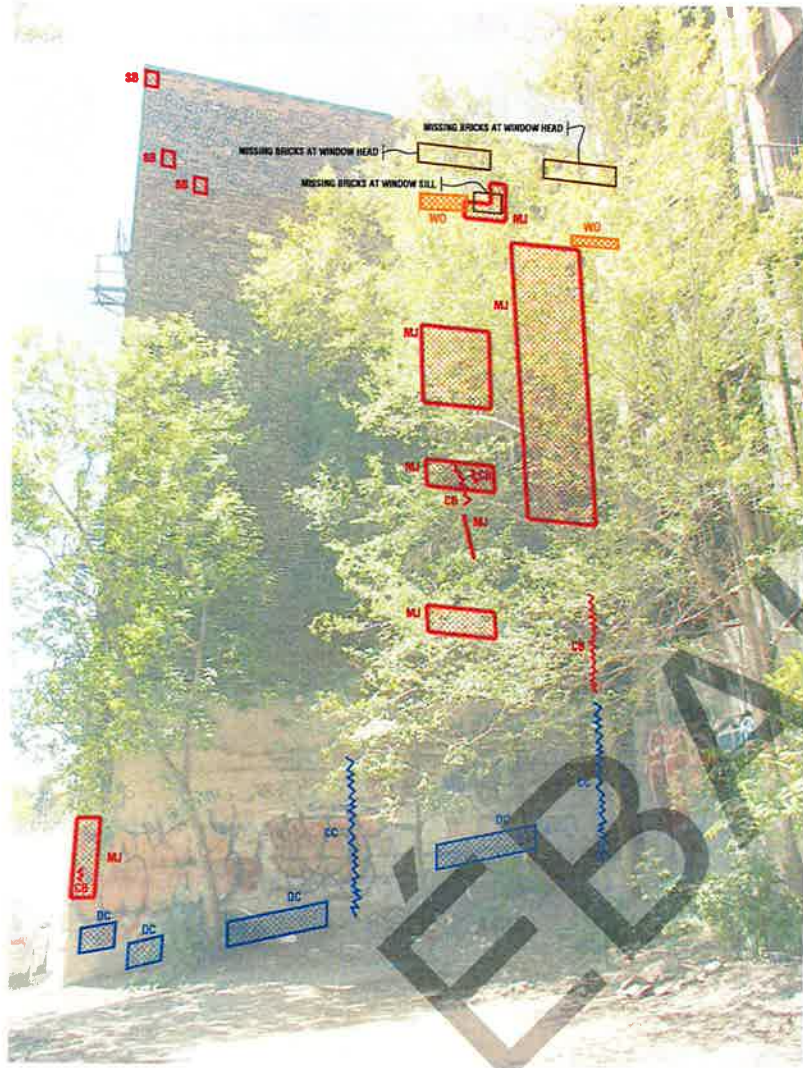
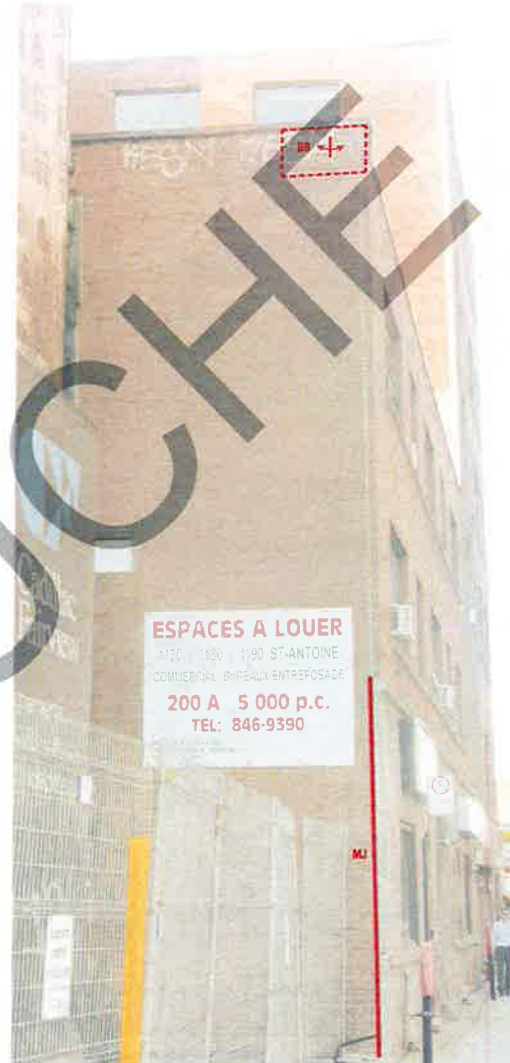
<b>MISCELLANEOUS</b>	<b>EF</b> [Blue box]	[Blue arrow]	<b>GS</b> [Red staining]	GENERALIZED STAINING (POLLUTION AND / OR WATER RUN-OFF)
OTHER FAILURE / NOTIFICATION (SEE NOTE)	<b>WO</b> [Red box]	[Red arrow]		
PHOTOGRAPH	<b>RS</b> [Red arrow]	[Red arrow]

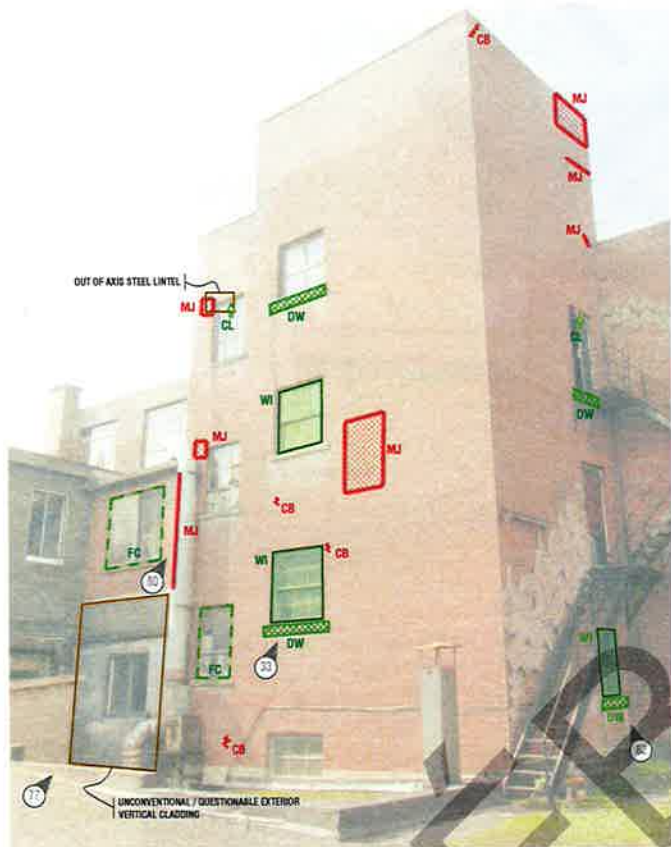
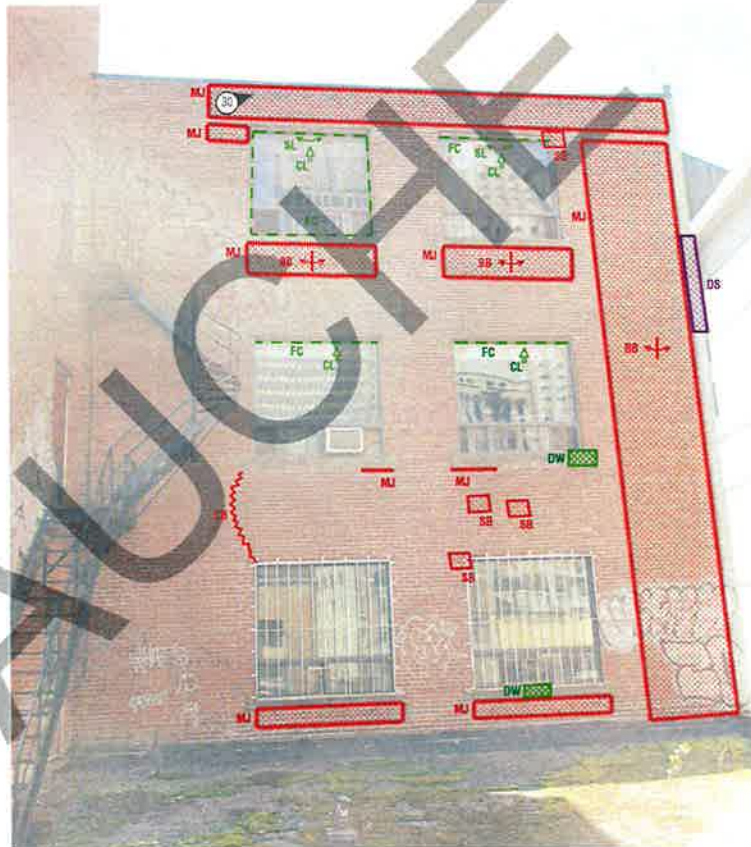
<b>MISCELLANEOUS</b>	<b>EF</b>	<b>EIF</b>	<b>GS</b>
OTHER FAILURE / NOTIFICATION (SEE NOTE)	EIF	EIF	GENERALIST'S STAINING, POLLUTION AND / OR WATER RUN-OFF
PHOTOGRAPH	<b>WO</b>	<b>RS</b>	
	WO	RS

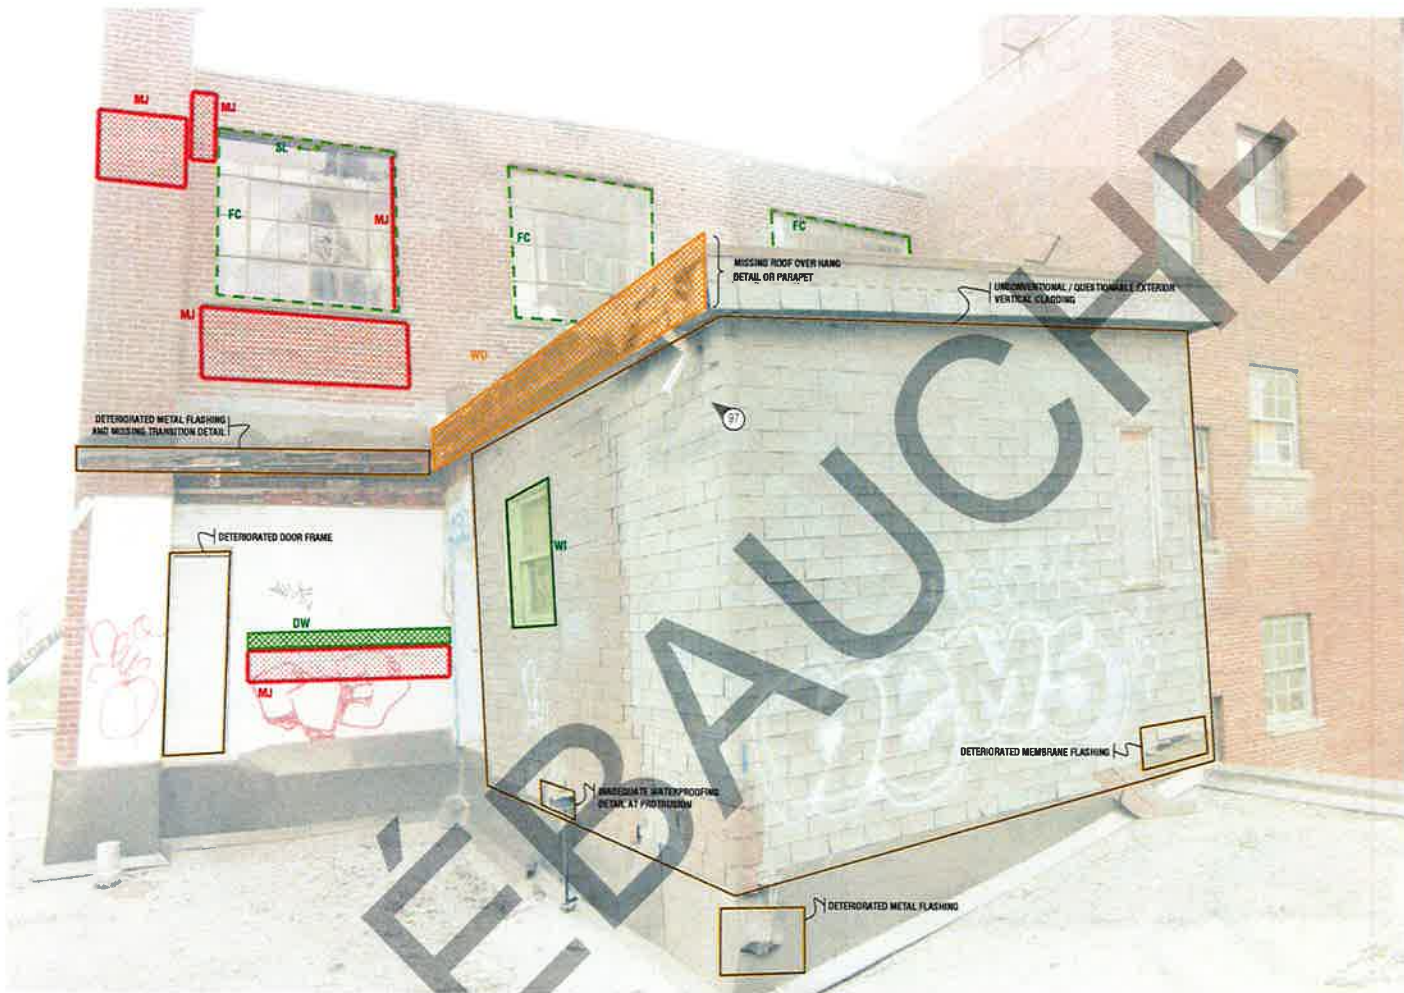
<b>MISCELLANEOUS</b>	<b>EF</b> [Blue Box]	EFFLUENT	<b>GS</b> [Red Box]	GENERALIZED STAINING (POLLUTION AND / OR WATER RUN-OFF)
<b>OTHER FAILURE / NOTIFICATION (SEE NOTE)</b>	<b>WO</b> [Red Box]	WORKING ON SITE	<b>RS</b> [Red Arrow]	RAVINE
<b>PHOTOGRAPH</b>

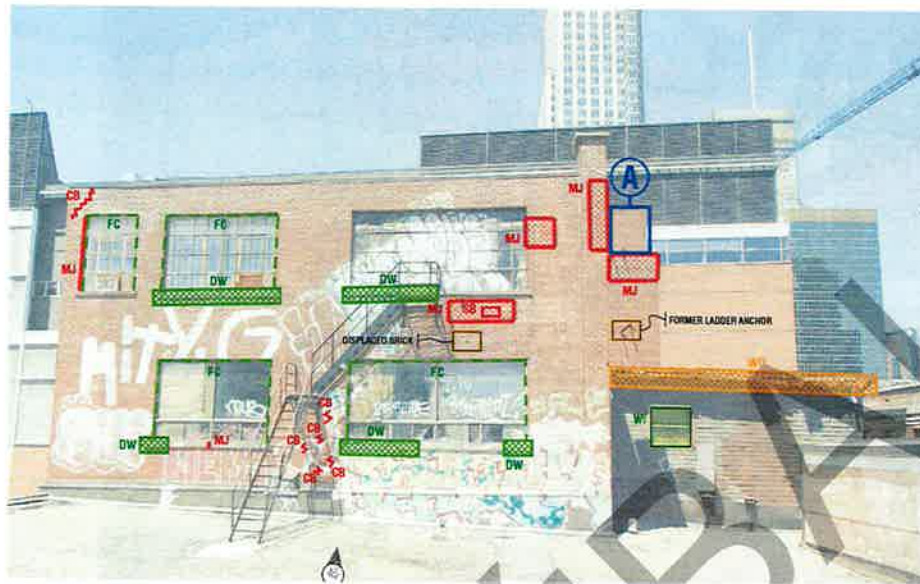
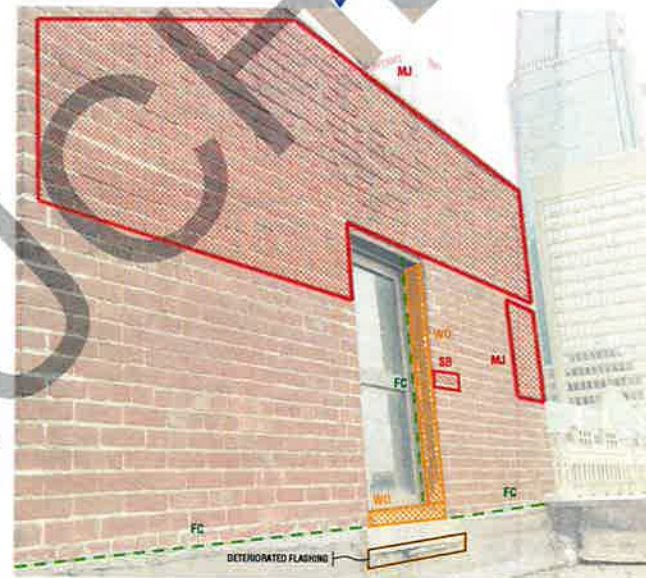
MISCELLANEOUS		OTHER FAILURE / NOTIFICATION (SEE NOTE)		PHOTOGRAPH		WINDOWS		GENERALIZED STAINING (POLLUTION AND / OR WATER RUN-OFF)
	WOOD		ROOF & SKY

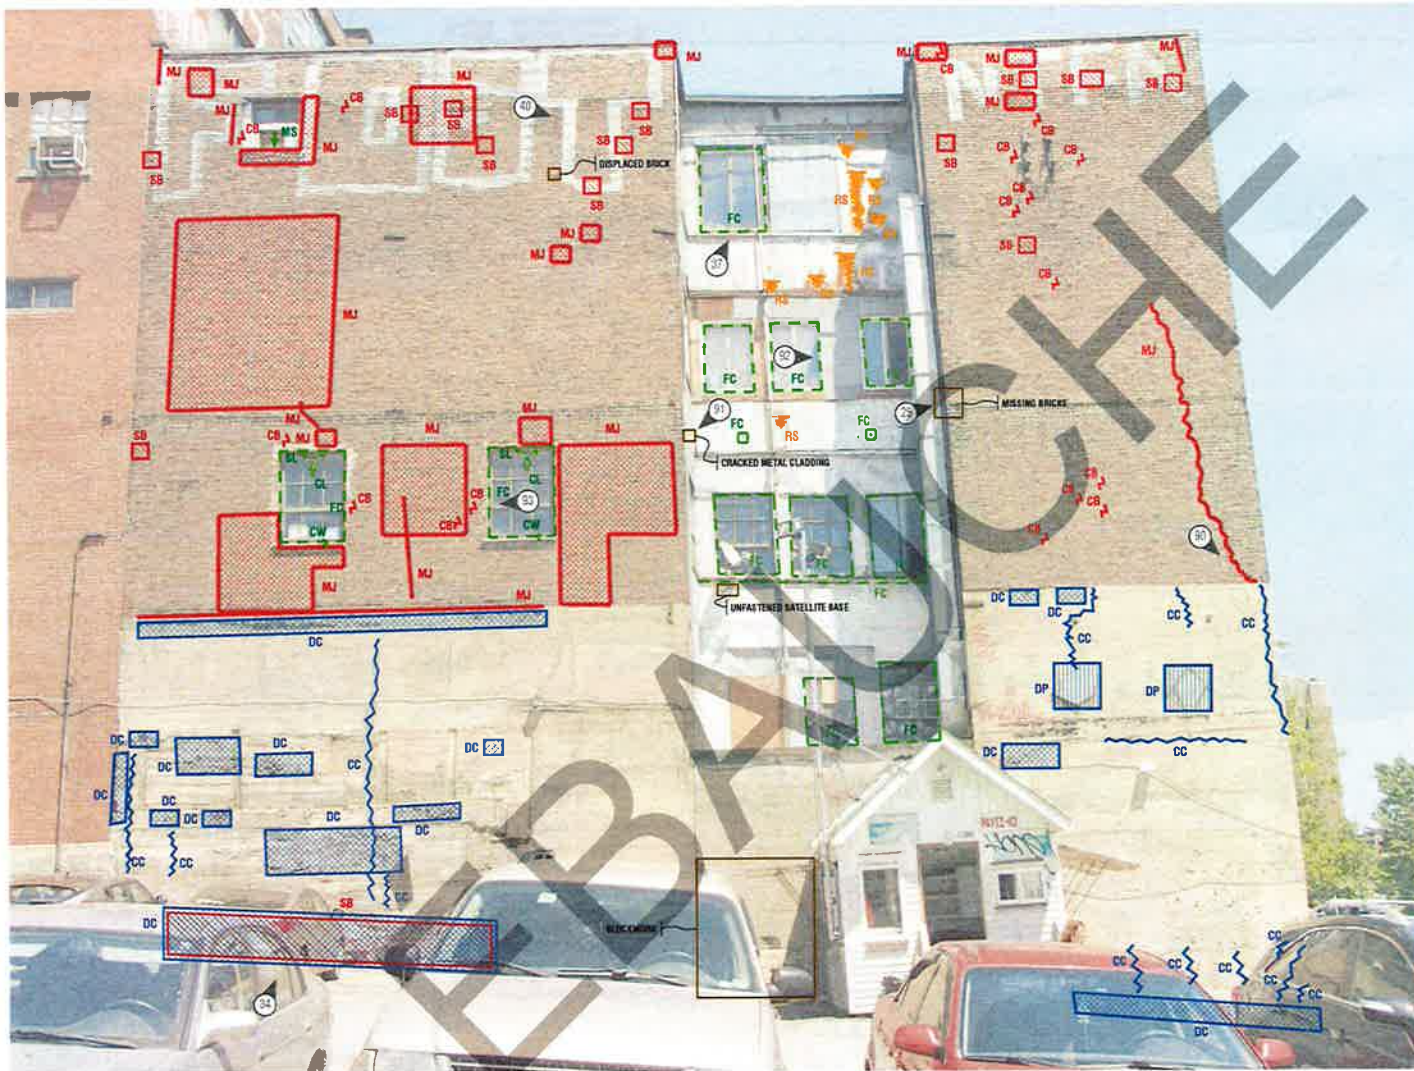
<b>MISCELLANEOUS</b>	<b>EF</b> [Blue box] <b>EFFLUENCE</b>	<b>GS</b> [Red box with white dots] <b>GENERALIZED STAINING (POLLUTION AND / OR WATER RUN-OFF)</b>
<b>OTHER FAILURE / NOTIFICATION (SEE NOTE)</b>	<b>WO</b> [Red box with white arrow] <b>DEFLECTED WINDOW</b>	
<b>PHOTOGRAPH</b>	<b>RS</b> [Red box with white arrow] <b>RESTRICTION</b>

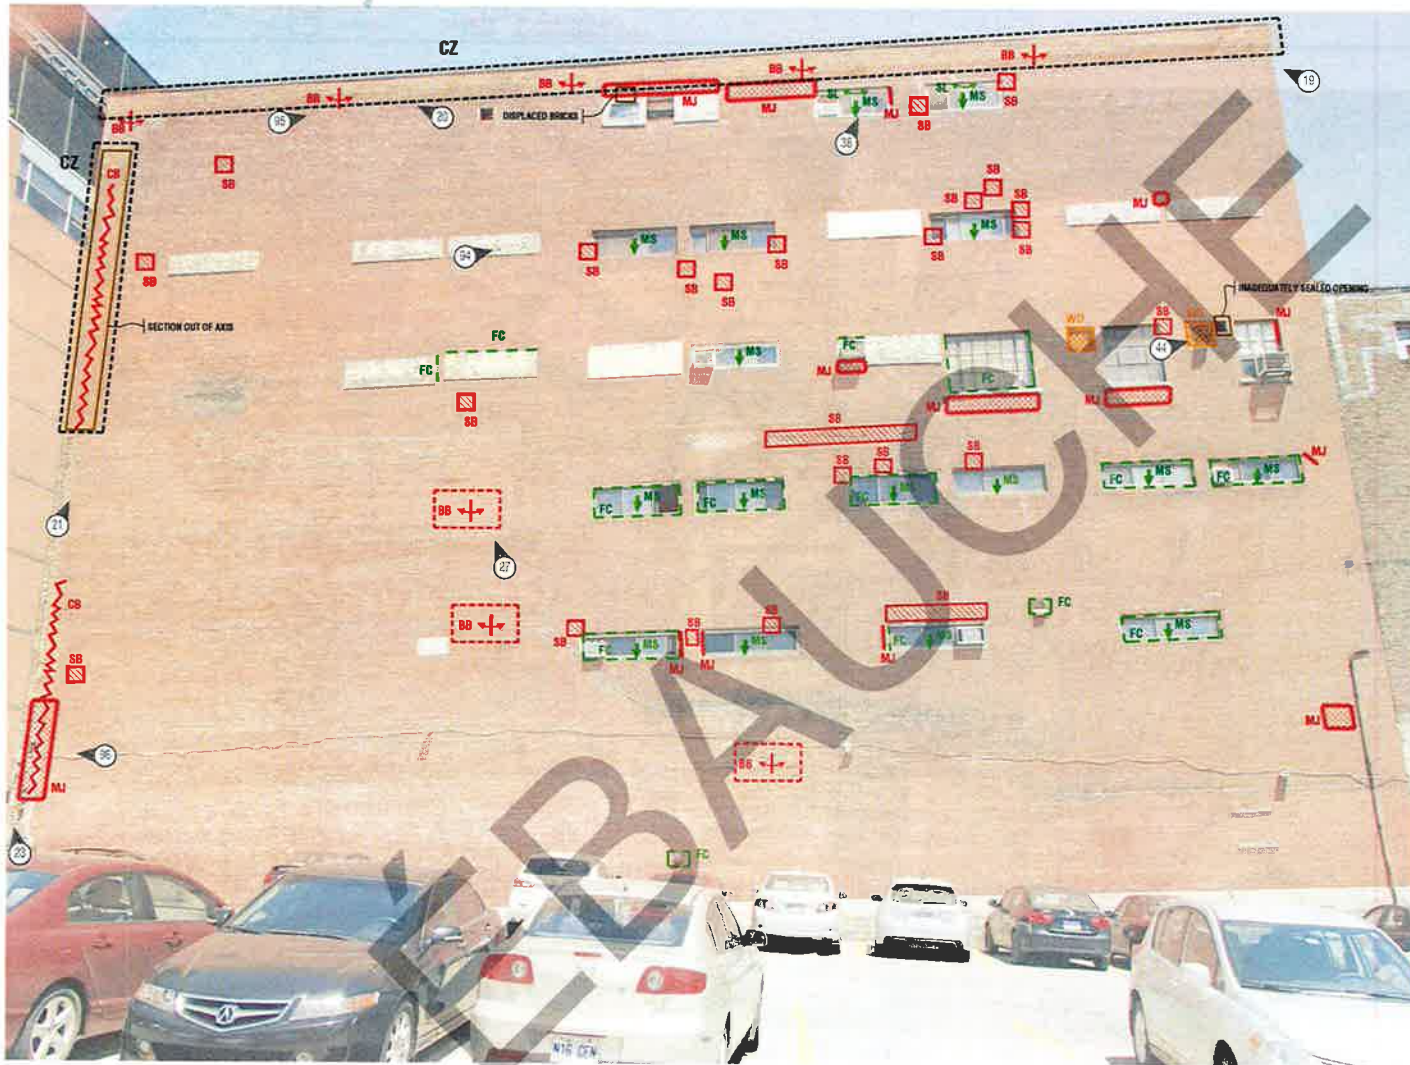
OTHER FAILURE / NOTIFICATION (SEE NOTE)  
 PHOTOGRAPH

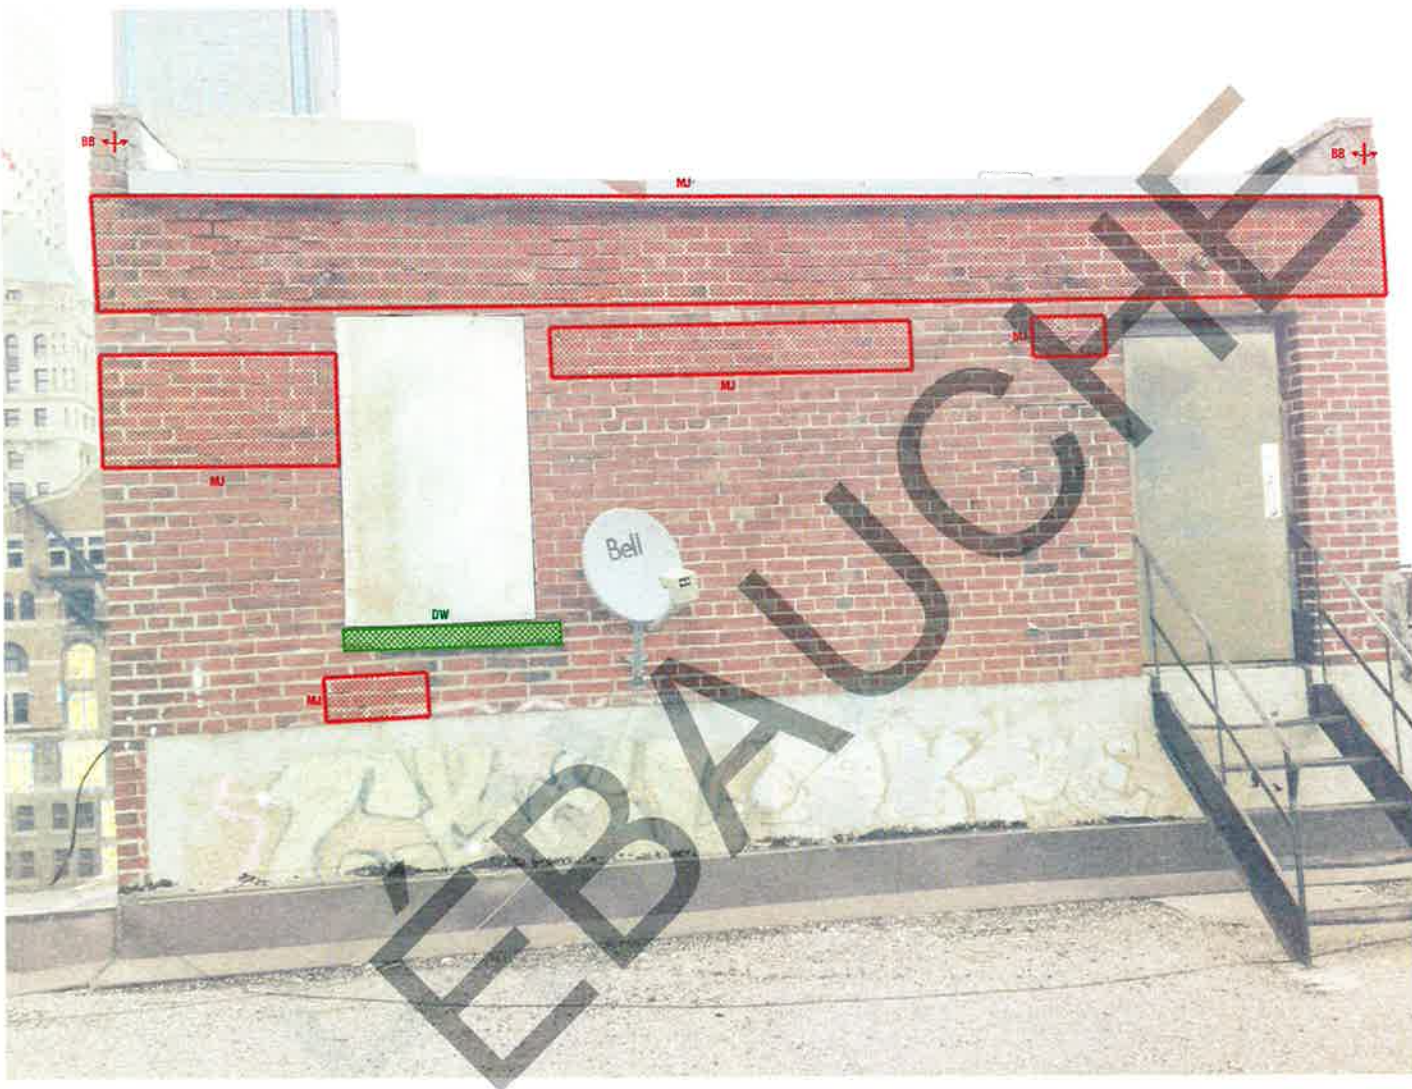
<b>MISCELLANEOUS</b>	<b>EF</b> EFFLUENTS	<b>GS</b> GENERALIZED STAINING (POLLUTION AND / OR WATER RUN-OFF)
OTHER FAILURE / NOTIFICATION (SEE NOTE)	<b>WO</b> WATER PENETRATION	
PHOTOGRAPH	<b>RS</b> RAIN SPATTER
