CONSULTATION • INVESTIGATION • DESIGN • CONSTRUCTION REVIEW

**EDIFICE** EXPERTS

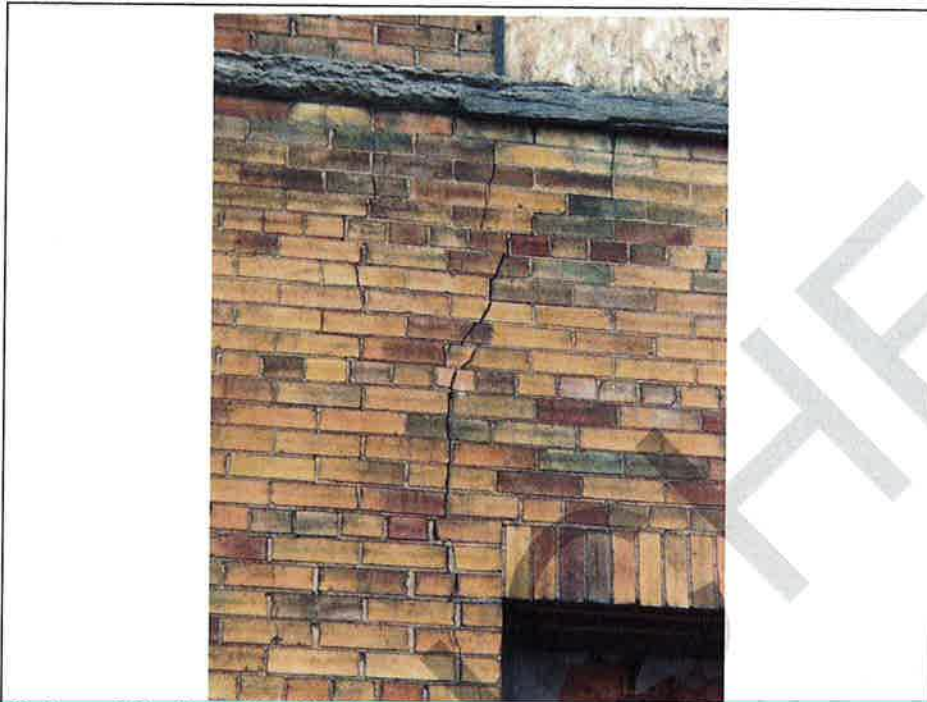
Photograph No. 47 : Building 1162 : Longitudinal cracking of bricks (west elevation)

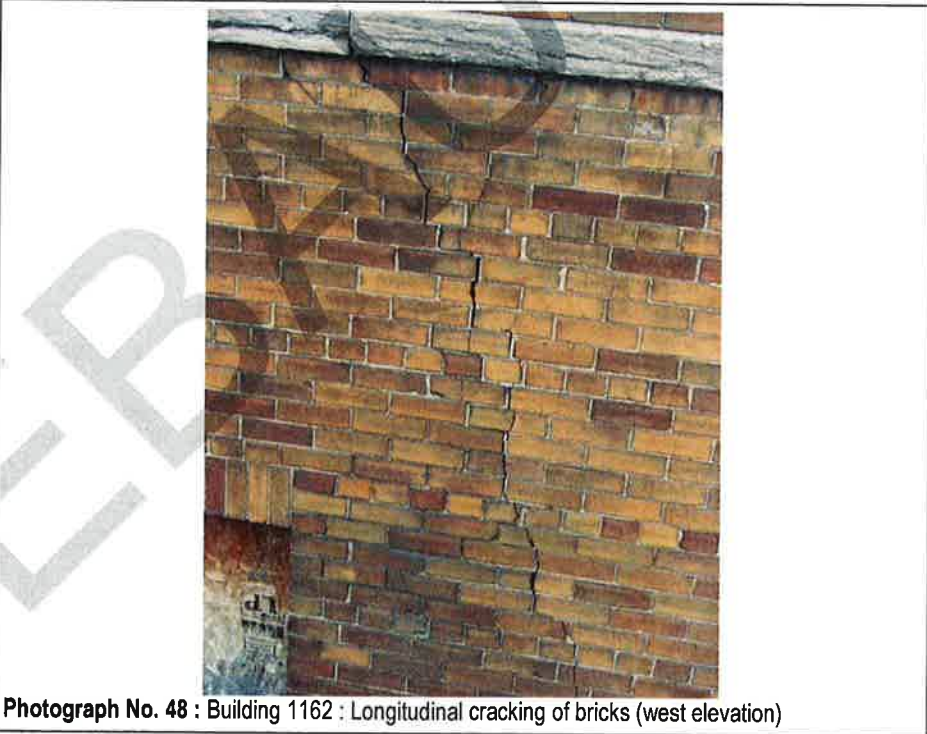
Photograph No. 48 : Building 1162 : Longitudinal cracking of bricks (west elevation)

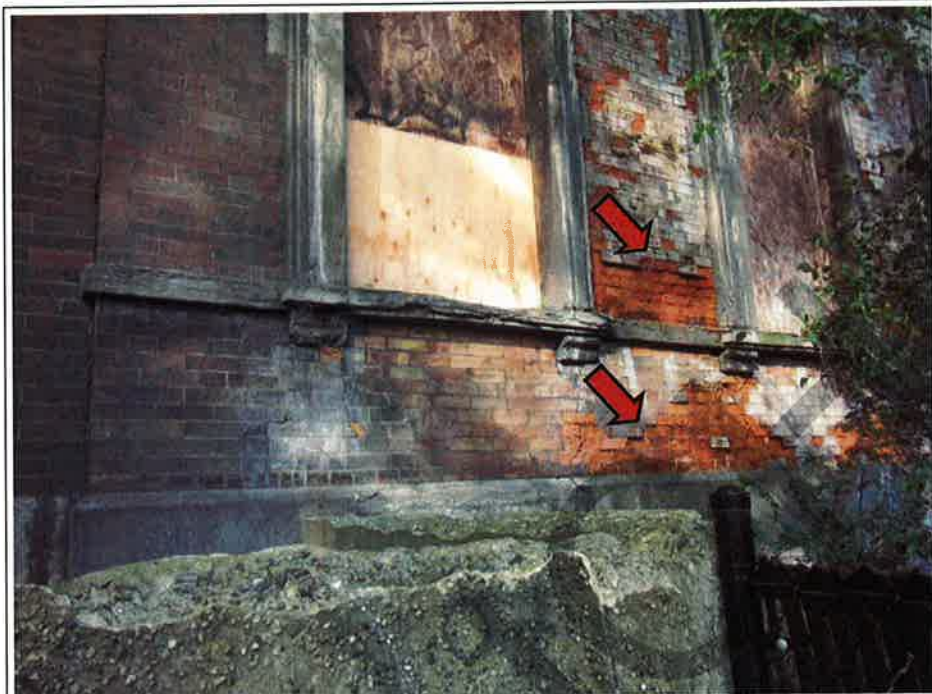
Photograph No. 49 : Building 1162 : Severe spalling of bricks (east elevation)

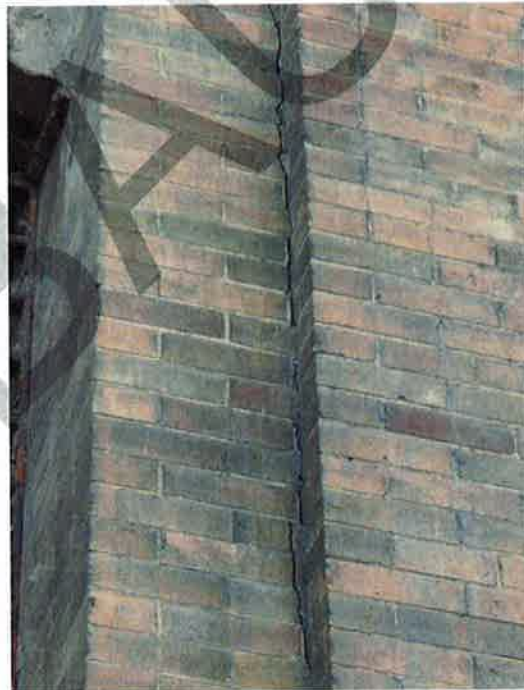
Photograph No. 50 : Building 1162 : Longitudinal cracking at brick offset (east elevation)

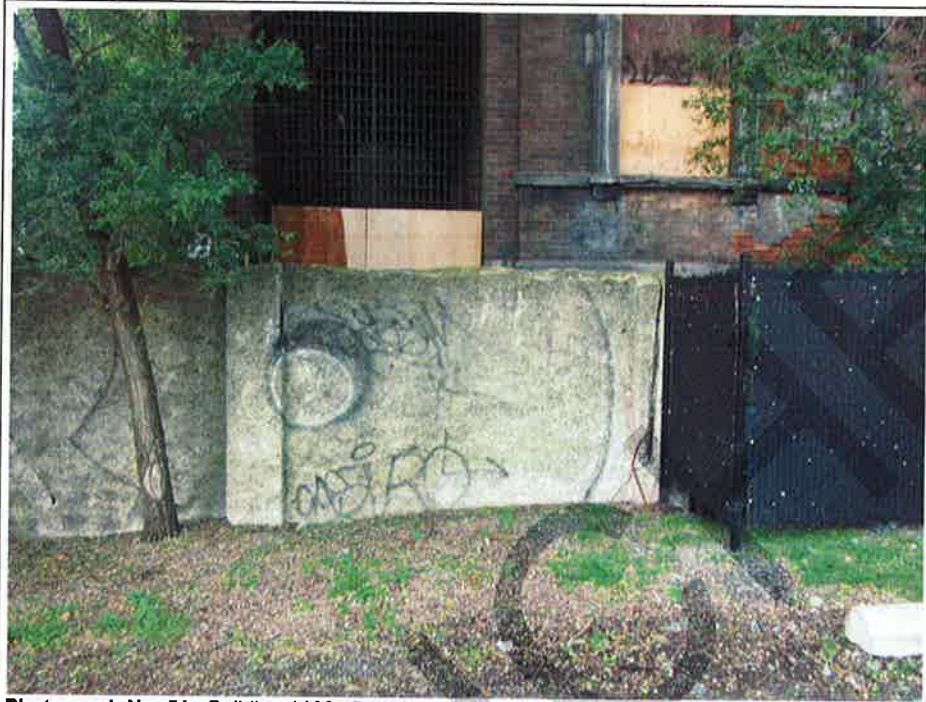
**Photograph No. 51 : Building 1162 : Deterioration of the retaining wall (parking)**

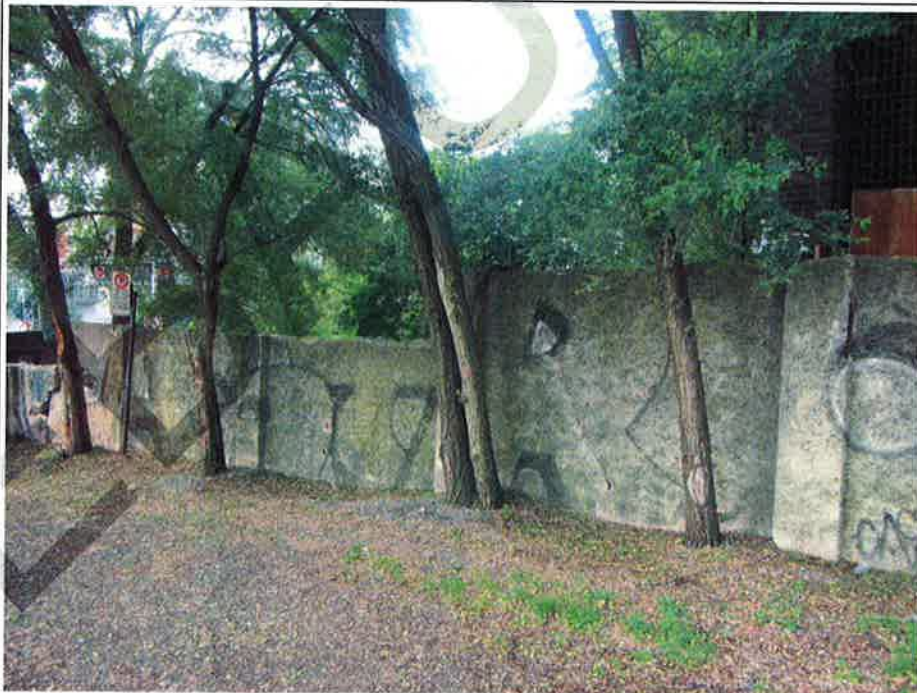
**Photograph No. 52 : Building 1162 : Deterioration of the retaining wall (parking)**

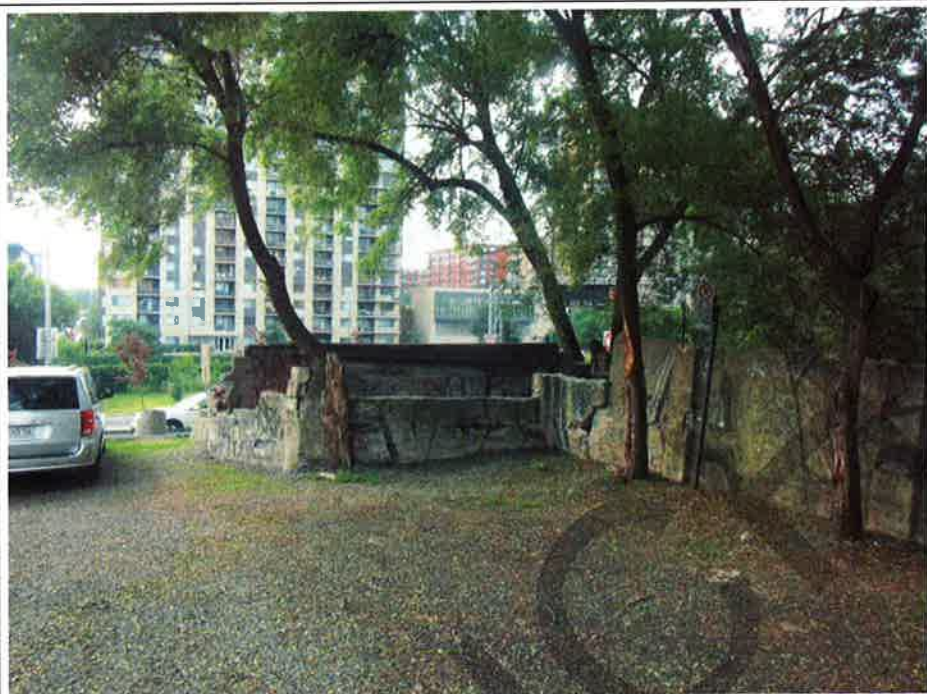
**Photograph No. 53** : Building 1162 : Deterioration of the retaining wall (parking)

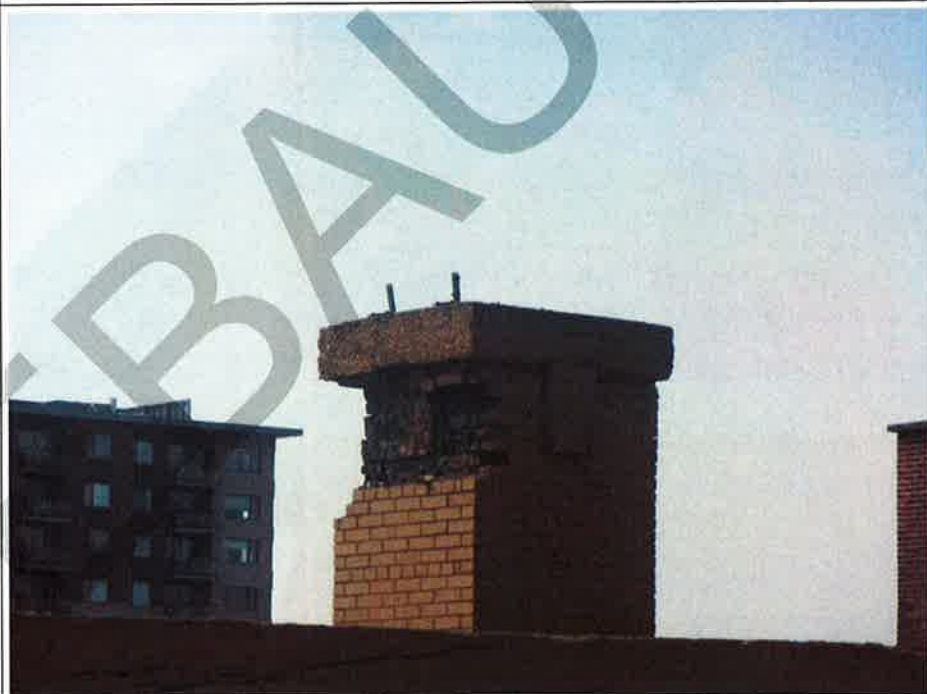
**Photograph No. 54** : Building 1162 : Missing bricks (roof level)

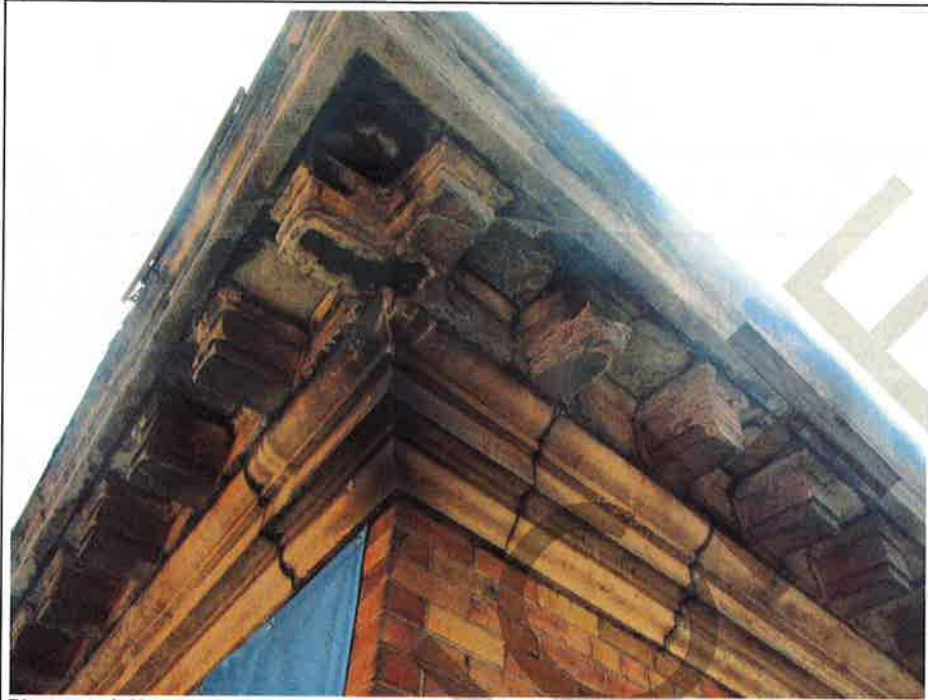
**Photograph No. 55 : Building 1162 : Stone and dentil deterioration (northwest corner)**

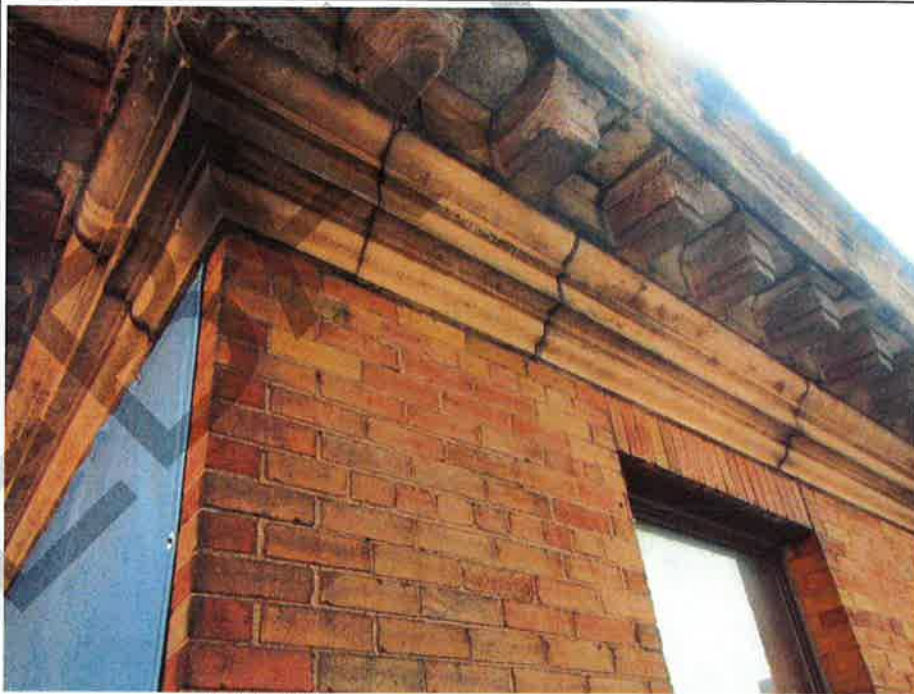
**Photograph No. 56 : Building 1162 : Erosion of string course stone (west elevation)**

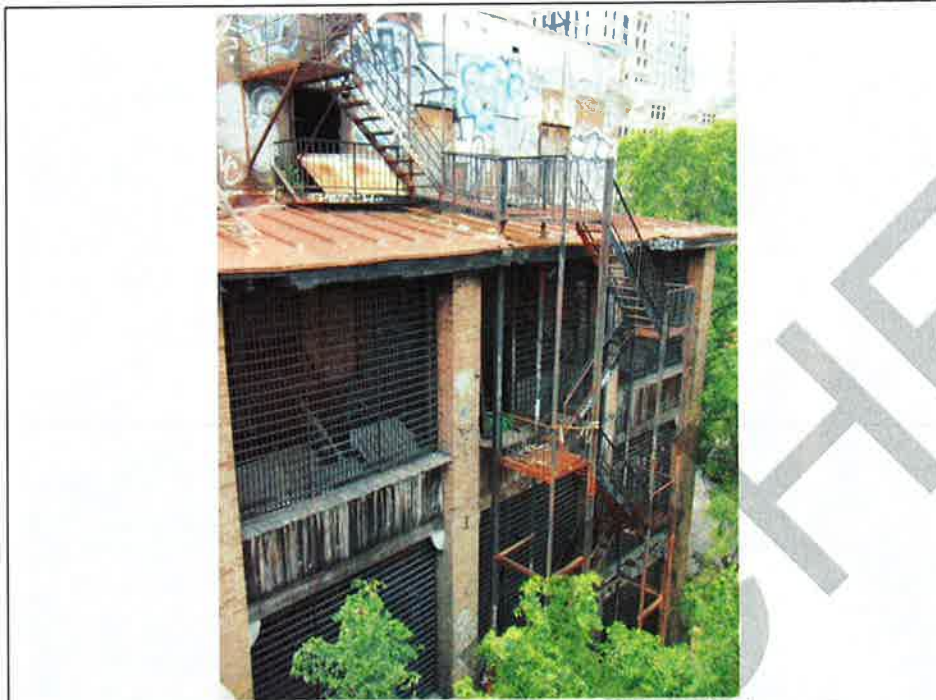
**Photograph No. 57** : Building 1162 : General view of fire damaged balconies and fire escapes (south elevation)

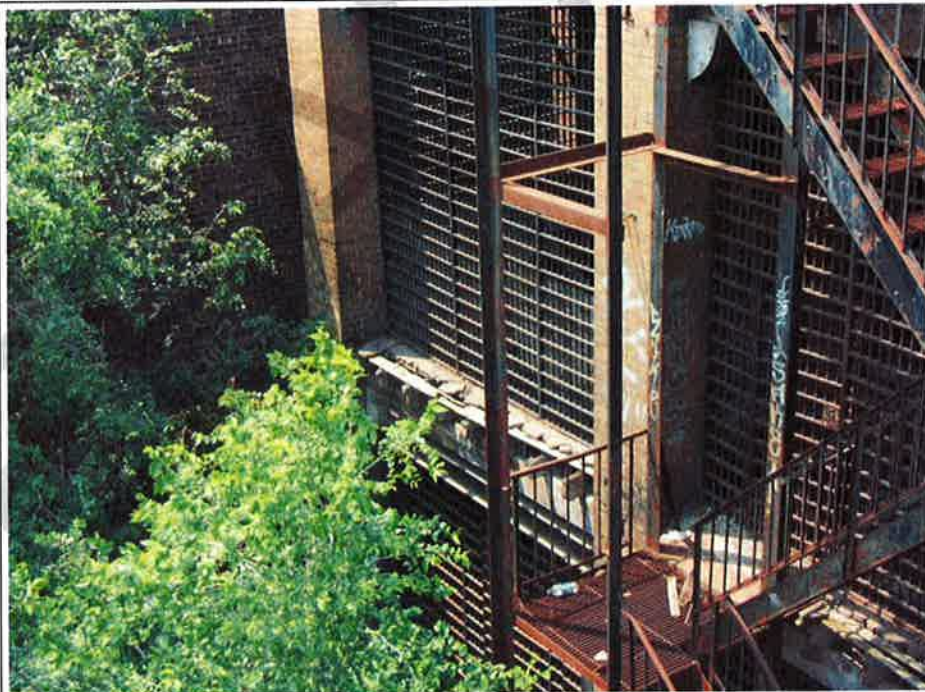
**Photograph No. 58** : Building 1162 : General view of fire damaged balconies and fire escapes (south elevation)

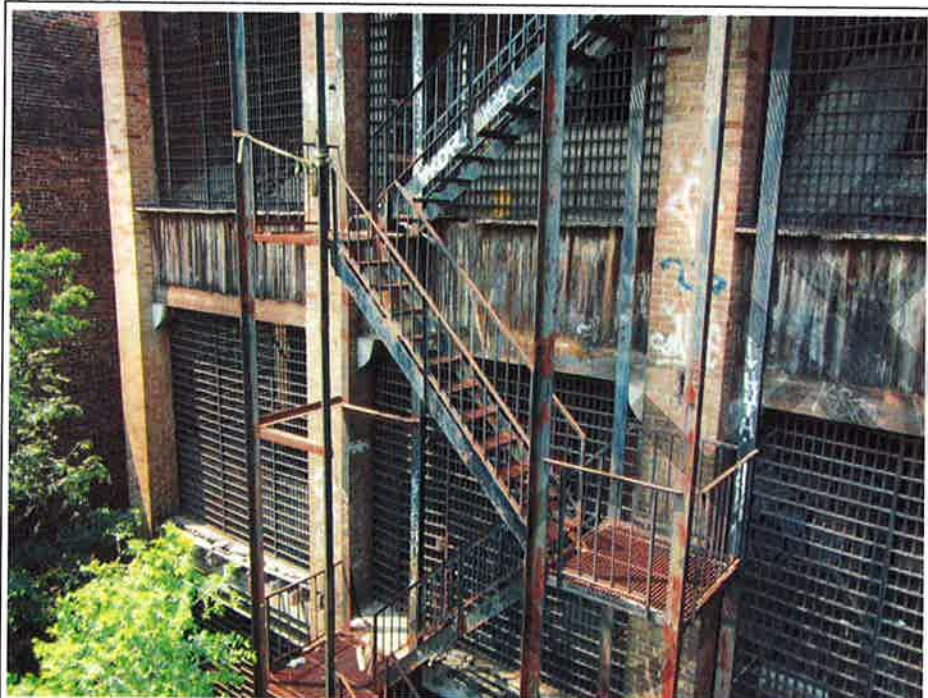
Photograph No. 59 : Building 1162 : General view of fire damaged balconies and fire escapes (south elevation)

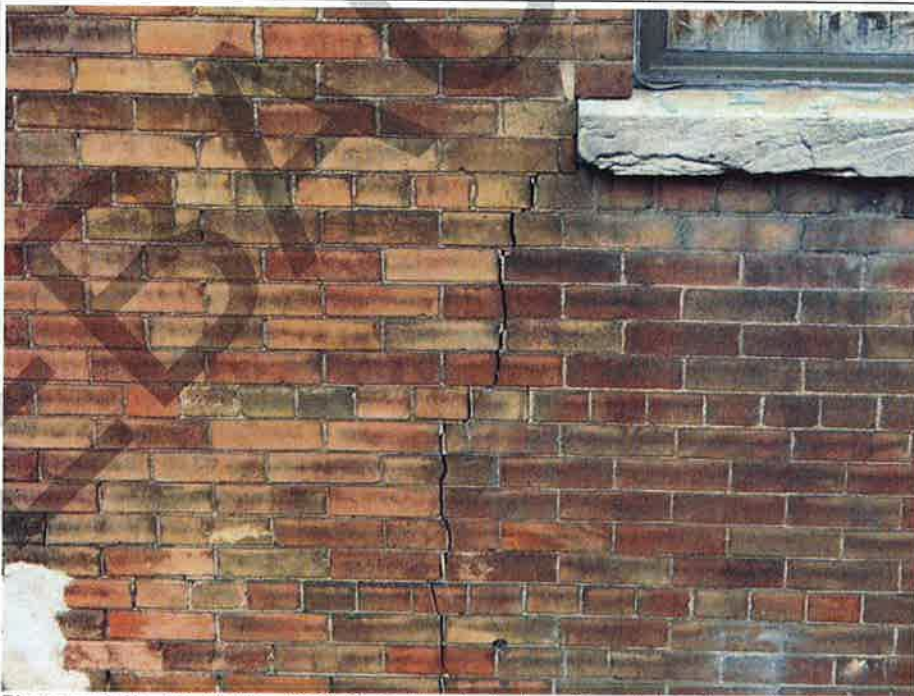
Photograph No. 60 : Building 1162 : Typical longitudinal cracking of bricks (west elevation)

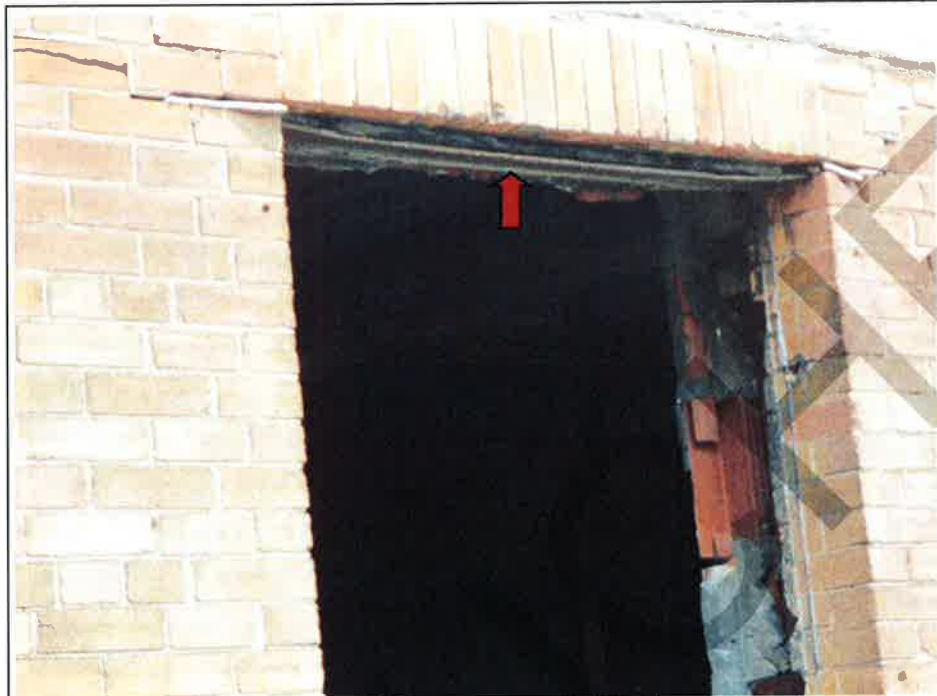
**Photograph No. 61 : Building 1162 : Severe corrosion of steel lintel (west elevation)**

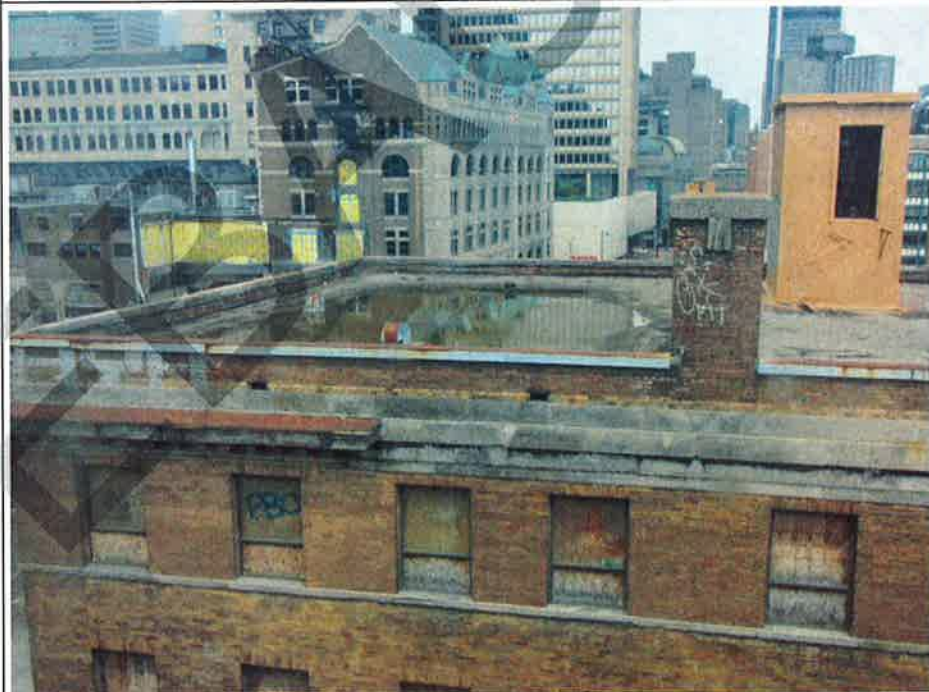
**Photograph No. 62 : Building 1162 : General view of roof level**

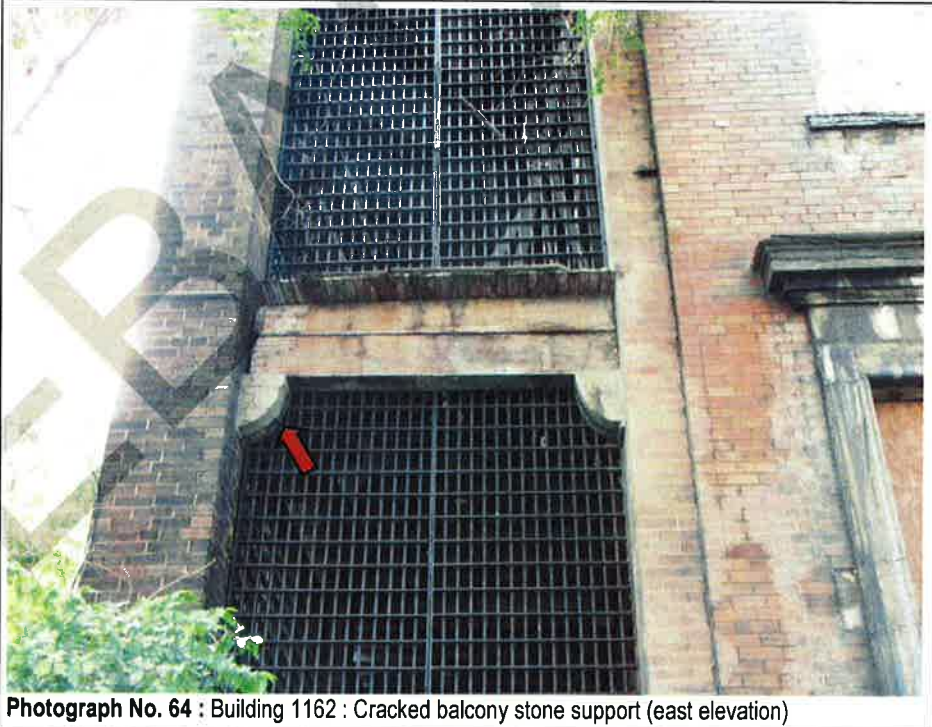
**Photograph No. 64** : Building 1162 : Cracked balcony stone support (east elevation)

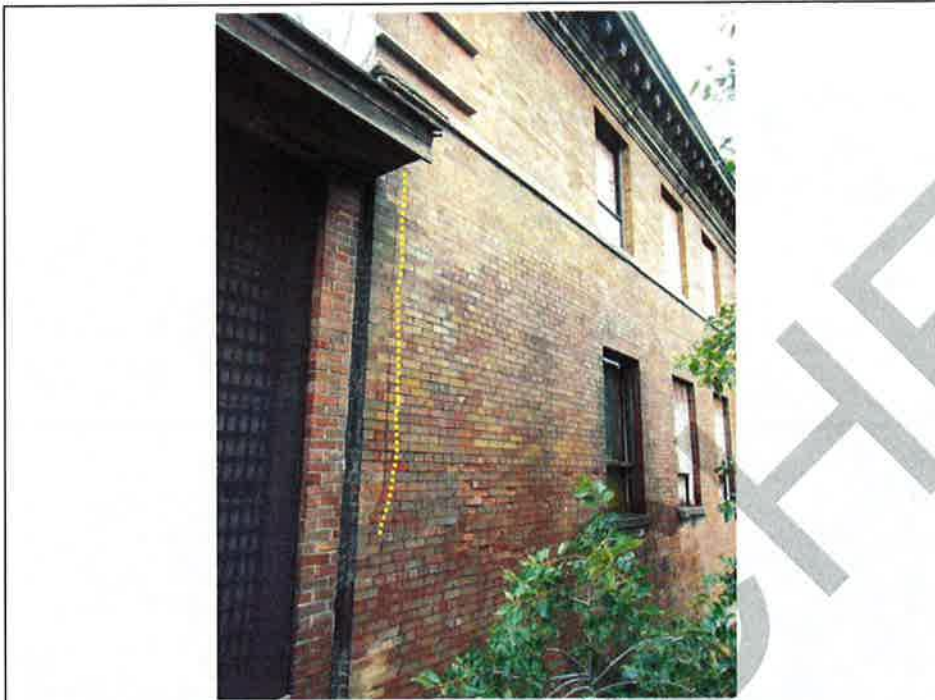
**Photograph No. 65** : Building 1162 : Longitudinal cracking of bricks at corner (east façade)

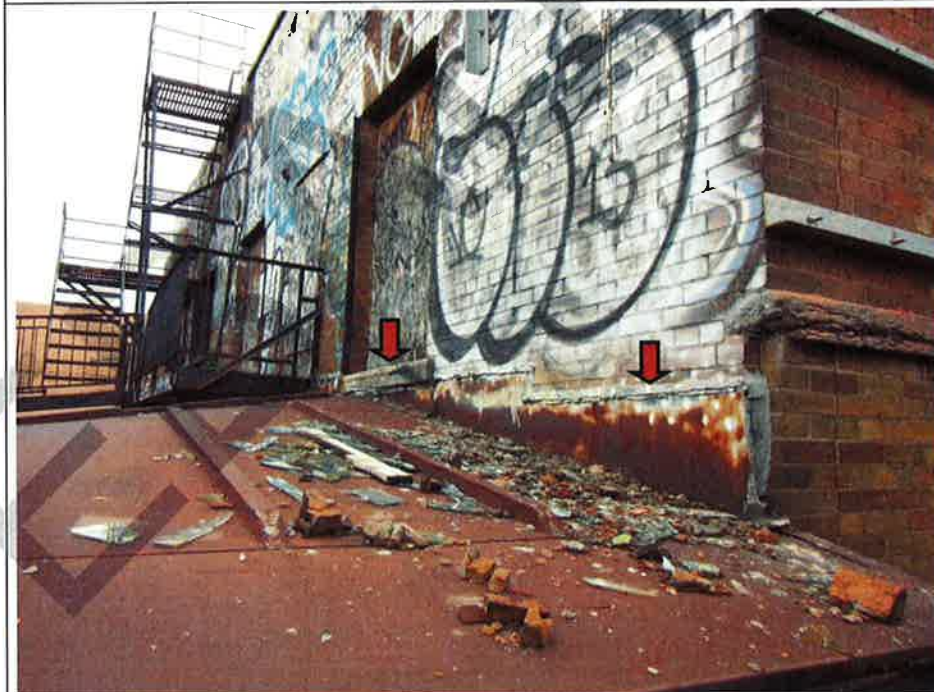
**Photograph No. 66** : Building 1162 : Deteriorated caulking at roof junction, excessive debris accumulation and cracked stone window sill (south elevation)

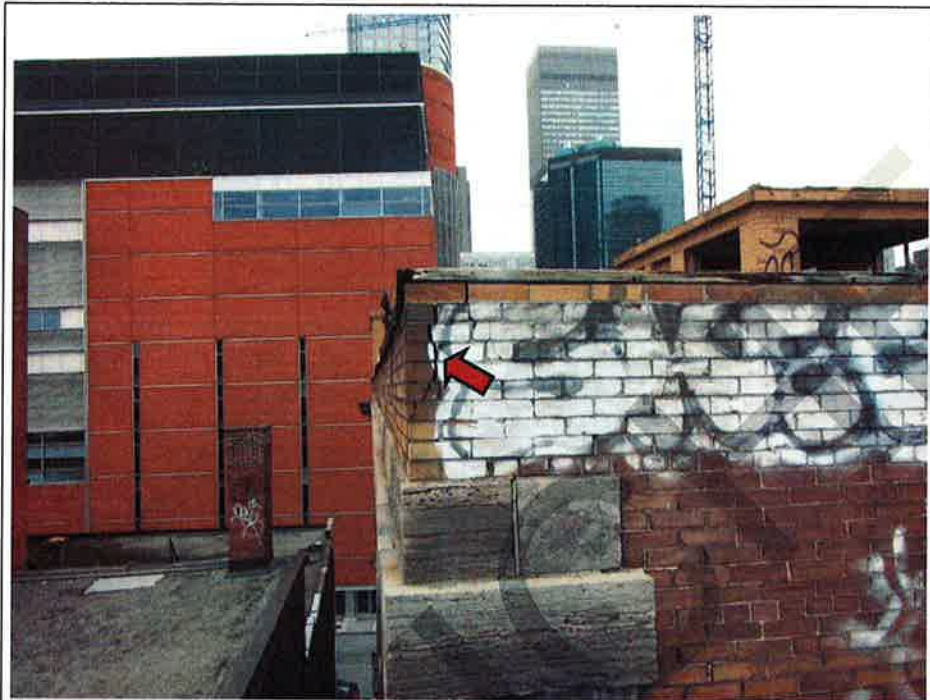
Photograph No. 67 : Building 1162 : Cracked masonry (southwest corner)

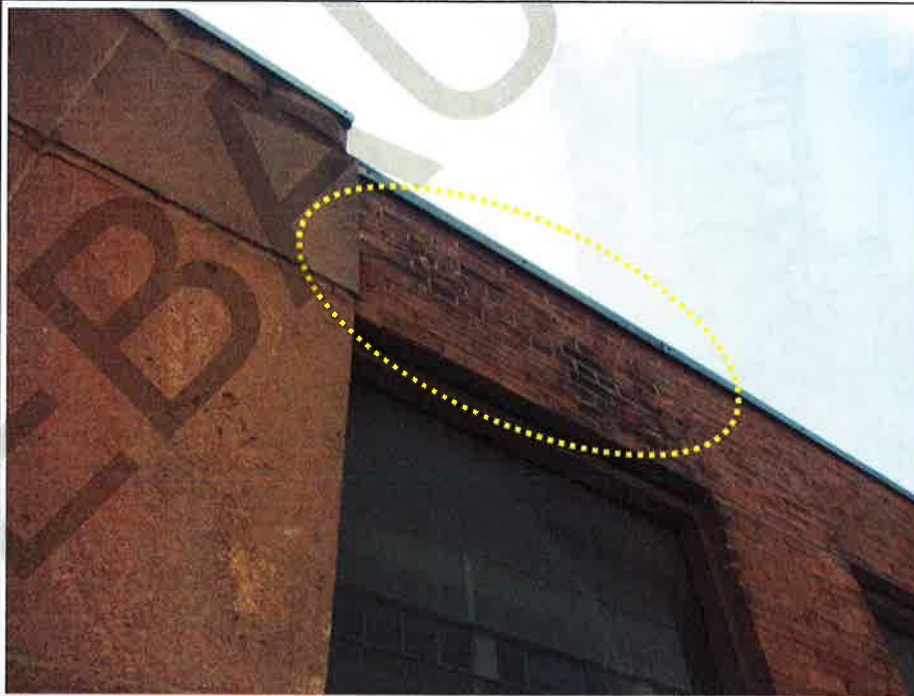
Photograph No. 68 : Building 1180 : Minor bowing of bricks (north elevation)

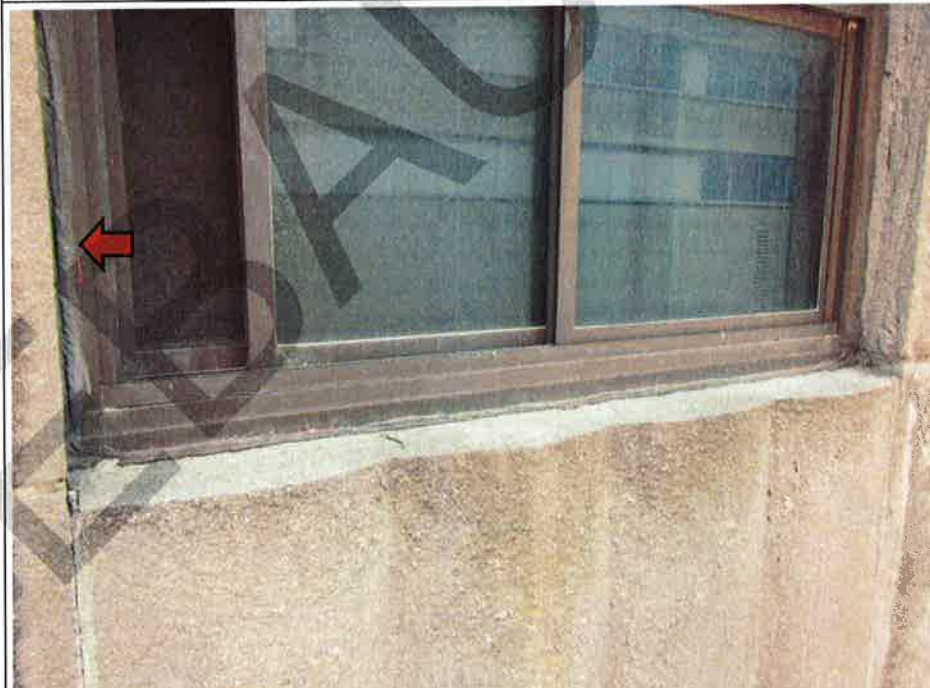
**Photograph No. 70** : Building 1180 : Cohesive failure of caulking (north elevation)

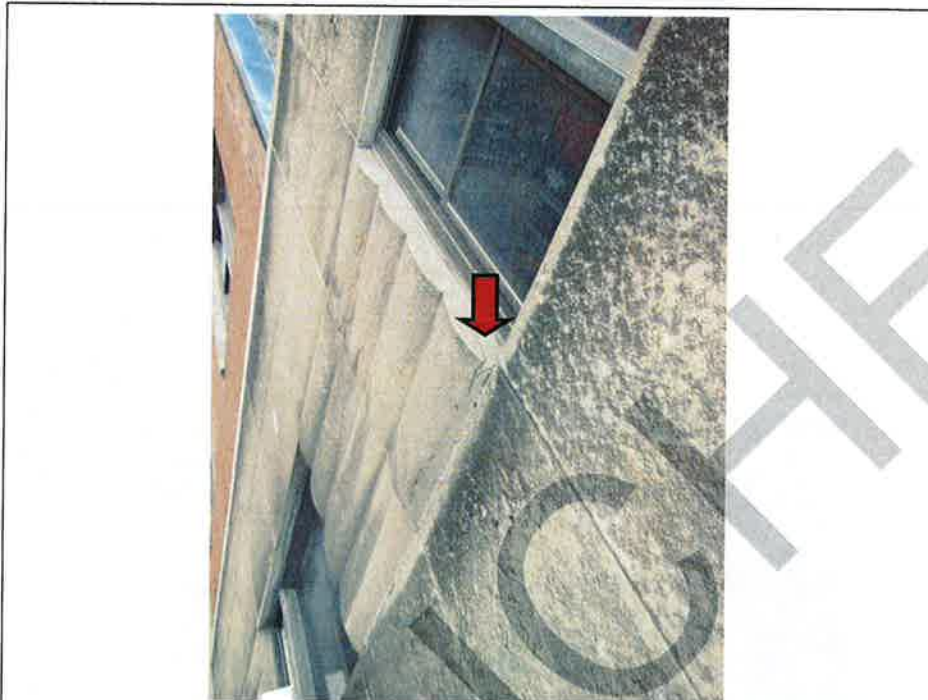
Photograph No. 71 : Building 1180 : Delamination of stone panel (**CRITICAL CONDITION**) (north elevation)

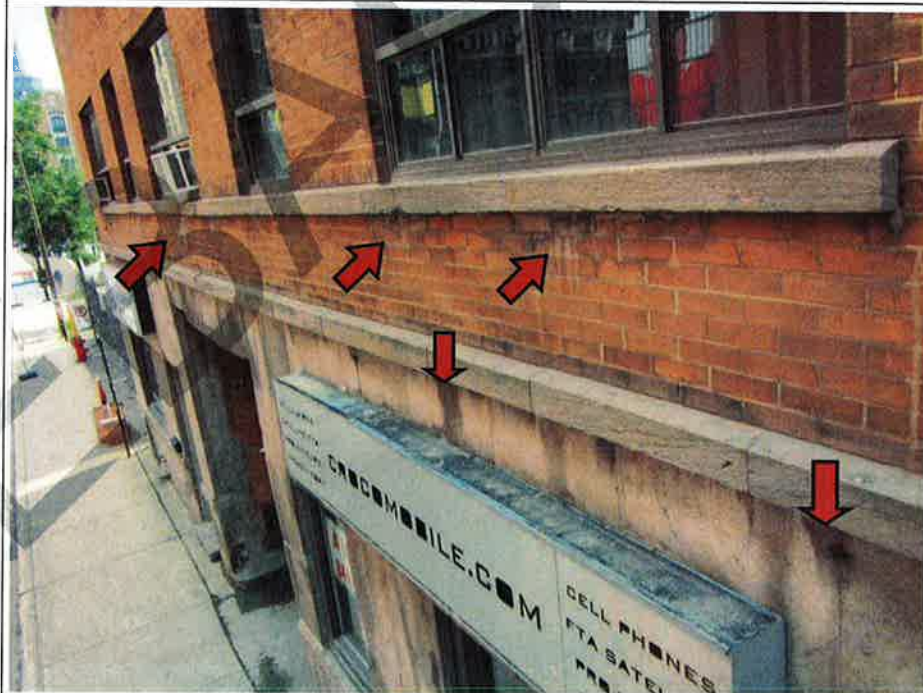
Photograph No. 72 : Building 1180 : Staining of stone and bricks (north elevation)

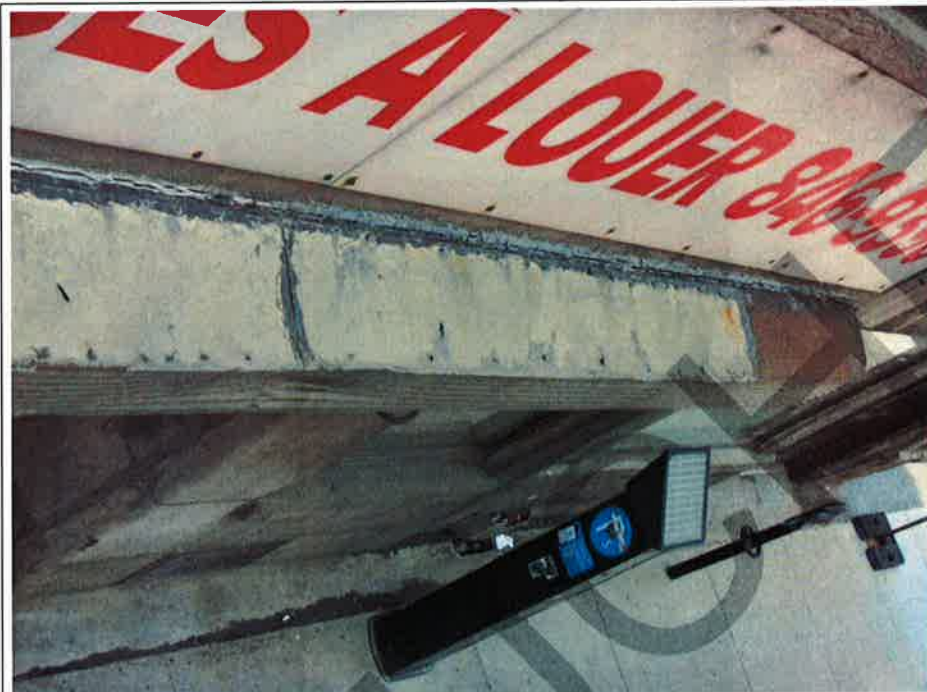
Photograph No. 73 : Building 1180 : Cohesive failure of caulking at metal flashing (north elevation)

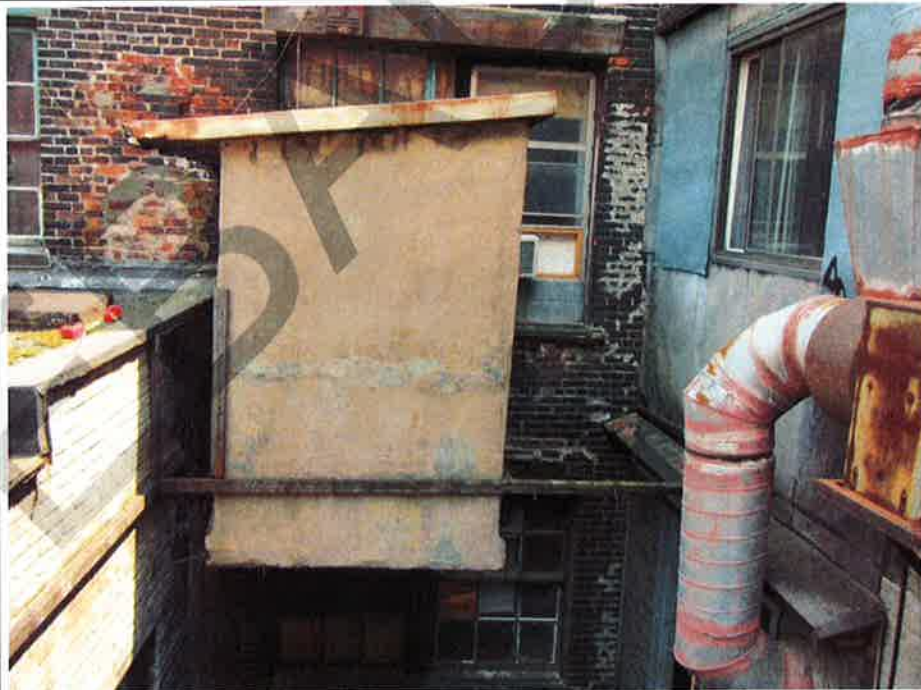
Photograph No. 74 : Building 1180: Overhanging room above courtyard (roof level)

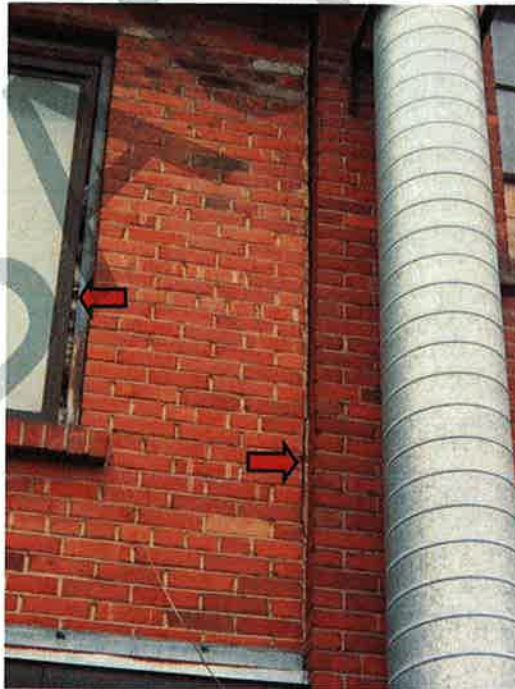
**Photograph No. 80 :** Building 1180: Poor window frame detail and inadequate detailing at masonry wall offset (east elevation – roof level)

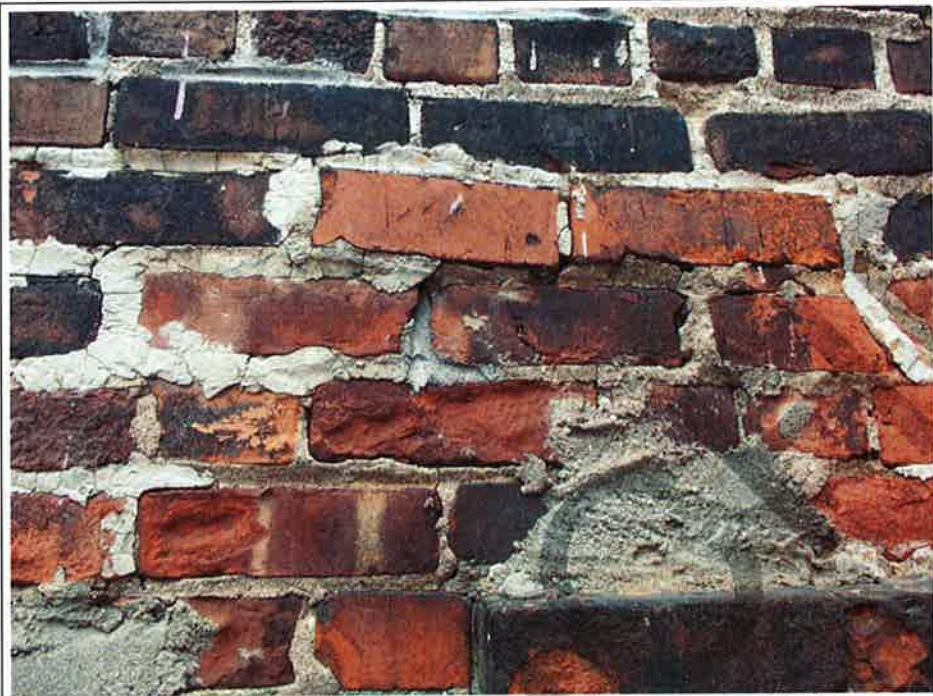
**Photograph No. 81** : Building 1180 : Typically poorly repointed mortar jointing (north elevation – roof level)

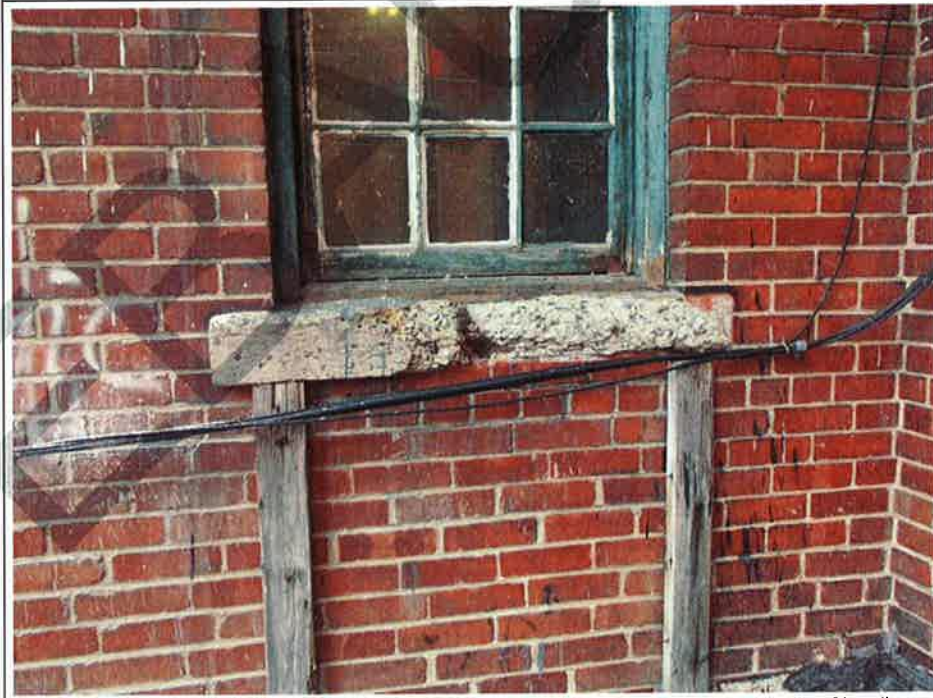
**Photograph No. 82** : Building 1180 : Spalled concrete window sill (north elevation – roof level)

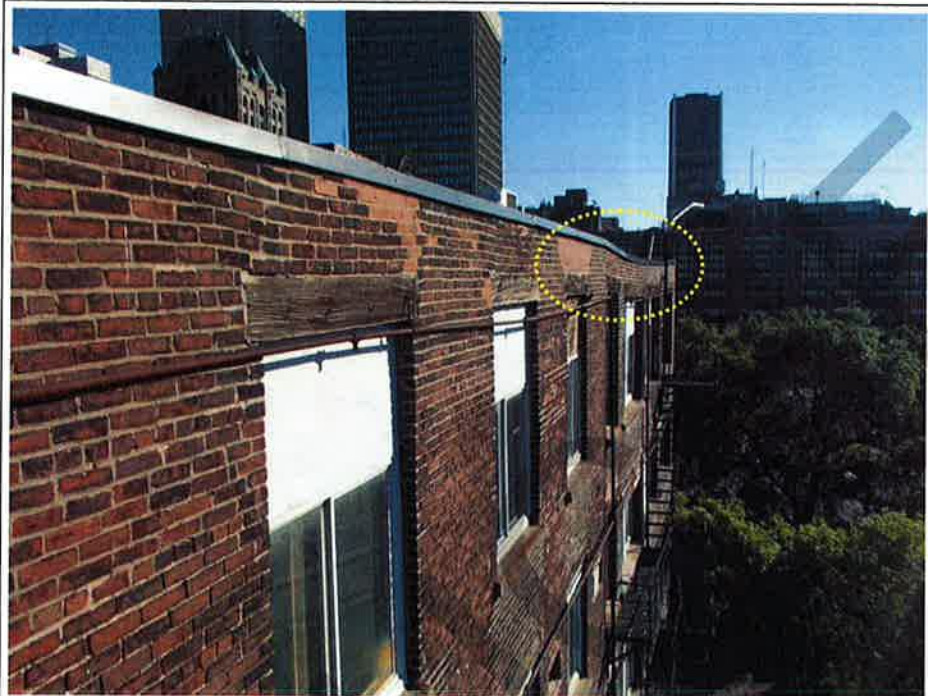
**Photograph No. 83 :** Building 1180 : Apparent localized severe settlement in building facade (all windows, sills and brick pattern beneath dip in parapet are significantly offset) (south facade)

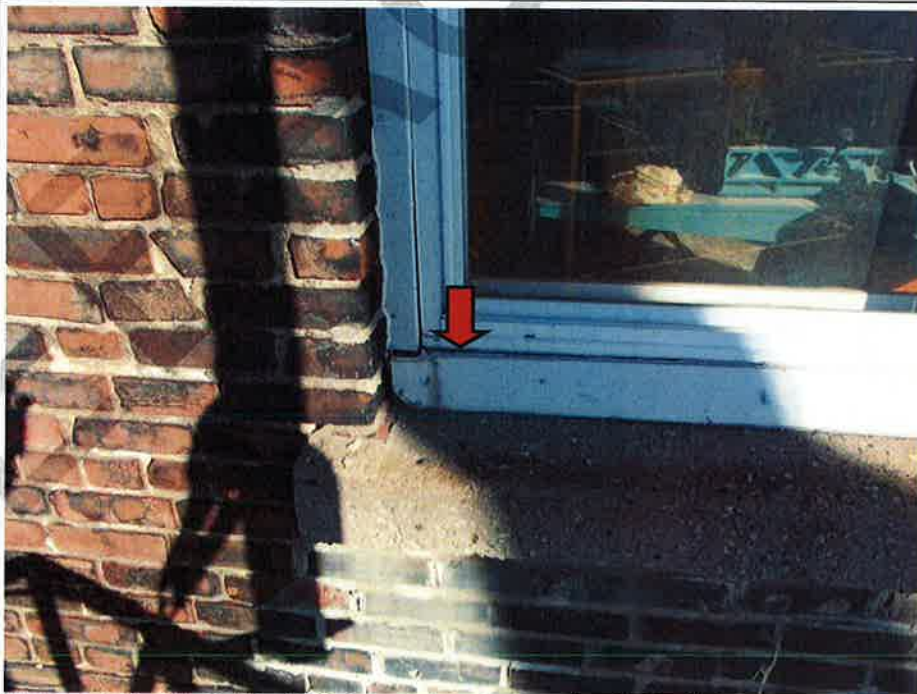
**Photograph No. 84 :** Building 1180: Damaged window frame (south elevation)

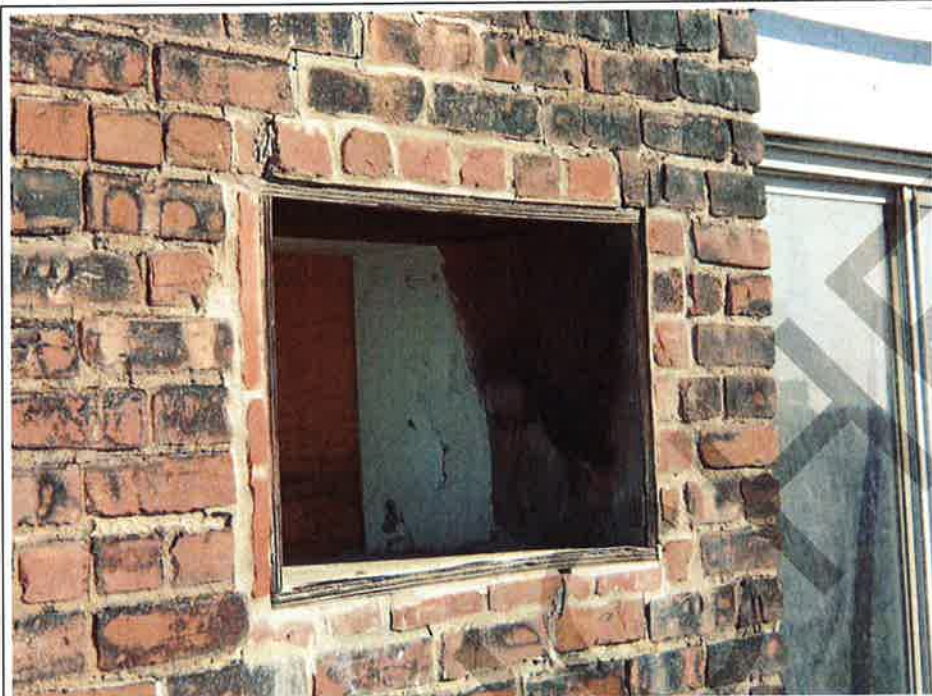
**Photograph No. 85** : Building 1180: Typical inadequate waterproofing at opening through wall (south elevation)

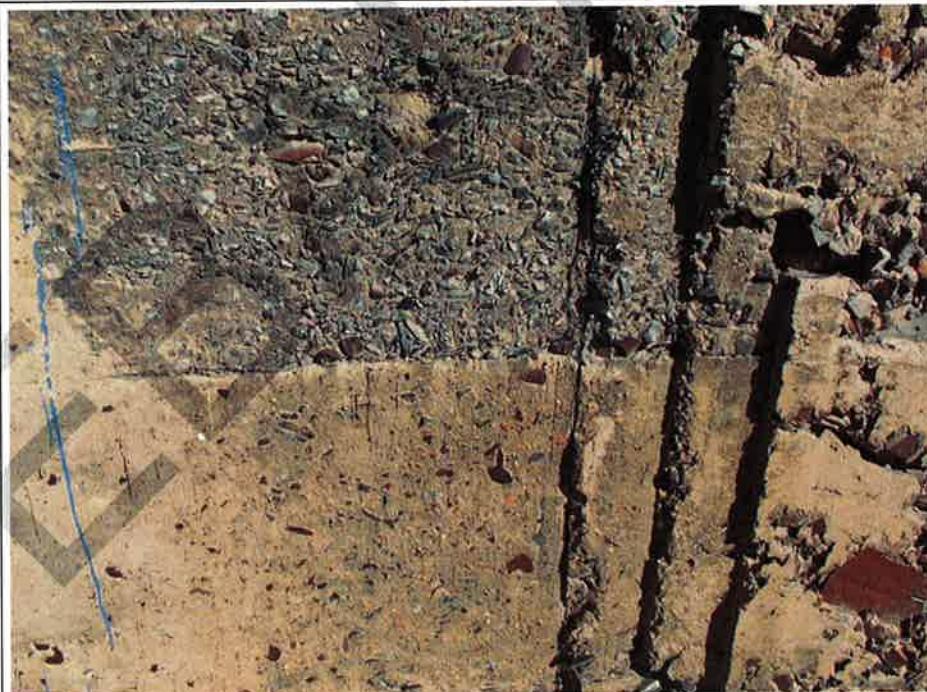
**Photograph No. 86** : Building 1180: Typical aggregate settlement and honeycombing of concrete wall (south elevation)
