Ville de Montréal

**TRUNK SEWER INSPECTION AND
CONDITION ASSESSMENT STUDY**

Project Bonaventure

DRAFT REPORT

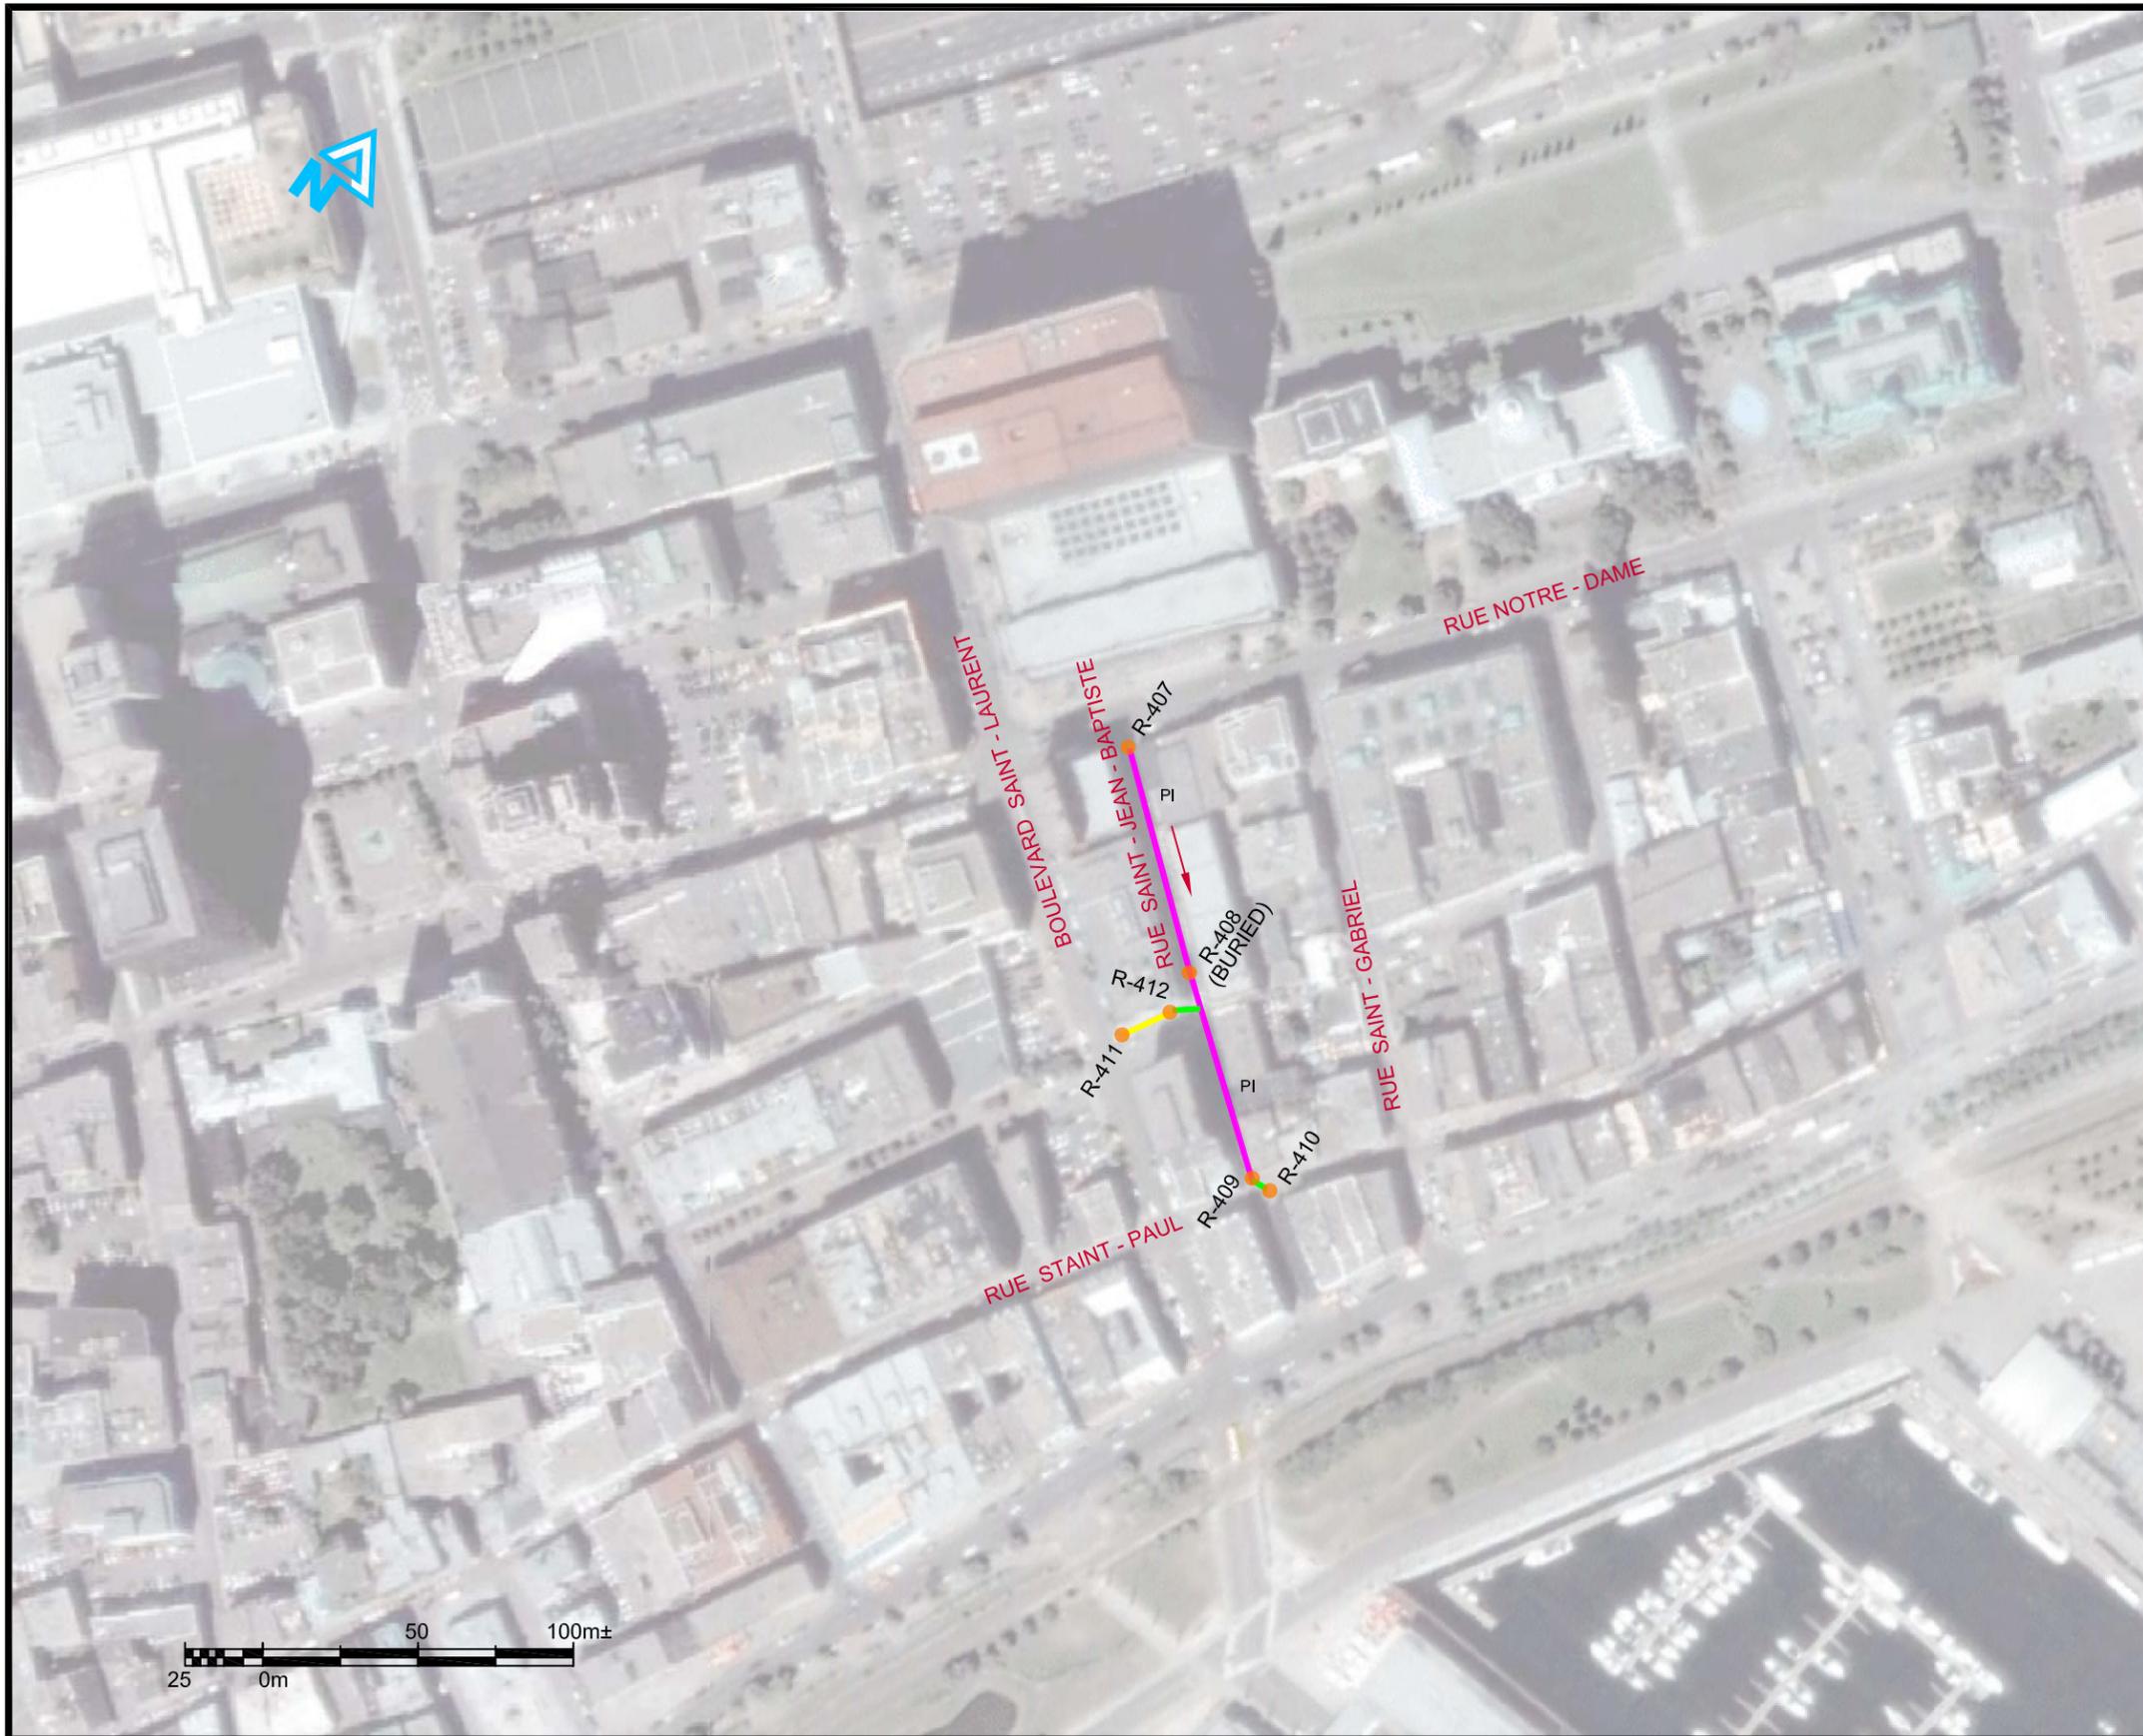
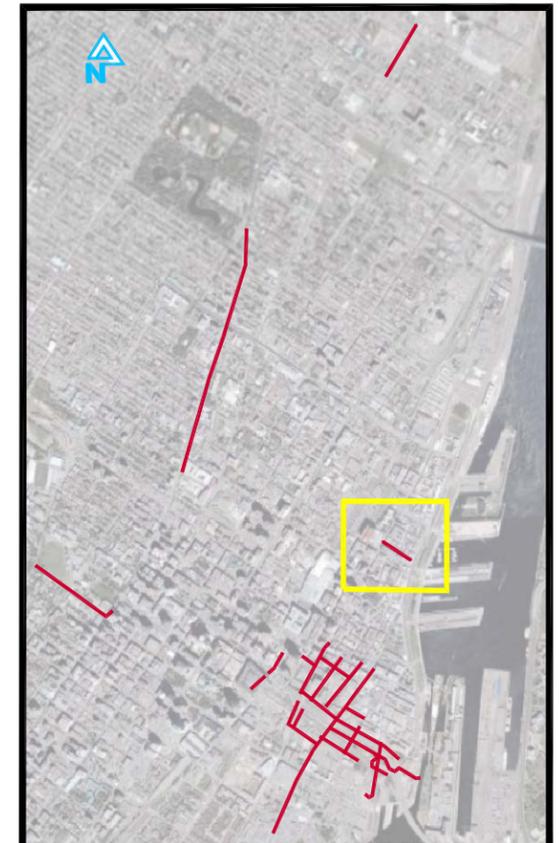
General: This sewer comprises 4 sections of 900 x 600 mm egg shaped brick pipe and one section of 600 mm circular concrete. Detailed inspection observations are provided in Table 2-3 and Figure 2-3. Longitudinal fractures at the crown and some deformation observed (see photograph in Chapter 3). Longitudinal cracks and cracked bricks (shrinkage cracks) observed. This sewer is otherwise structurally sound.

Sewer Section	Observations	Grade
MH 303-30-301 to MH 303-30-300	900x600 mm Egg shaped Concrete, 5% Water level, D/S Debris – Concrete 10%, Sewer deviates down marginal Longitudinal crack 2:00 at 5.9 m, Infiltration running at crack	Fair. Due to infiltration, crack. (1 Section)
MH 303-30-300 to MH 303-30-299	900x600 mm Egg shaped Concrete, 5% Water level D/S Missing mortar, Infiltration running	Poor. Due to infiltration. (1 Section)
MH 303-30-299 to MH 303-30-298	900x600 mm Egg shaped Brick, 5% Water level D/S Missing mortar, Bricks displaced, Sewer deviates left – slight, Infiltration running throughout, Infiltration gushing throughout	Bad. Due to infiltration. (1 Section)
MH 303-30-298 to MH 303-30-297	900x600 mm Egg shaped Brick, 5% Water level D/S Missing mortar, Bricks displaced, Vertical deformation 5% Longitudinal fractures: 12:00 at 2.0, 58.9 m Infiltration running – 2:00 at 51.6 m, 5:00 at 22.2 m, 8:00 at 37.9, 38.9 m, 9:00 at 48.5 m, Gushing infiltration – 5:00 at 5.9, 23.0, 32.1 m, 6:00 at 56.2, 59.2, 61.1, 7:00 at 52.3 m	Bad. Due to fractures, infiltration. (1 Section)

MH 303-30-297 to MH 303-30-296	900x600 mm Egg shaped Brick, 5% Water level D/S Missing bricks, Sewer change: Material – concrete, Shape – concrete, Dimension – 600 mm	Bad. Due to missing bricks. (1 Section)
MH 303-30-296 to MH 303-30-295	900x600 mm Egg shaped Brick, 5% Water level D/S Missing mortar, Bricks displaced, missing, Vertical deformation 5 to 10%, Longitudinal fracture 12:00 at 17.9, Longitudinal crack 10:00 & 2:00 at 49.5 m, Infiltration running at 48.5, dripping at 48.9 m	Bad. Due to missing bricks, fracture, infiltration. (1 Section)
MH 303-30-295 to MH 303-30-294	900x600 mm Egg shaped Brick, 5% Water level, D/S Missing mortar, Missing mortar medium, Bricks displaced Longitudinal fracture 12:00 at 0.1 m, Infiltration dripping at 43.6 m	Poor. Due to fracture. (1 Section)
MH 303-30-294 to MH 303-30-293	D/S 900x600 mm Egg shaped Brick, 5% Water level Missing mortar medium, Bricks displaced, Debris – Rubble 5 to 15%, Longitudinal fracture 12:00 11.8 m U/S 900x600 mm Egg shaped Brick, 15% Water level Debris – 10 to 15%, Survey abandoned due to overlap	Poor. Due to fracture. (1 Section)
